Summary of Observations

Table 1
Franklin, Ma
Summary of Observations
Made During Structural Inspection

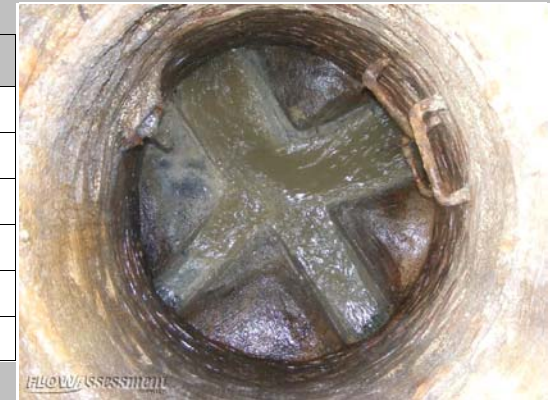
ITEM	MATERIAL	CONDITION	Leaks (gpm)	Photo	DEFECTS
FRAME	CAST	1			
CORBEL	BRICK/PARGED	2			Missing mortar, loose pieces
STEPS	STEEL	2			Corroded
WALLS	BRICK/PARGED	2			Very light mineral deposits
FLOOR	BRICK/PARGED	1			
INVERT	BRICK	1

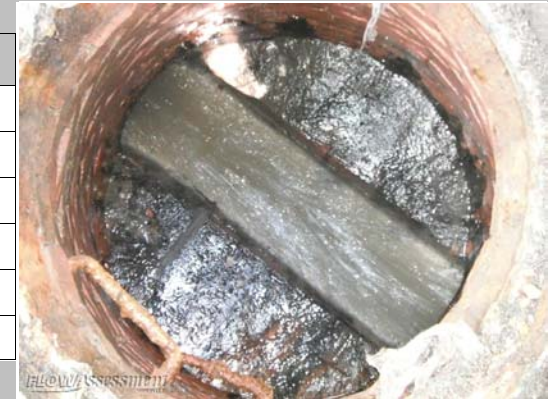
ITEM	MATERIAL	CONDITION	Leaks (gpm)	Photo	DEFECTS
FRAME	CAST	2			Corroded
CORBEL	BRICK	2			Missing mortar
STEPS	STEEL	2			Corroded
WALLS	BRICK	2			Wet to 2', mineral deposits
FLOOR	BRICK/PIP	2			Mineral deposits
INVERT	BRICK	1

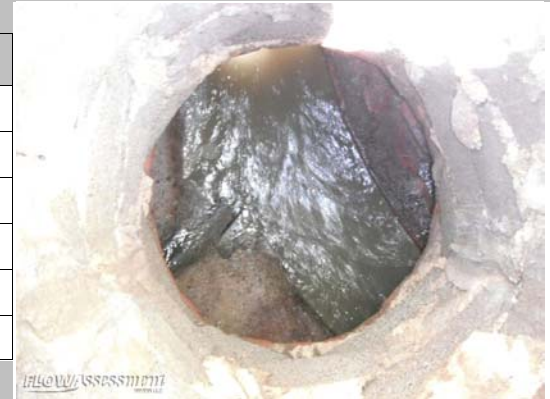
ITEM	MATERIAL	CONDITION	Leaks (gpm)	Photo	DEFECTS
FRAME	CAST	1			
CORBEL	BLOCK	1			
STEPS	NONE	0			
WALLS	BRICK	2			Roots, mineral deposits
FLOOR	BRICK	2			Loose pieces, roots
INVERT	BRICK/PIP	2			Loose pieces

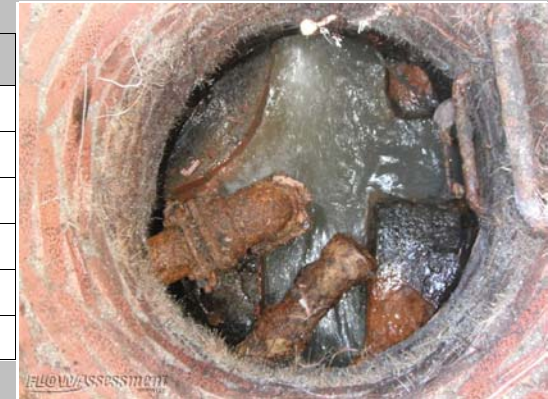
ITEM	MATERIAL	CONDITION	Leaks (gpm)	Photo	DEFECTS
FRAME	CAST	1			
CORBEL	BRICK	1			
STEPS	STEEL	2			Corroded
WALLS	BRICK	3			Mineral deposits, roots, wet to 3'
FLOOR	BRICK	1			
INVERT	BRICK	2			Missing mortar

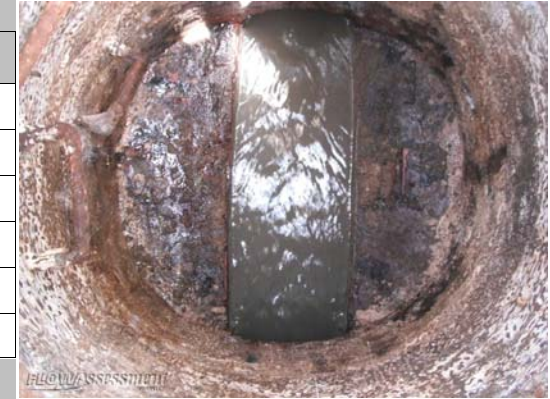
ITEM	MATERIAL	CONDITION	Leaks (gpm)	Photo	DEFECTS
FRAME	CAST	1			
CORBEL	BRICK/PARGED	1			
STEPS	STEEL	2			Corroded
WALLS	BRICK/PARGED	2			Wet to 3', mineral deposits
FLOOR	BRICK/PARGED	1			
INVERT	BRICK	1

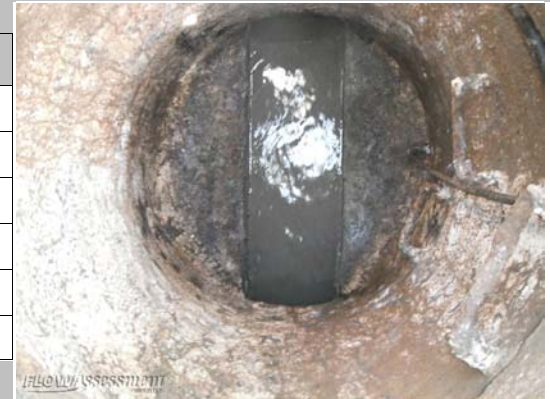
ITEM	MATERIAL	CONDITION	Leaks (gpm)	Photo	DEFECTS
FRAME	CAST	1			
CORBEL	BRICK/PARGED	2			Loose pieces
STEPS	STEEL	3			Corroded
WALLS	BRICK/PARGED	2			Mineral deposits
FLOOR	BRICK/PARGED	2			Mineral deposits
INVERT	BRICK/PARGED	1

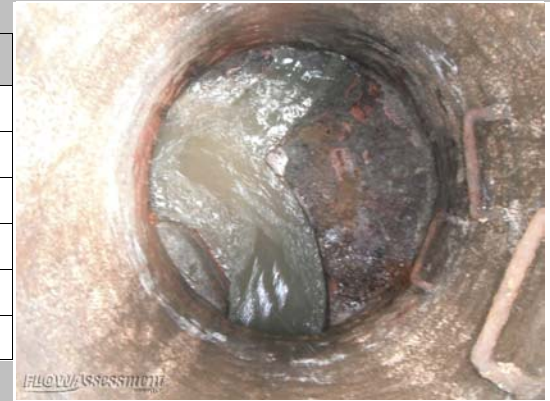
ITEM	MATERIAL	CONDITION	Leaks (gpm)	Photo	DEFECTS
FRAME	CAST	1			
CORBEL	BRICK/PARGED	1			
STEPS	STEEL	2			Corroded
WALLS	BRICK/PARGED	2			Mineral deposits, missing pieces
FLOOR	BRICK	1			
INVERT	BRICK	1

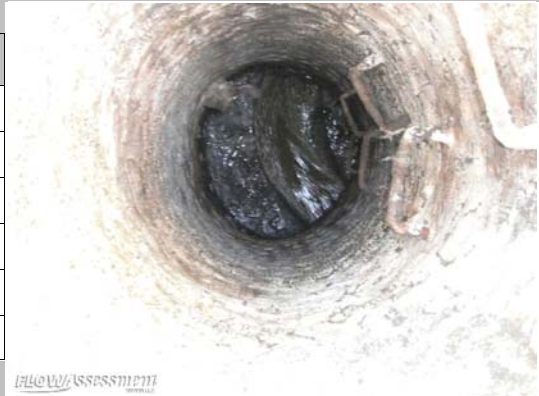
ITEM	MATERIAL	CONDITION	Leaks (gpm)	Photo	DEFECTS
FRAME	CAST	1			
CORBEL	PARGED	1			
STEPS	STEEL	2			Corroded
WALLS	PARGED	3	0.05		Missing mortar, wet with mineral deposits to 3' above floor
FLOOR	BRICK	2			Missing mortar
INVERT	BRICK	1

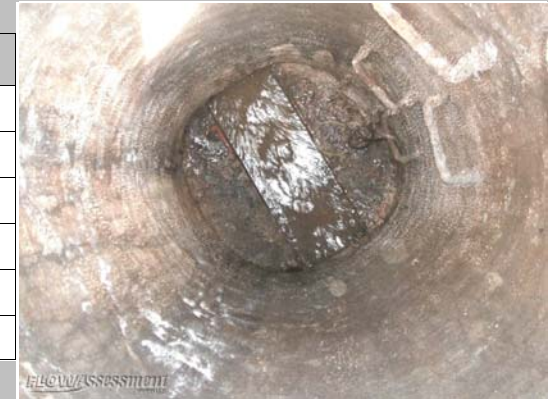
ITEM	MATERIAL	CONDITION	Leaks (gpm)	Photo	DEFECTS
FRAME	CAST	1			
CORBEL	BRICK/PARGED	1			
STEPS	CAST	2			Corroded
WALLS	BRICK/PARGED	3			Wet to 2.5' above floor
FLOOR	BRICK/PARGED	1			
INVERT	BRICK	1

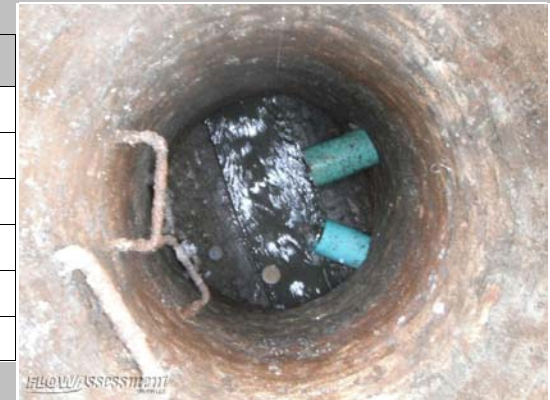
ITEM	MATERIAL	CONDITION	Leaks (gpm)	Photo	DEFECTS
FRAME	CAST	1			
CORBEL	PARGED	2			Missing mortar, missing pieces
STEPS	CAST	2			Corroded
WALLS	BRICK/PARGED	2			Missing pieces
FLOOR	BRICK/PIP	1			
INVERT	BRICK	1

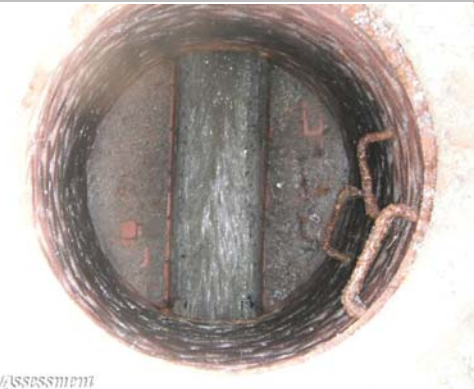
ITEM	MATERIAL	CONDITION	Leaks (gpm)	Photo	DEFECTS
FRAME	CAST	1			
CORBEL	BRICK/BLOCK	1			
STEPS	STEEL	3			Corroded
WALLS	BRICK	2			Wet to 4'
FLOOR	BRICK/PARGED	1			
INVERT	BRICK	1

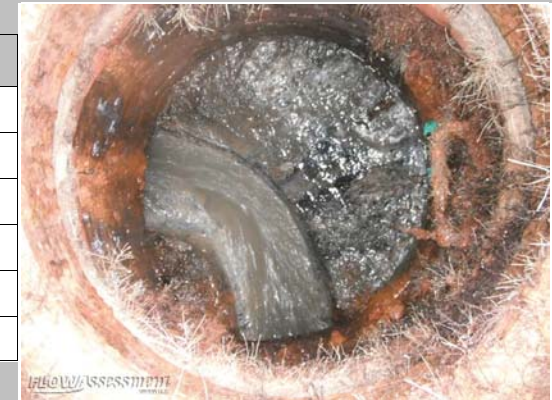
ITEM	MATERIAL	CONDITION	Leaks (gpm)	Photo	DEFECTS
FRAME	CAST	1			
CORBEL	BRICK/STEEL	2			Light roots
STEPS	STEEL	3			Corroded
WALLS	BRICK	2	0.1		Light roots, moderate mineral deposits
FLOOR	BRICK	1			
INVERT	BRICK	1

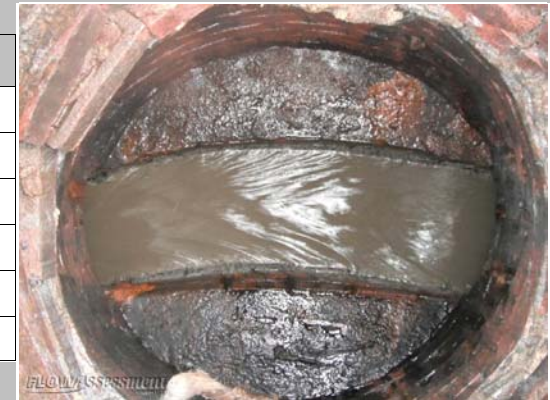
ITEM	MATERIAL	CONDITION	Leaks (gpm)	Photo	DEFECTS
FRAME	CAST	1			
CORBEL	BRICK	3			Missing mortar, loose pieces, broken brick
STEPS	STEEL	3			Corroded
WALLS	BRICK	3			Missing mortar, light mineral deposits
FLOOR	PARGED	1			
INVERT	CNI	0			High flow

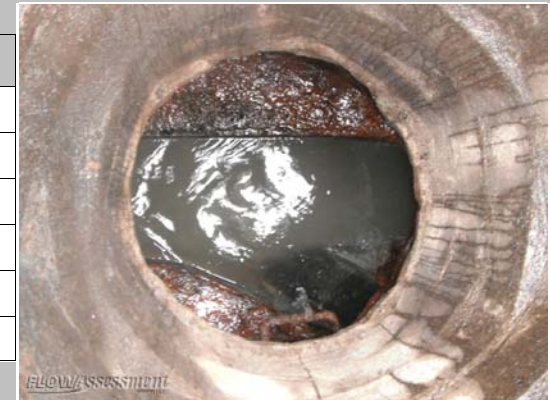
ITEM	MATERIAL	CONDITION	Leaks (gpm)	Photo	DEFECTS
FRAME	CAST	1			
CORBEL	BRICK/BLOCK/PARGED	2			Missing mortar, light mineral deposits
STEPS	CAST	3			Corroded
WALLS	BRICK	3	0.1		Moderate mineral deposits, wall leak
FLOOR	BRICK	2			Moderate mineral deposits
INVERT	BRICK	2			Moderate mineral deposits

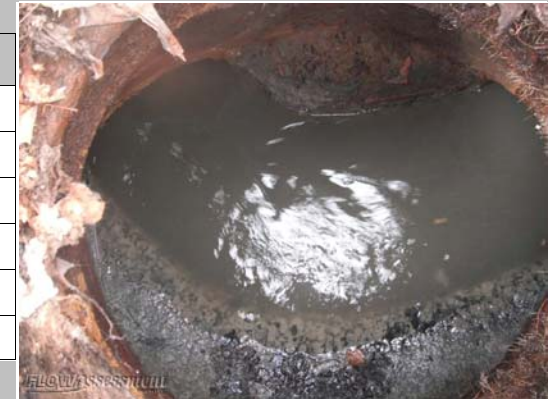
ITEM	MATERIAL	CONDITION	Leaks (gpm)	Photo	DEFECTS
FRAME	CAST	2			Moderate tuberculation
CORBEL	BRICK	2			Light roots
STEPS	NONE	0			
WALLS	BRICK	2			Light roots
FLOOR	BRICK	1			
INVERT	BRICK	1

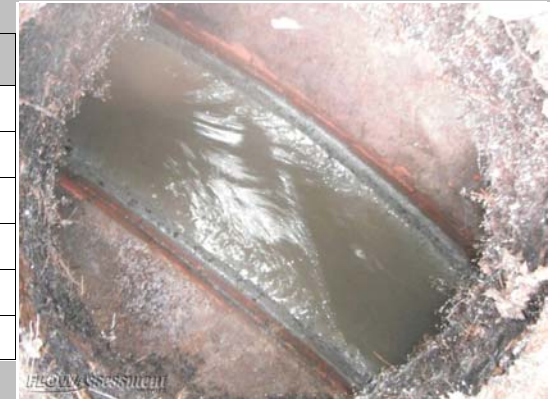
ITEM	MATERIAL	CONDITION	Leaks (gpm)	Photo	DEFECTS
FRAME	CAST	1			
CORBEL	BRICK	2			Light roots, light mineral deposits
STEPS	NONE	0			
WALLS	BRICK	2			Light roots
FLOOR	BRICK	1			
INVERT	BRICK	1

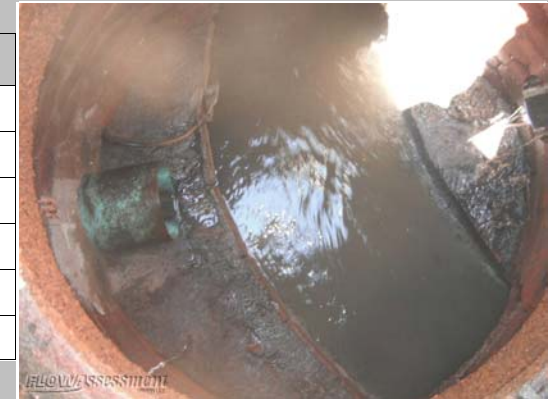
ITEM	MATERIAL	CONDITION	Leaks (gpm)	Photo	DEFECTS
FRAME	CAST	2			Corroded
CORBEL	BLOCK	2			Missing mortar, minor no infiltration
STEPS	NONE	0			
WALLS	BRICK	0			
FLOOR	BRICK	1			
INVERT	BRICK	1

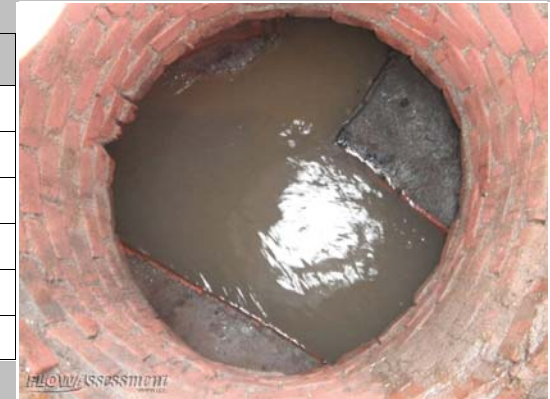
ITEM	MATERIAL	CONDITION	Leaks (gpm)	Photo	DEFECTS
FRAME	CAST	1			
CORBEL	BRICK	2			Missing mortar
STEPS	NONE	0			
WALLS	BRICK	1			
FLOOR	BRICK/PARGED	1			
INVERT	BRICK	1

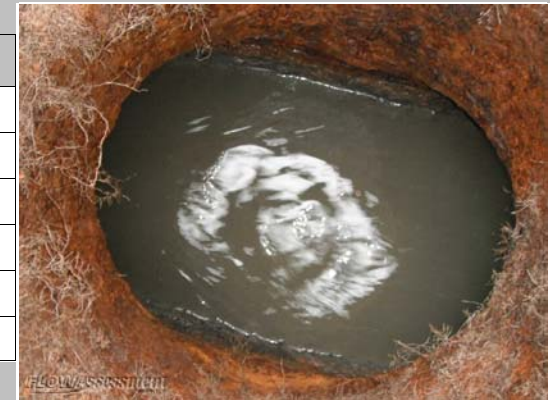
ITEM	MATERIAL	CONDITION	Leaks (gpm)	Photo	DEFECTS
FRAME	CAST	1			
CORBEL	BRICK	2			Missing mortar at frame seal, light roots
STEPS	NONE	0			
WALLS	CIP	1			
FLOOR	NONE	0			
INVERT	CIP	1

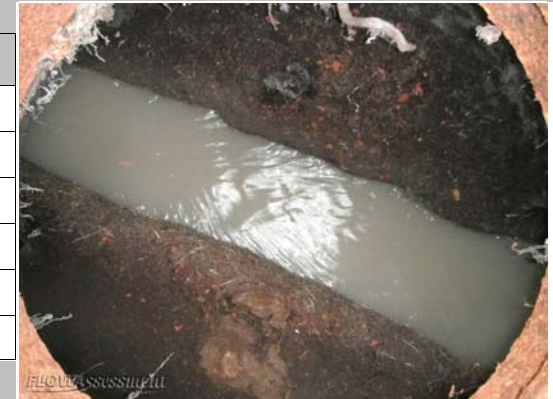
ITEM	MATERIAL	CONDITION	Leaks (gpm)	Photo	DEFECTS
FRAME	CAST	2			Loose frame, missing mortar
CORBEL	BRICK	3			Roots, missing mortar
STEPS	NONE	0			
WALLS	BRICK	4			Roots
FLOOR	CNI	4			Roots
INVERT	CNI	4			Roots, channel restricted 15%
