**A Comprehensive Investigation & Analysis of
Existing Conditions
at the
South Franklin Congregational Meeting House
762 Washington St
Franklin, MA**

Prepared for
The Town of Franklin, MA
by

CIVITECTS

11 May 2015

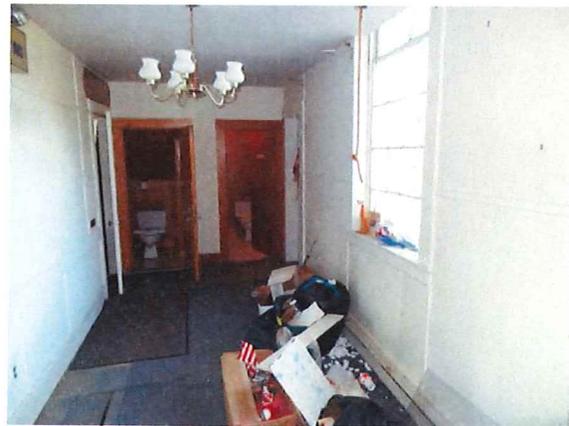
Photo A.3 – North Vestibule

First floor spaces include a vestibule at the north entrance with both male and female toilet rooms at the west end of the vestibule (Photo A.3). Electrical service is fed to a storage space at the east end of the vestibule where the electrical panel is located. To the southern of the vestibule is the meeting room with fixed pews and a raised platform at the south end of the space (Photos A.1 and A.2). Interior walls and ceiling finishes consist of painted plaster over wood lathe. The existing wood floor boards are painted. The building also contains a crawlspace with a dirt floor which is accessed by removing several floor boards in the north vestibule. A detailed structural assessment of the condition of existing 1st floor framing members was completed by structural engineering consultant DM Berg and is included herein.

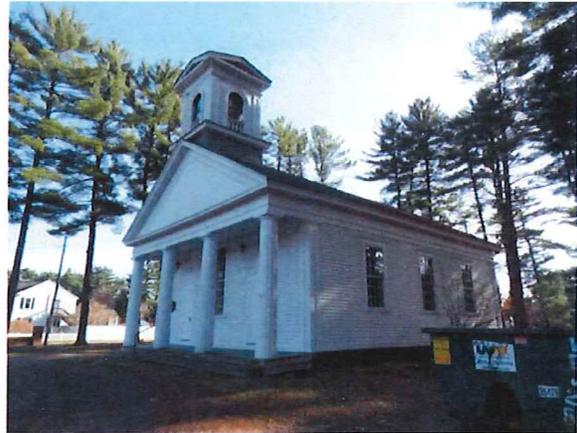
Photo B.2 – View from Washington Street

The parking area and driveway appears to consist primarily of gravel (Photo B.2). Pine needles scattered around the perimeter of the building obscure much of the site; no impervious paved surfaces were noted. Parking spaces are not identified; there is no striping delineating either accessible or non-accessible parking spaces. There is no signage identifying accessible parking spaces.

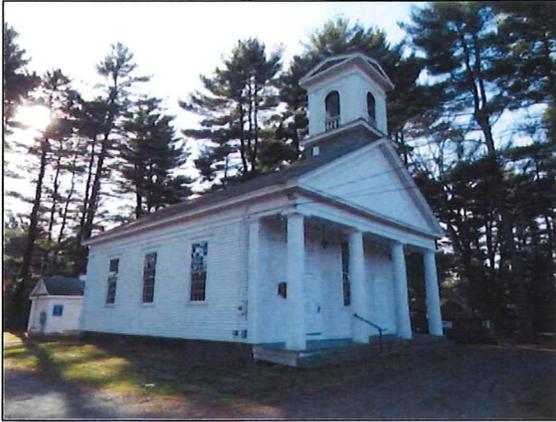
Photo C.1 – Building Exterior

Exterior walls consist of wood framing with white painted clapboard siding and corner boards at each of the building's four corners (Photo C.1). Both the wood framing and siding appear to be in good condition. The foundation wall is comprised of large granite slabs over stone rubble (Photo C.2). The joints between the granite slabs are not sealed and are open to the crawlspace below the first floor. The granite units themselves are in good condition with no visible cracks observed.

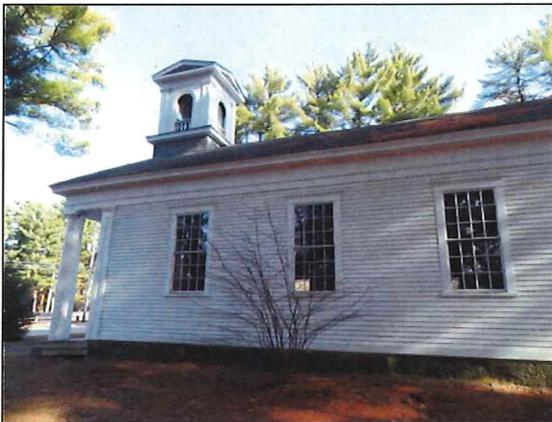
Photo C.3 – 12 over 12 windows at West Elevation

There are a total of nine exterior windows; one window at the north elevation, three windows at both east and west elevations, and two windows at the south elevation. The window at the north elevation, located in the vestibule, is a 16 over 16 double hung wood window and is in good condition. The remaining windows, located in the Meeting Hall space, are 12 over 12 double-hung wood windows and are also in good condition (Photo C.3). Windows at the south façade are provided with exterior shutters. The existing windows are not energy efficient by current energy standards; glazing is single paned. The windows do not appear to be in immediate need of replacement or repair.

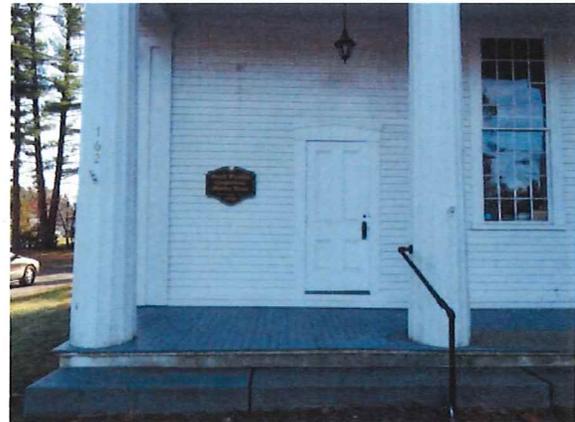
Photo C.4 – Portico at North Façade

Exterior doors consist of two egress doors along the north elevation (Photo C.4). Both doors and frames are wood and assumed to be original to the building and are in fairly good condition. Existing door hardware does not meet accessibility regulations.

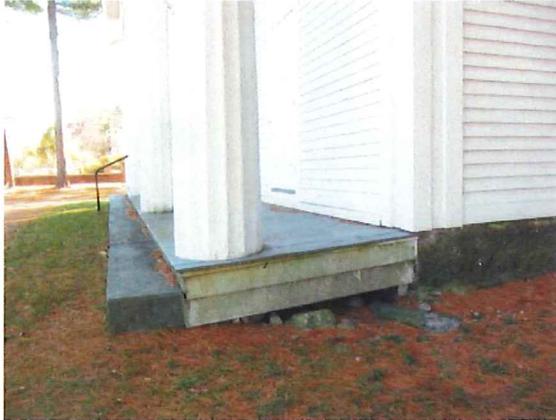
Photo D.1 – North portico

The main entrance to the Meeting House is located along the north elevation. Access to the first floor is by way of a painted wood-framed portico and granite risers which span the full width of the north façade (Photos C.4 and D.1). First floor egress is limited to two single doors which exit from the north vestibule to the portico; there are no other egress doors servicing the first floor. The overall condition of the portico framing, wood floor boards, and granite risers is good (Photo D.1).

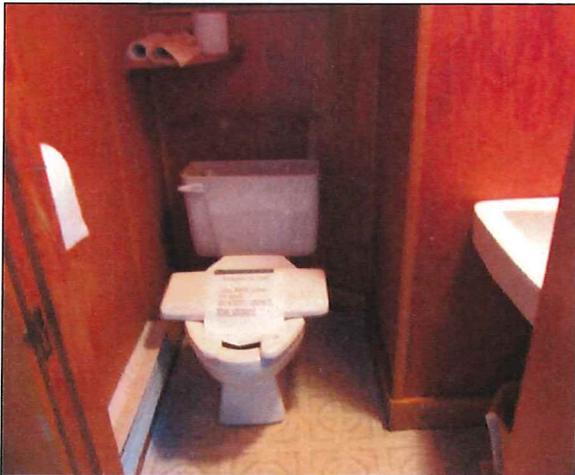
Photo F.1 – Men's toilet room

Neither toilet room is code compliant and do not meet MAAB regulations; sinks controls consist of knobs; mounting heights are non-conforming and, in general, the rooms do not meet the dimensional requirements of the MAAB. As noted in RDK's report, the plumbing code requires both a male and female toilet room. The town may wish to explore the option of a unisex toilet room however, a variance requiring multiple approvals would be required.

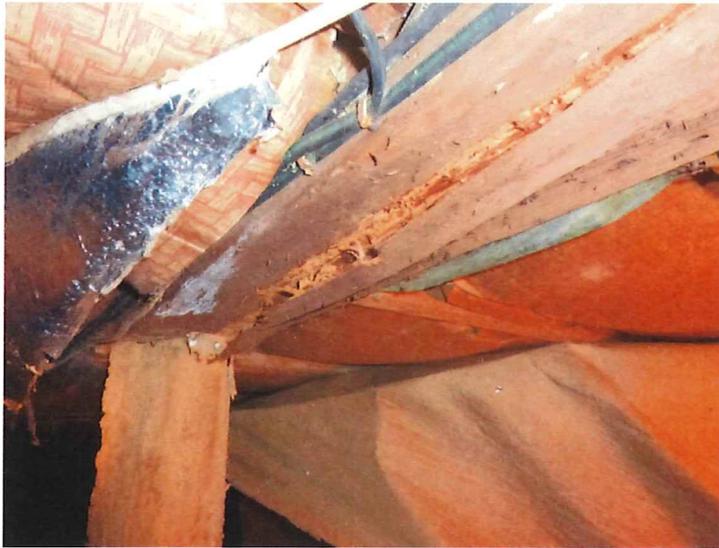
Photo 1

- We observed the first interior first floor girder line to have sections of girder with powder post beetle damage. We observed the beetle emergence holes along the girder as well as soft wood that could be pried loose with a screwdriver (Photos 1 and 2).
- We observed several timber posts to have powder post beetle damage. These posts seemed to be located towards the front of the building on the first interior girder line. We observed the beetle emergence holes on the entire length of the posts (Photos 3 and 4).

4. IEBC section 1106.2 Unsafe Structural Elements, requires all identified unsafe structural components such as the observed insect damaged and rotted wood joists, sills, girders and posts of the first floor framing to be replaced or strengthened.

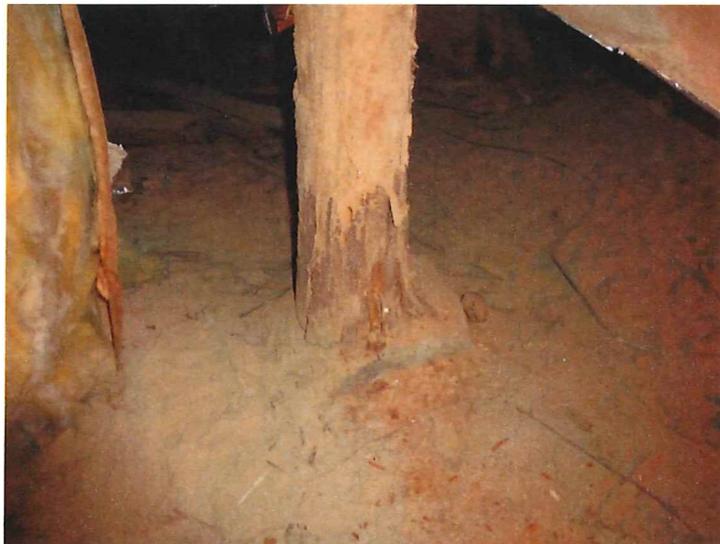
Photo 4

- We observed the insect damaged timber posts to be crushing and splitting at the base (Photo 4).
- We observed the timber posts to be bearing on loose stones. There is no connection from the posts to stones (Photos 5 and 6). At one post we observed the post to be supported only on one corner of the post (Photo 7).
- At the square interior post we observed the base to rotted with split and soft wood (Photo 8).
- We observed the ceiling plaster and ceiling joists are support from the bottom chord of the queen rod truss (Photo 9).
- We observed the roof purlins to be supported at its end on a diagonal strut that bears on the front exterior bearing wall (Photo 10).
