Notice of Intent

Prepared for: Town of Franklin Department of Public Works

Project Description

This is a retroactive filing for emergency work that was completed at the Nicholas Drive/Prospect Street culvert.

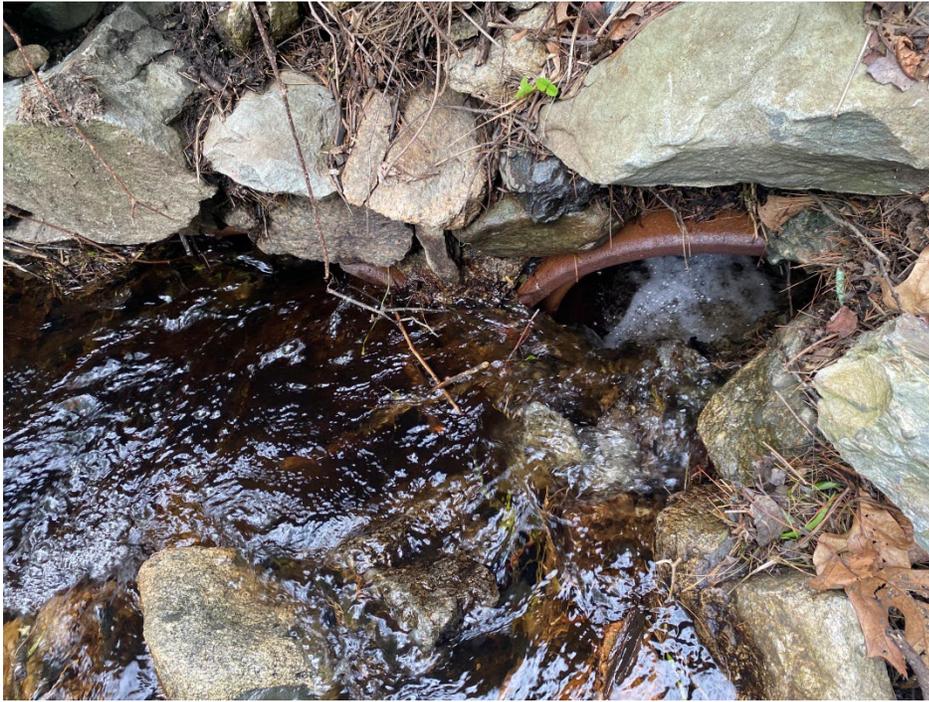
On May 12, the water had subsided enough to inspect the top ~50% of the pipes. As you will see in the attached photo, one pipe is visible; yet the other was experiencing impeded flow due to debris and fallen stones. The stones that impeded the pipe originated from the dry-laid-stone headwall, which is estimated to have been constructed nearly 100 years ago. At this time, a few stones were carefully removed (by hand) from their obstructive position in order to enhance flow. Subsequent rain events proved that a negative feedback loop was occurring. As the height of the water level ebbed and flowed with additional rain events - additional soil would wash away and undermine additional stones.

Figure 1: May 12th, 2025. One pipe flowing at 50% capacity, impeded by fallen stones. The second pipe is not visible due to fallen stones originating from a failing headwall.

On July 15 2025, the Stormwater crew re-established/stabilized the headwall along the southern bank of the roadway. A mini-excavator was mobilized to carefully remove the remainder of the existing headwall. The excavator entered the work zone by travelling within 1

The dimensions of the existing 'headwall' consisted of 15 linear feet by 5 linear feet of stone/small boulders that were less than 1 foot in diameter. The bucket of the excavator removed the stone and placed it in a 1 ton vehicle, which was parked on the roadway. The stones were transported to the Department of Public Works storage yard. Four-to-eight inch trap rock replaced the former headwall stones. This work remained within the footprint of the previously removed stone along the bank of the roadway. Due the nature of the previous conditions which lead to the emergency repair, a portion of the bank had eroded in front of the pipes. Three ½ yard buckets of sediment from the bank erosion were removed from in front of the pipes. Also, due to the poor condition of the existing two 18" clay pipes, a 4 foot section of 18" corrugated plastic pipe was sleeved into each of the existing pipes, in order to provide additional strength for the existing "chipped" and "cracked" pipes. While mats were used to minimize excavator tracks along its travel, a steel rake was used to smooth out ridges that had formed. The area was then over-seeded with a native-conservation-mix.

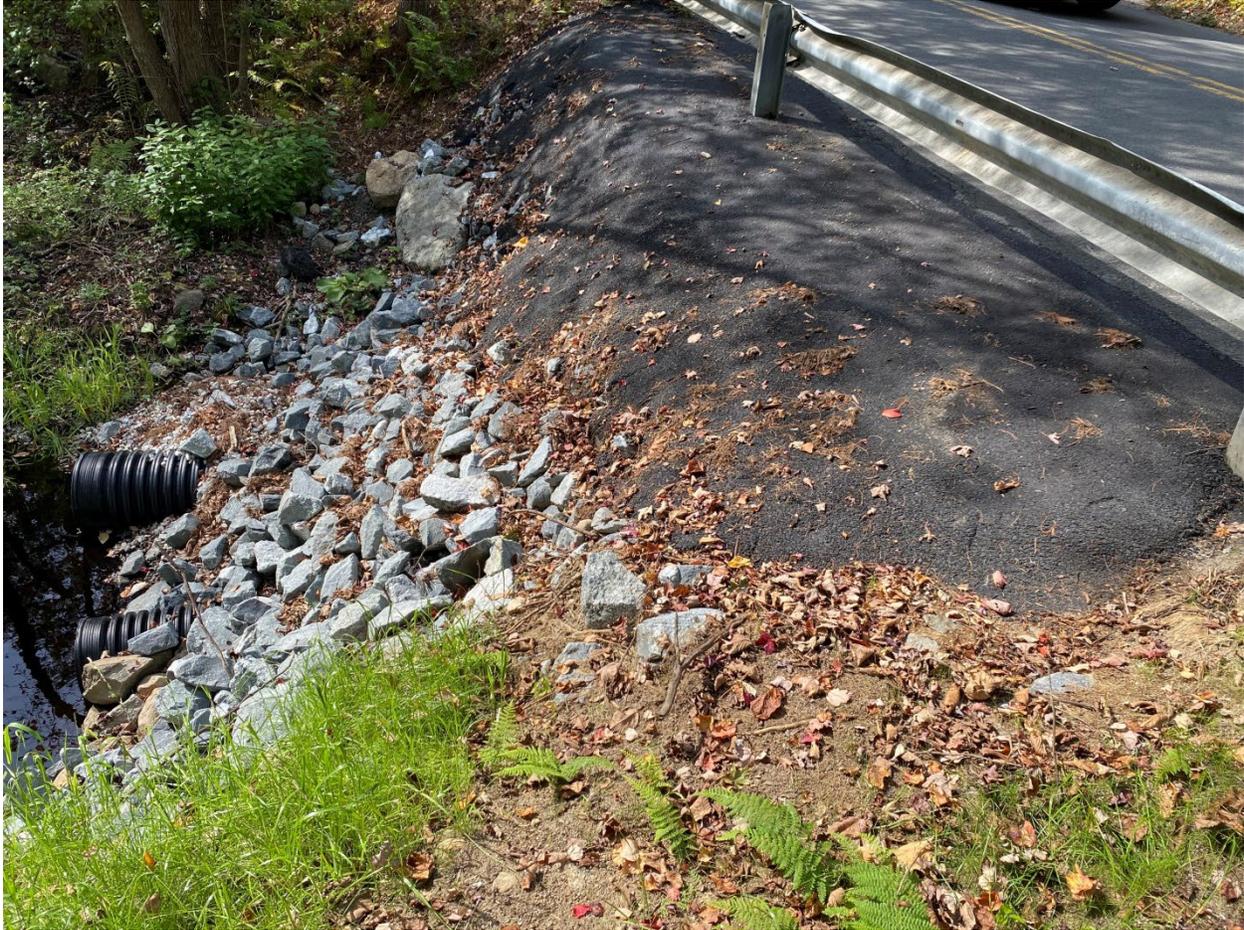
Figure 2: Completed project.
