# South Franklin Congregational Meeting House

## Existing Conditions Report and Peer Review

762 Washington Street,  
Franklin, MA 02038

September 30, 2020

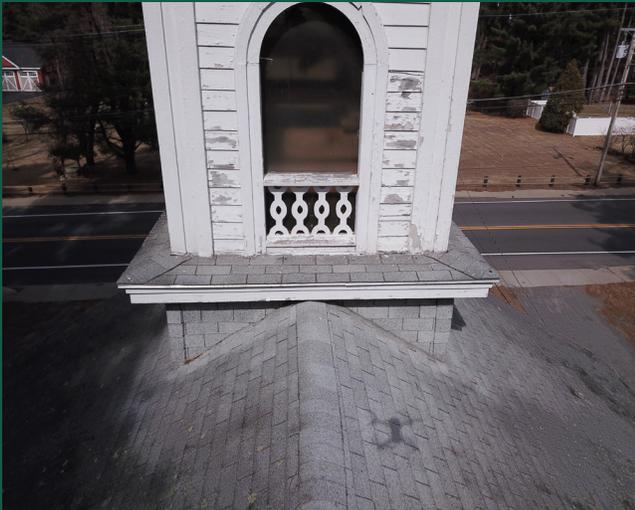
Close up detail at the cupola and main roof connection. Note slight granular loss occurring on most shingles due to age.

This roofing system age is unknown, but given the visible granule loss the roof appears to be reaching the end of its useful life expectancy. Granule loss which is uniform across the roof is usually a result of normal weathering. Over time, the bond between the granules and asphalt deteriorates, and granules will be loosened and carried away by runoff.

**Roofing system is reaching the end of its life expectancy; consider replacement.**

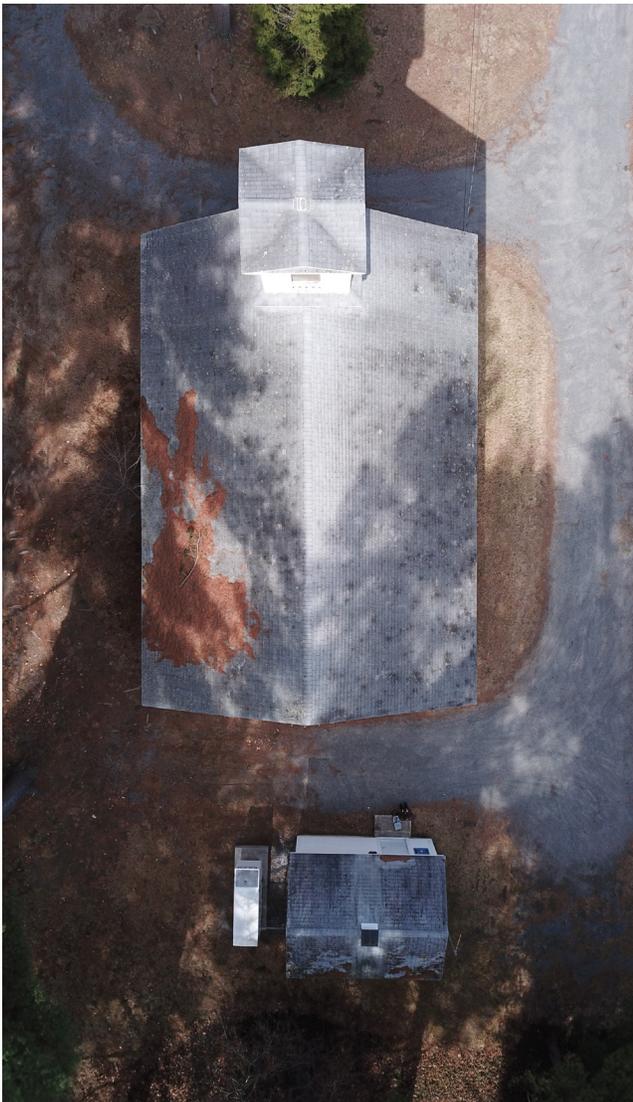
Several areas of the roof were observed to have algae, moss and lichens, which over time can enhance water retention, and lead to premature deck rot. Algae grow fastest in shady, damp areas, such as under large trees, which this property has adjacent to the building (west). In addition, this large pine tree has a large volume of needle drop which has fallen and stayed on the south west portion of the roof. This clumping of needles remains wet after a rain event and holds moisture, adding to premature shingle and deck damage. Future renovations should consider this condition carefully and implement a seasonally appropriate cleaning schedule to remove debris from the roof.

Overhead view from LLB drone showing upper cupola roof, main roof and adjacent pump house roof.

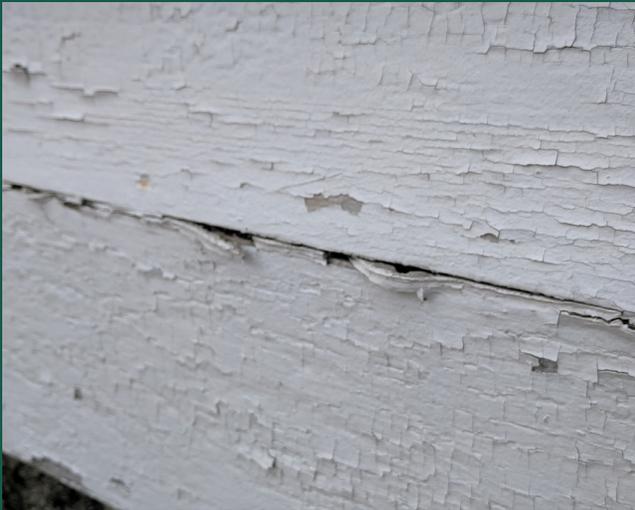
Detail photo at siding lap joint, observed flaking, craquelure paint.

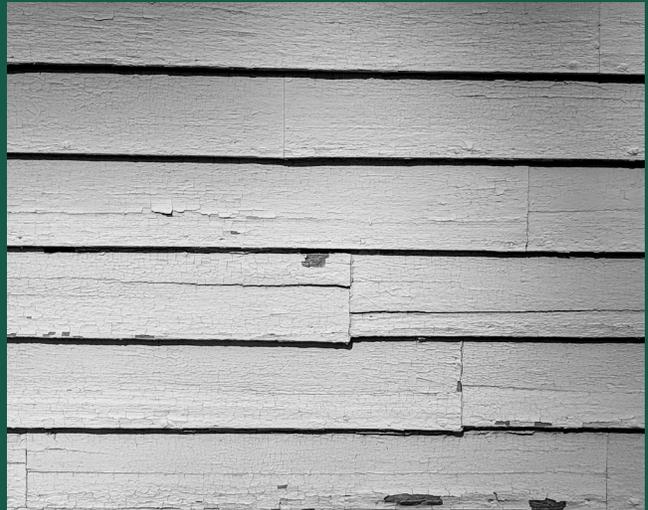
A number of horizontal splits occurring in the siding can be observed as well as paint loss.

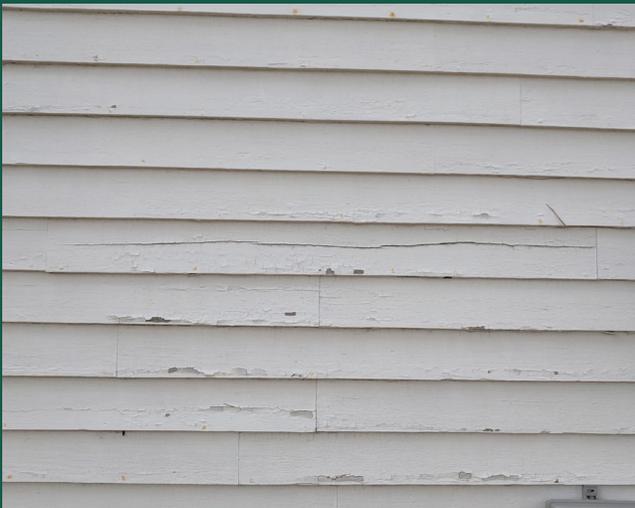
Horizontal split occurring in a siding board can be observed as well as paint loss.

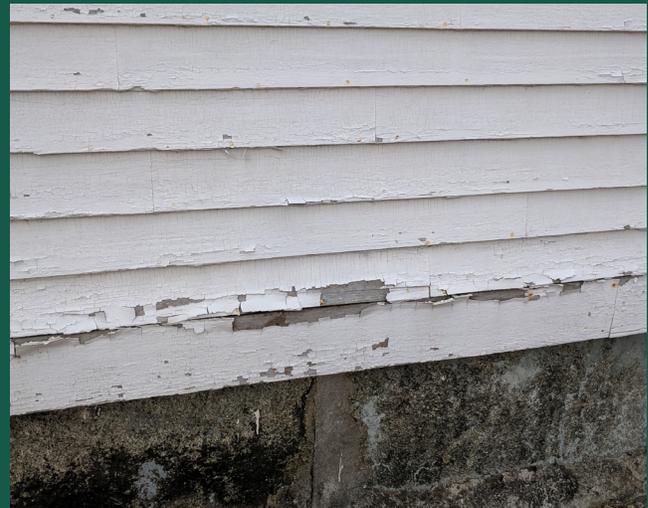
Paint loss at the bottom most siding and trim board.

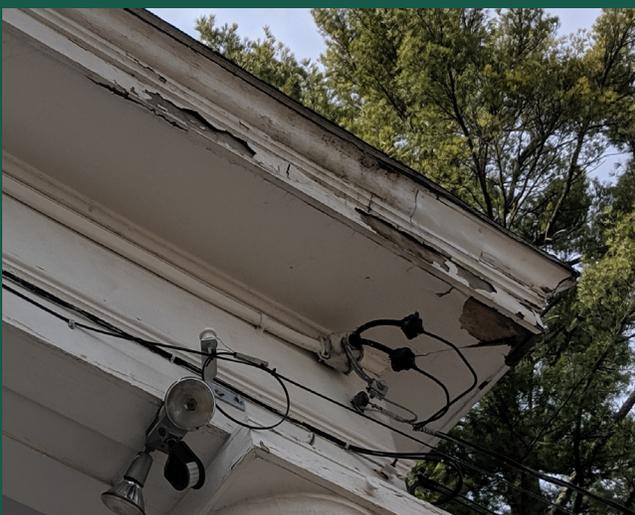
Deterioration of the paint and exposed wood trim at original roof detailing.

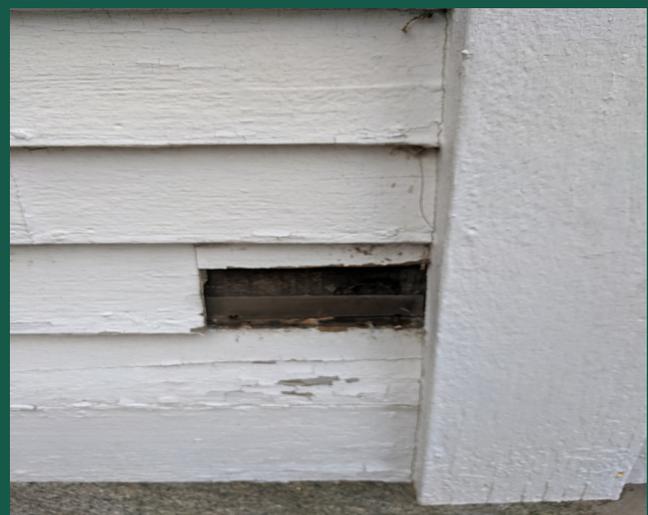
Missing siding piece exposing sheathing behind.

**Some siding is failing or missing; roughly 5% of the exterior facade will require wood repair.**

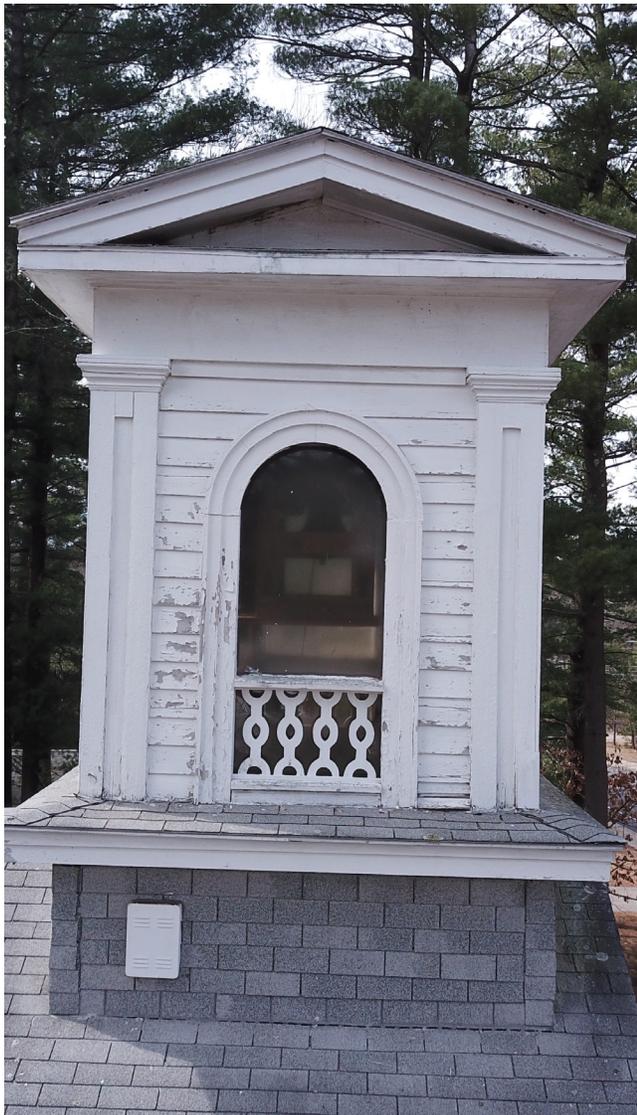
Paint loss at cupola exposing wood siding and trim. A number of siding pieces have split horizontally.

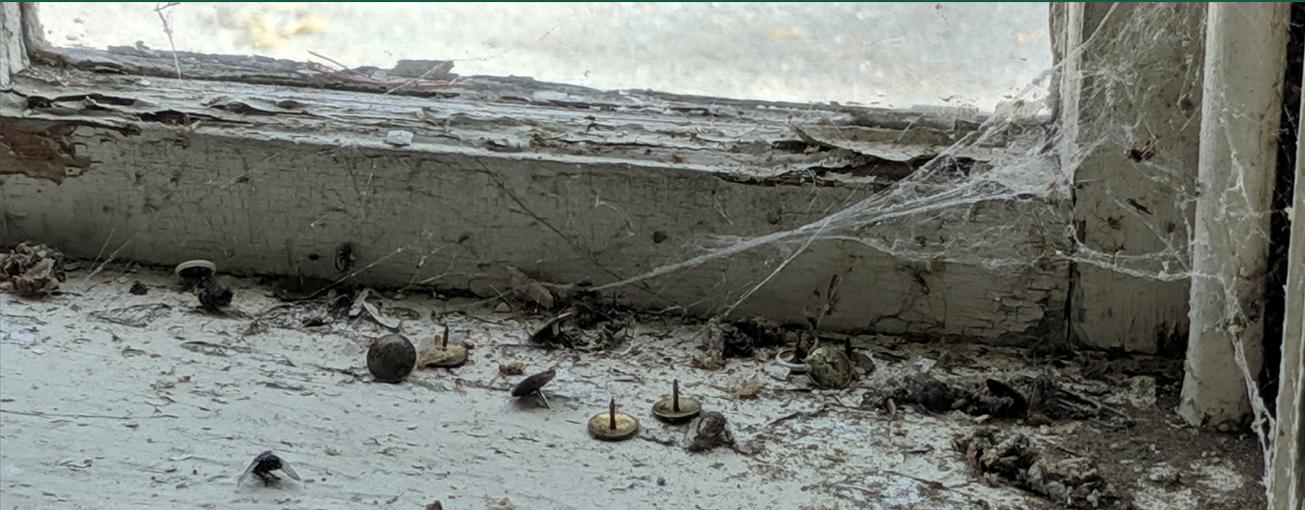
Evidence of water damage and paint loss at window sill on east side.

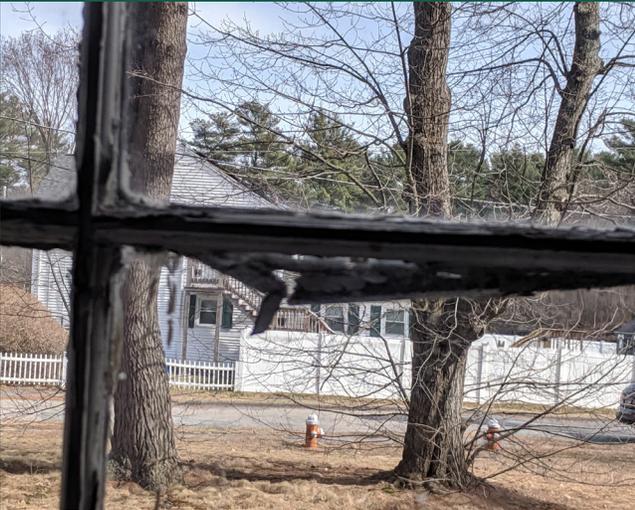
Evidence of putty loss and damaged muntin on east side window.

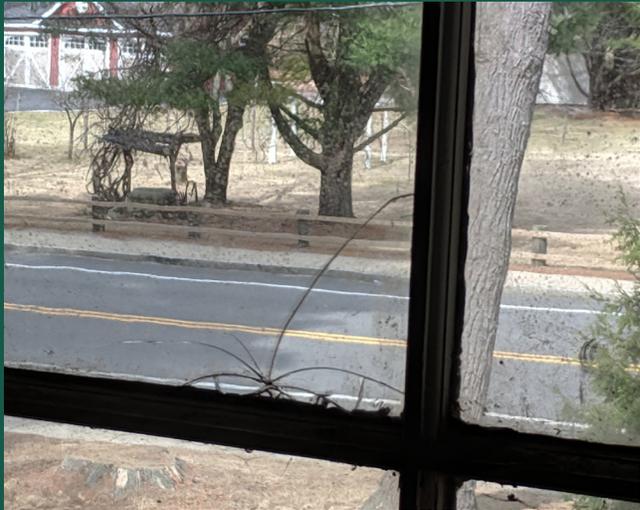
Evidence of cracked light at second floor window.

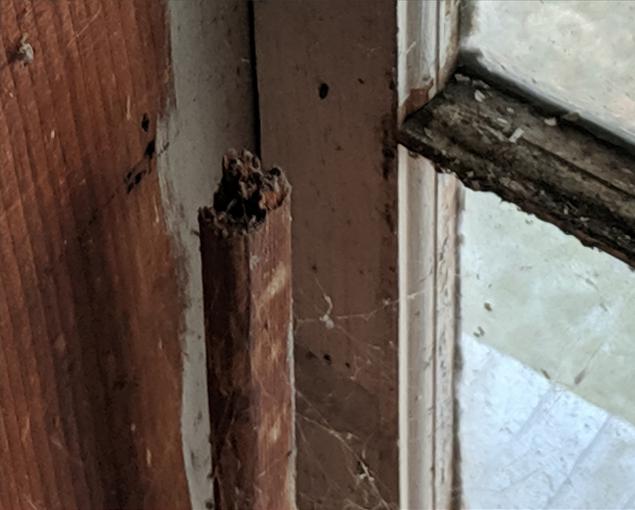
The sash stile show signs of wear and damage at second floor. Sash bars are also deteriorating.

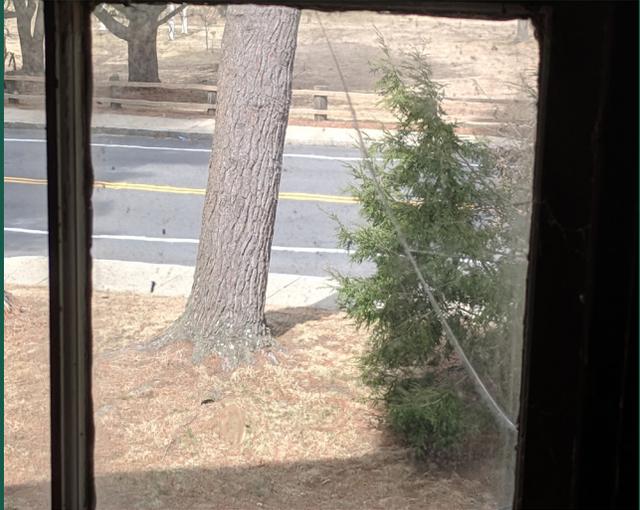
Evidence of cracked light at second floor window.

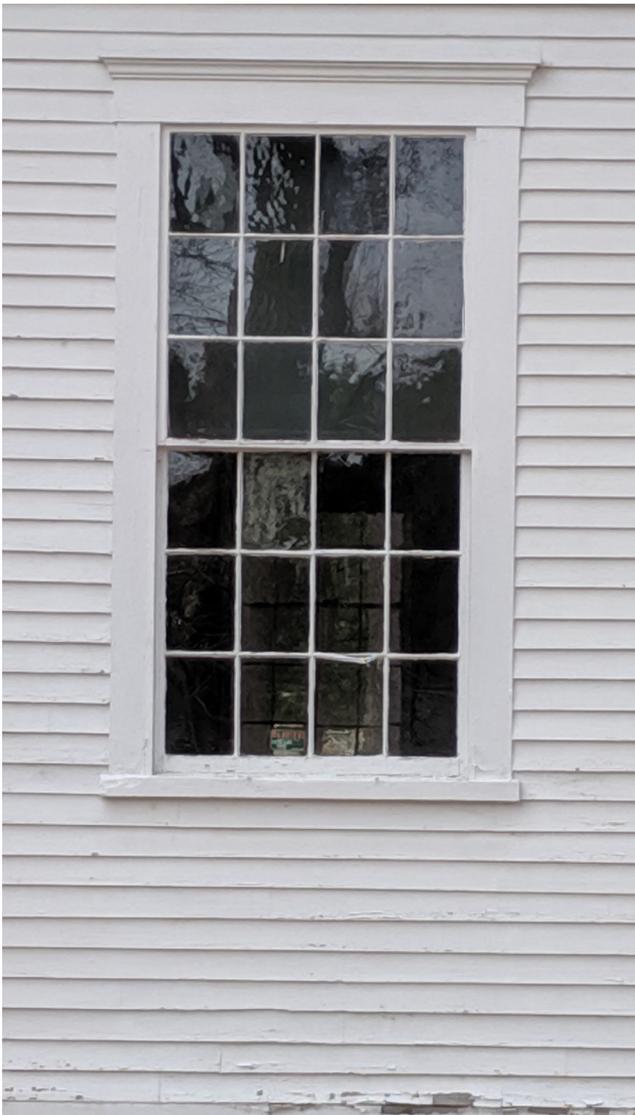
Exterior picture of typical 12 over 12 window. Notice the damaged muntin rail referenced on opposite page.

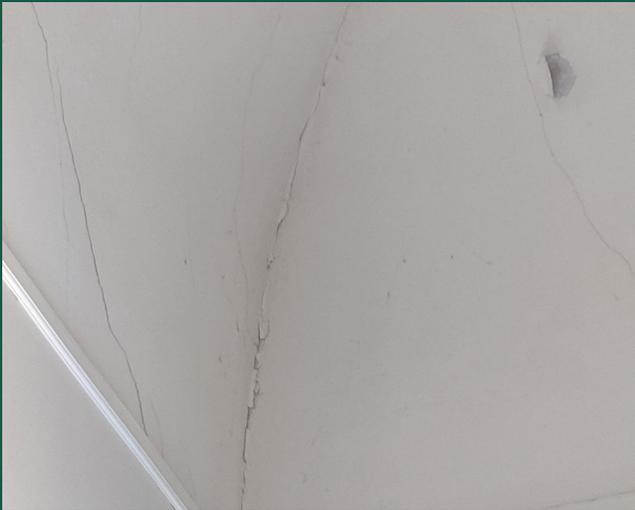
Close up detail at the ceiling showing paint and plaster cracks.

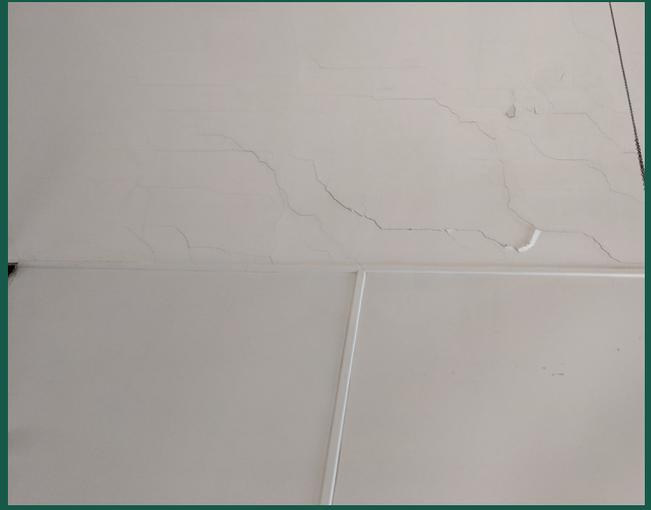
Close up detail at the ceiling showing paint and plaster cracks.

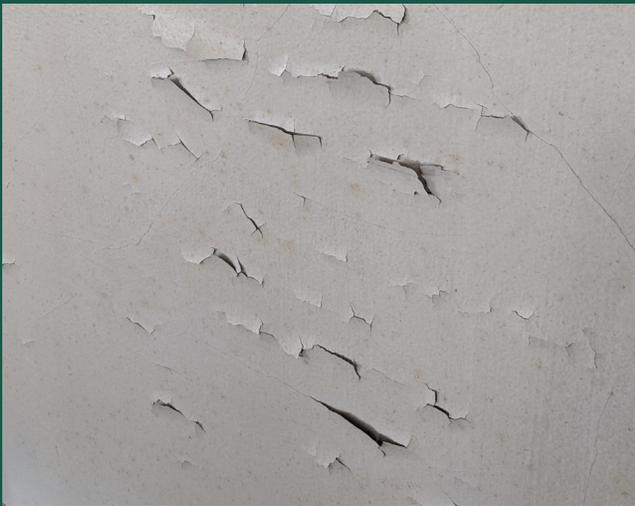
Paint cracking and peeling in main assembly room.

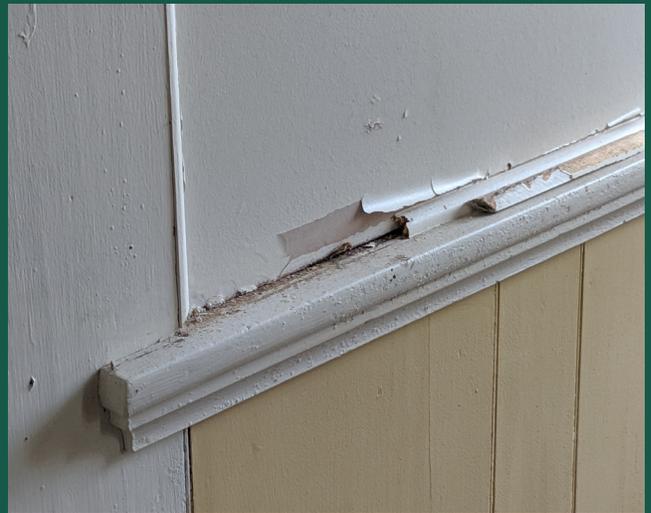
Cracked and peeling paint at wood trim in main assembly room.

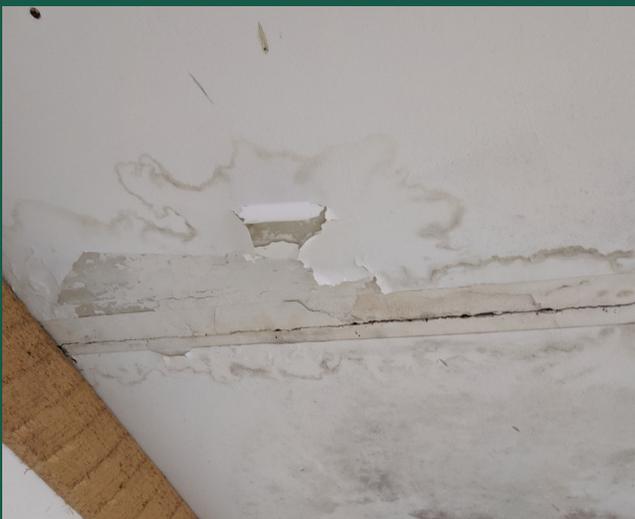
Apparent water damage and peeling paint at second floor.

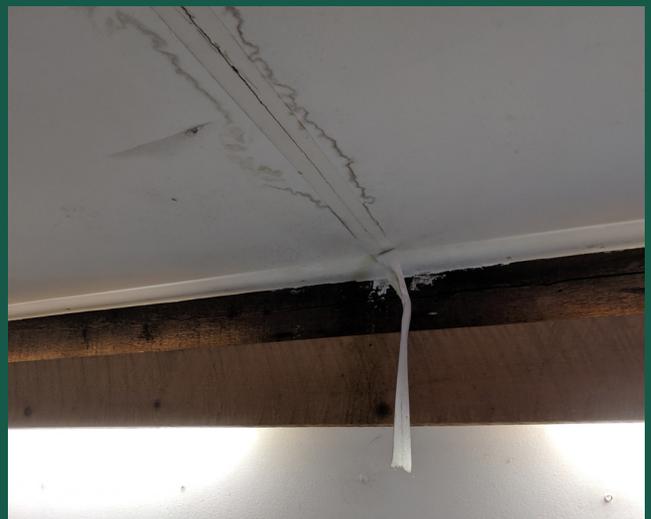
Apparent water damage to ceiling panel at second floor.

The mezzanine showed signs of water damage on the ceiling, presumably from the cupola above. There are numerous areas in the main assembly room where paint loss is prevalent. Signs of cracked plaster can also be observed.

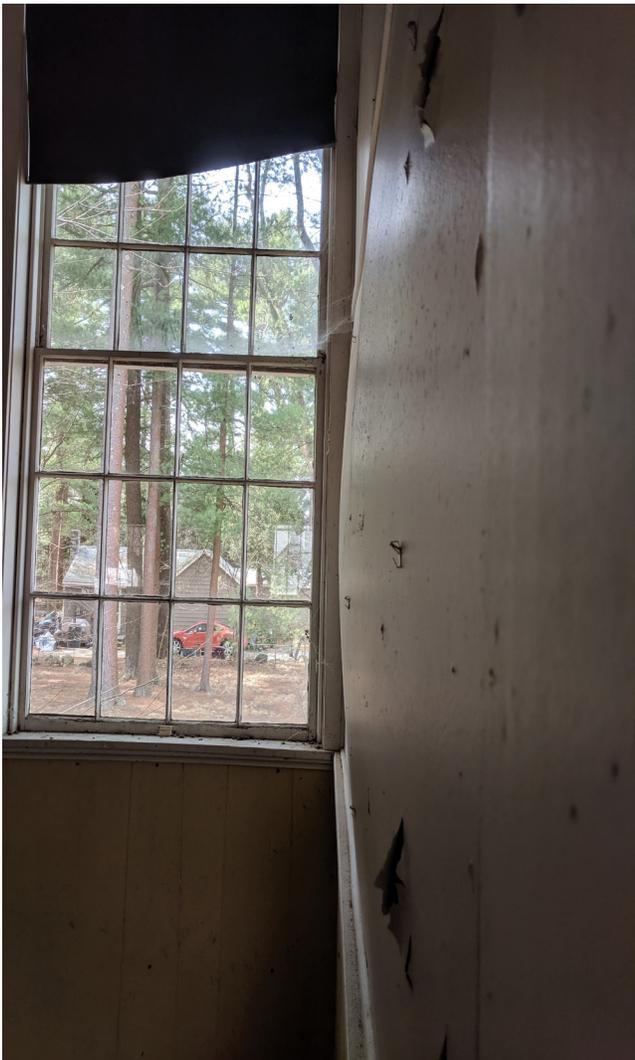
Wall supporting second floor mezzanine (opposite of stair) is bowing. This should be further evaluated.

One wall, the northwest wall in the main assembly room, showed signs of bulging out from vertical from starting about 36" above the floor to about 6'. This should be evaluated to determine its cause (water, damage, pest infestation, structural settling) so that a repair can be determined.

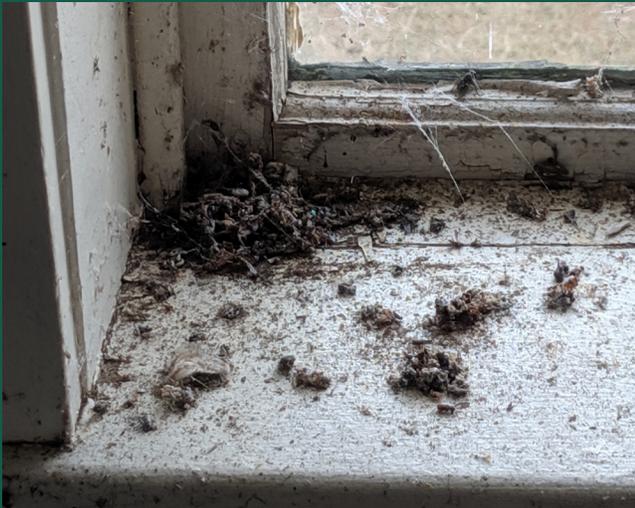
Close up detail at a window sill (typical) showing pest and animal waste.

Animal waste that becomes airborne can transmit disease. It is recommended that a thorough cleaning be performed to remove all existing waste and a long term pest control plan be put into place to begin to get the situation under control.

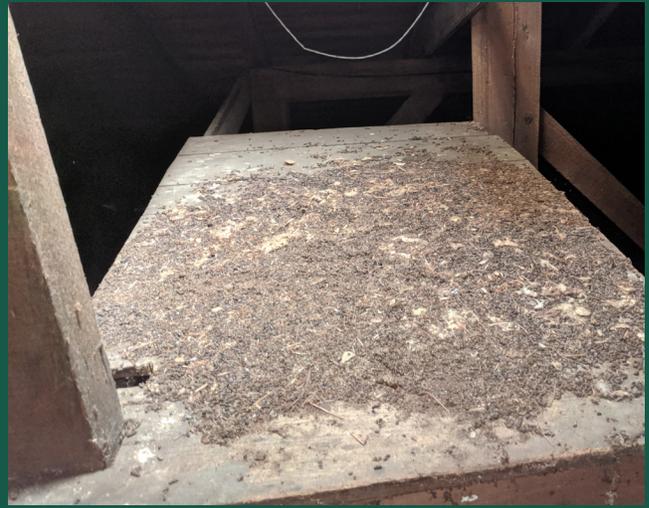
Observed bird droppings inside of the bell tower.

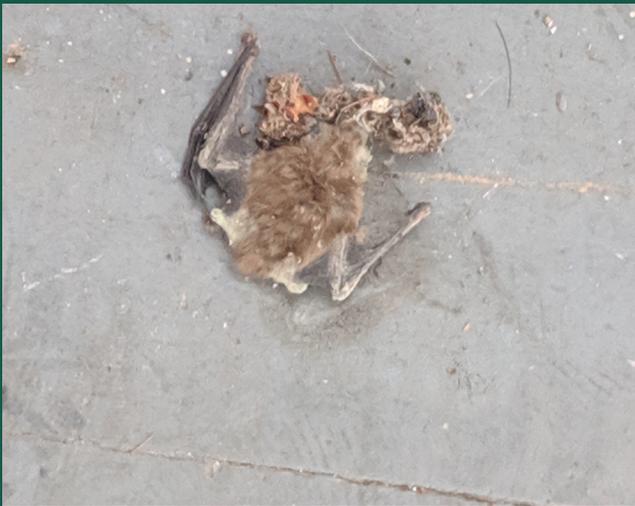
Observed dead bat in the main lobby.

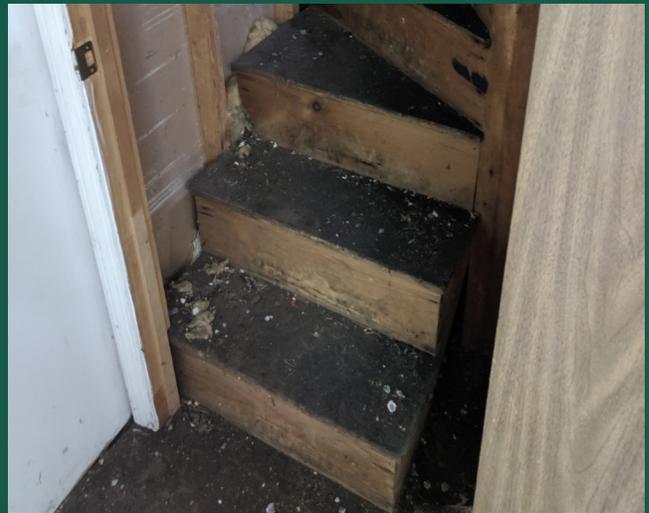
Observed bird droppings on the stair to the attic.

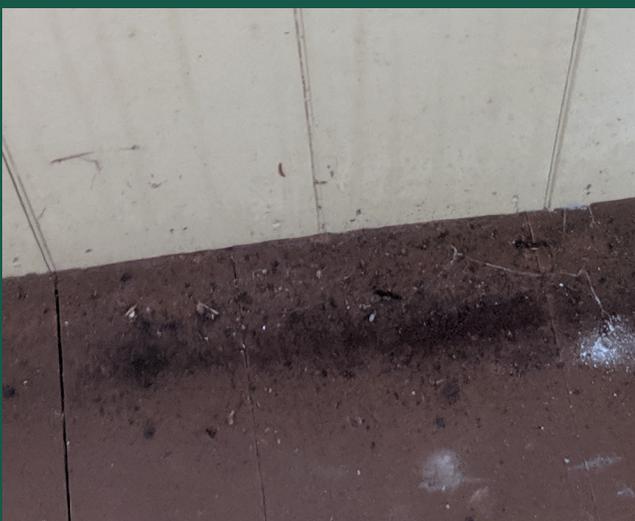
Evidence of animal droppings.

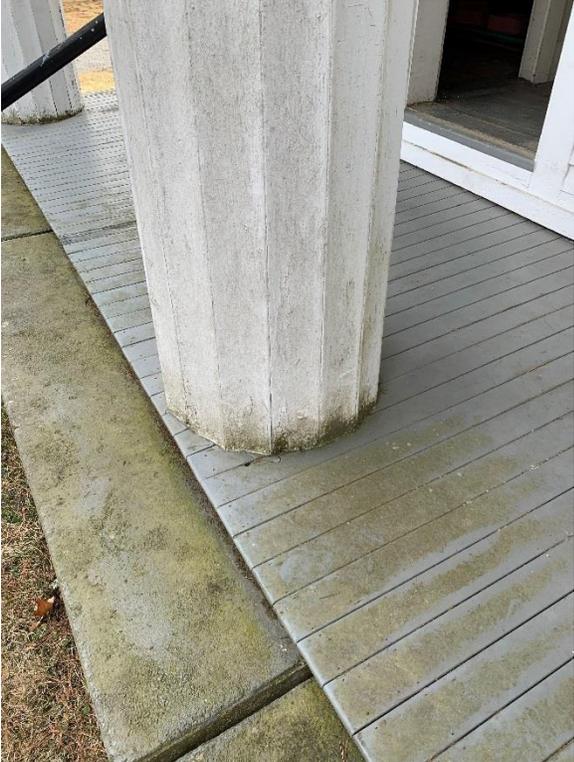
*Photo 2*

Four main pillars support the roof at the main entry of the building. The third pillar from the left (looking at the entry) has settled. The reason for settlement is because of damage due to moisture. (See photo 2)

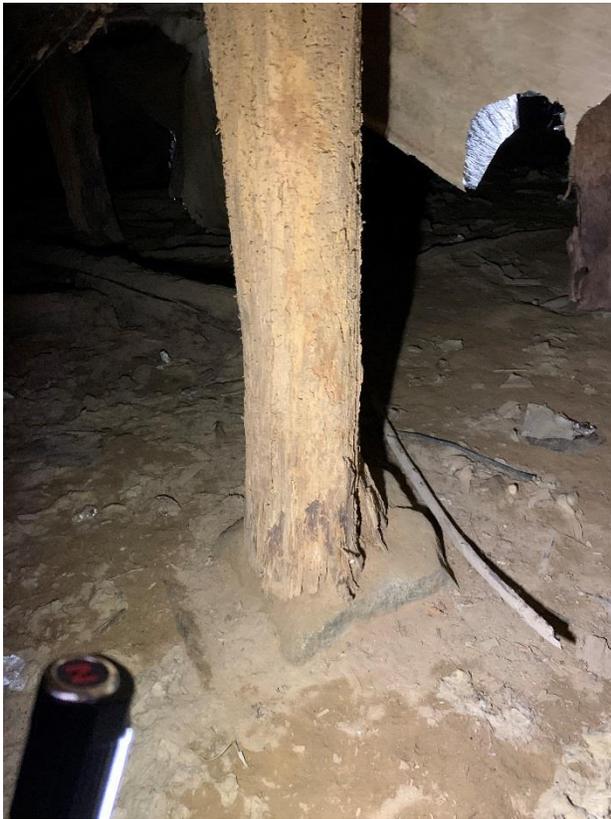
*Photo 3*

It was noted the first line of girders and multiple timber posts were subject to powder post beetle damage. In addition, many posts are splitting and crushing at their base. (See photo 3.)

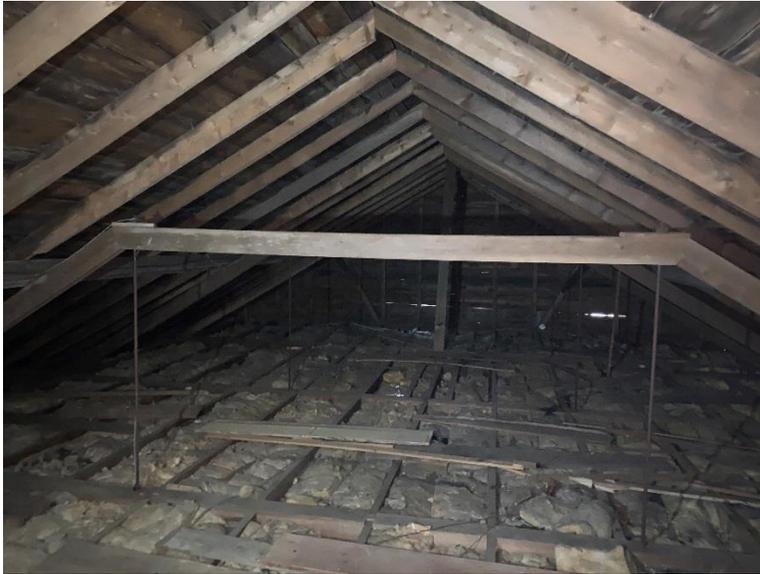
*Photo 4*

We proceeded up passed the mezzanine, to view the roof structure. The roof is made up of sloped rafters, supported at the top of the exterior bearing walls, the ridge beam, and midspan by purlins. The purlins are supported by wood and iron rod trusses. It was noted the some of the rafters were subject to light checking, but generally thee roof is in good condition. (See Photo 4)

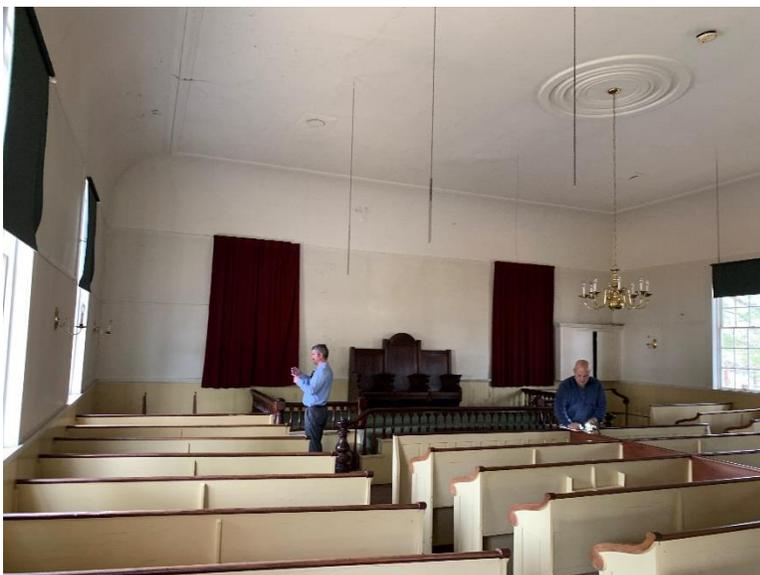
*Photo 5*

Lastly, we proceeded down into the main assembly area. Although the wall framing was not visible to us, there was no evidence of racking or bowing of the bearing walls. (See Photo 5.)

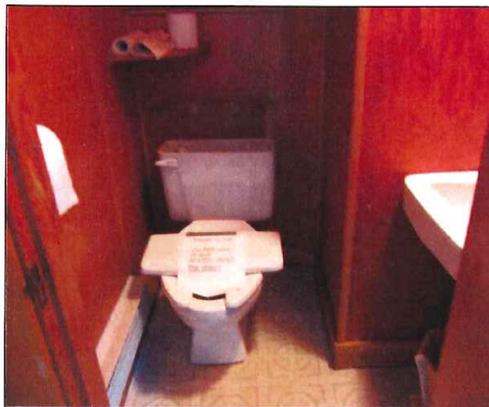
Neither toilet room is code compliant and do not meet MAAB regulations; sinks controls consist of knobs; mounting heights are non-conforming and, in general, the rooms do not meet the dimensional requirements of the MAAB. As noted in RDK's report, the plumbing code requires both a male and female toilet room. The town may wish to explore the option of a unisex toilet room however, a variance requiring multiple approvals would be required.

Photo F.1 – Men's toilet room
