# 4 Cohasset Way

Franklin, MA

June 7, 2023

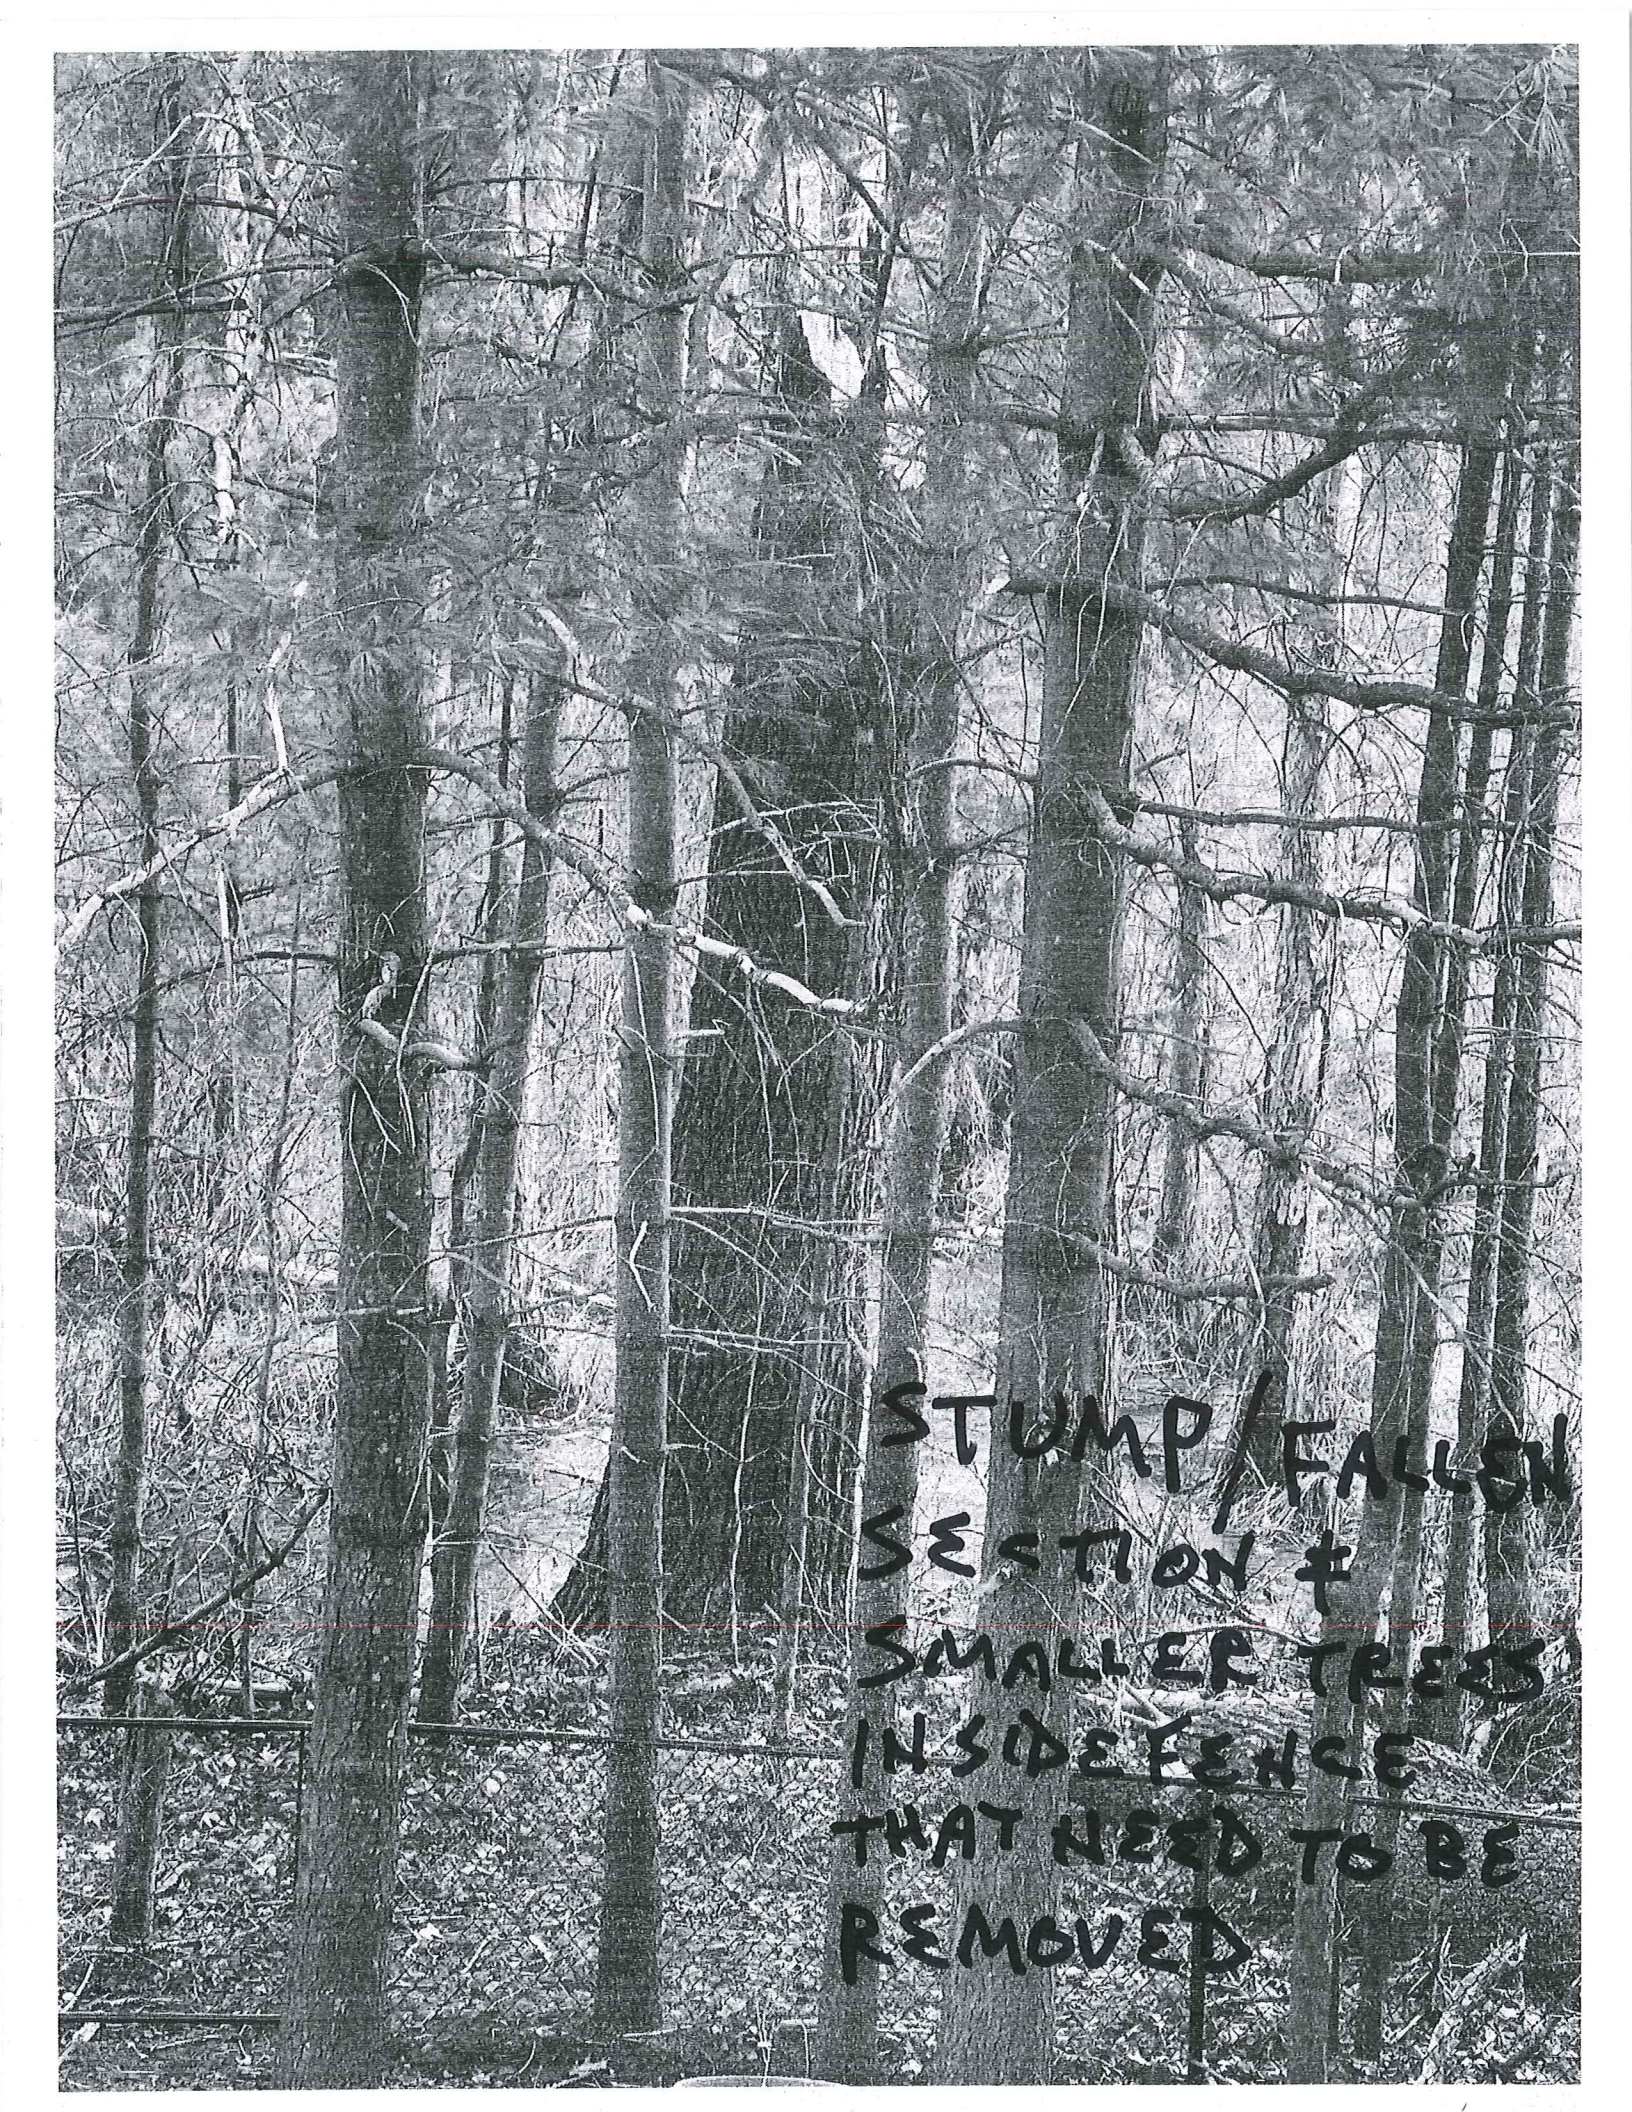
STUMP / FALLEN  
SECTION #  
SMALLER TREES  
INSIDE FENCE  
THAT NEED TO BE  
REMOVED

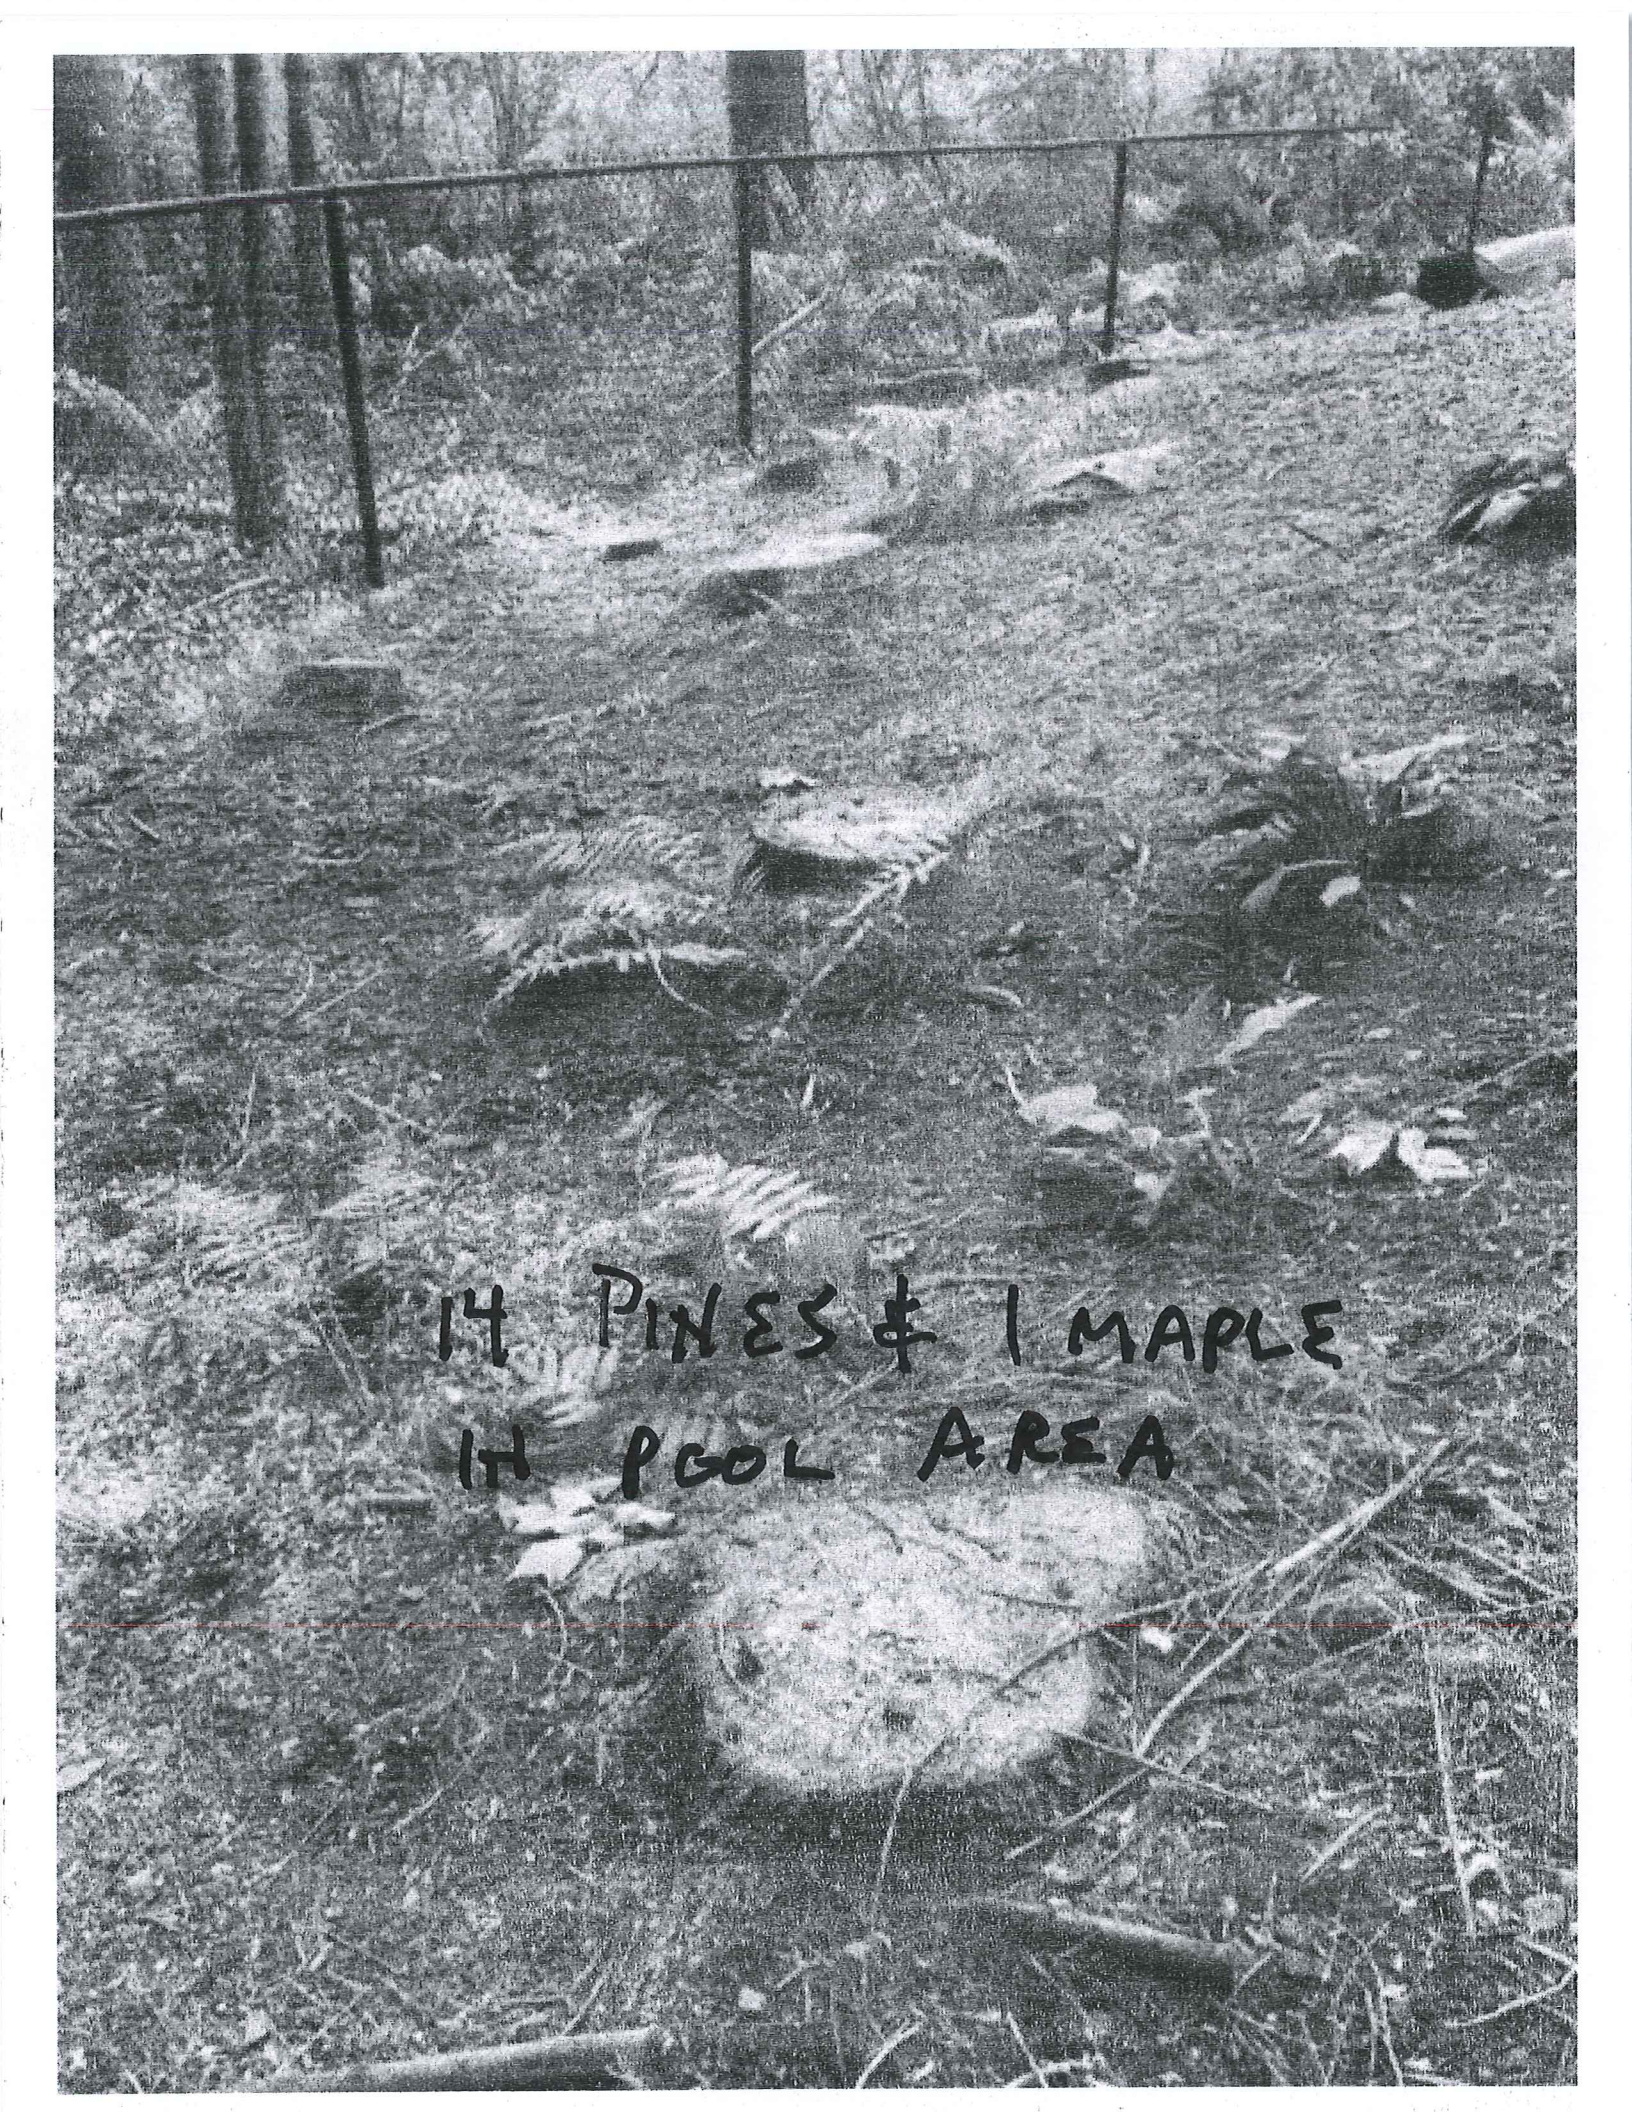
14 PINES & 1 MAPLE  
IN POOL AREA

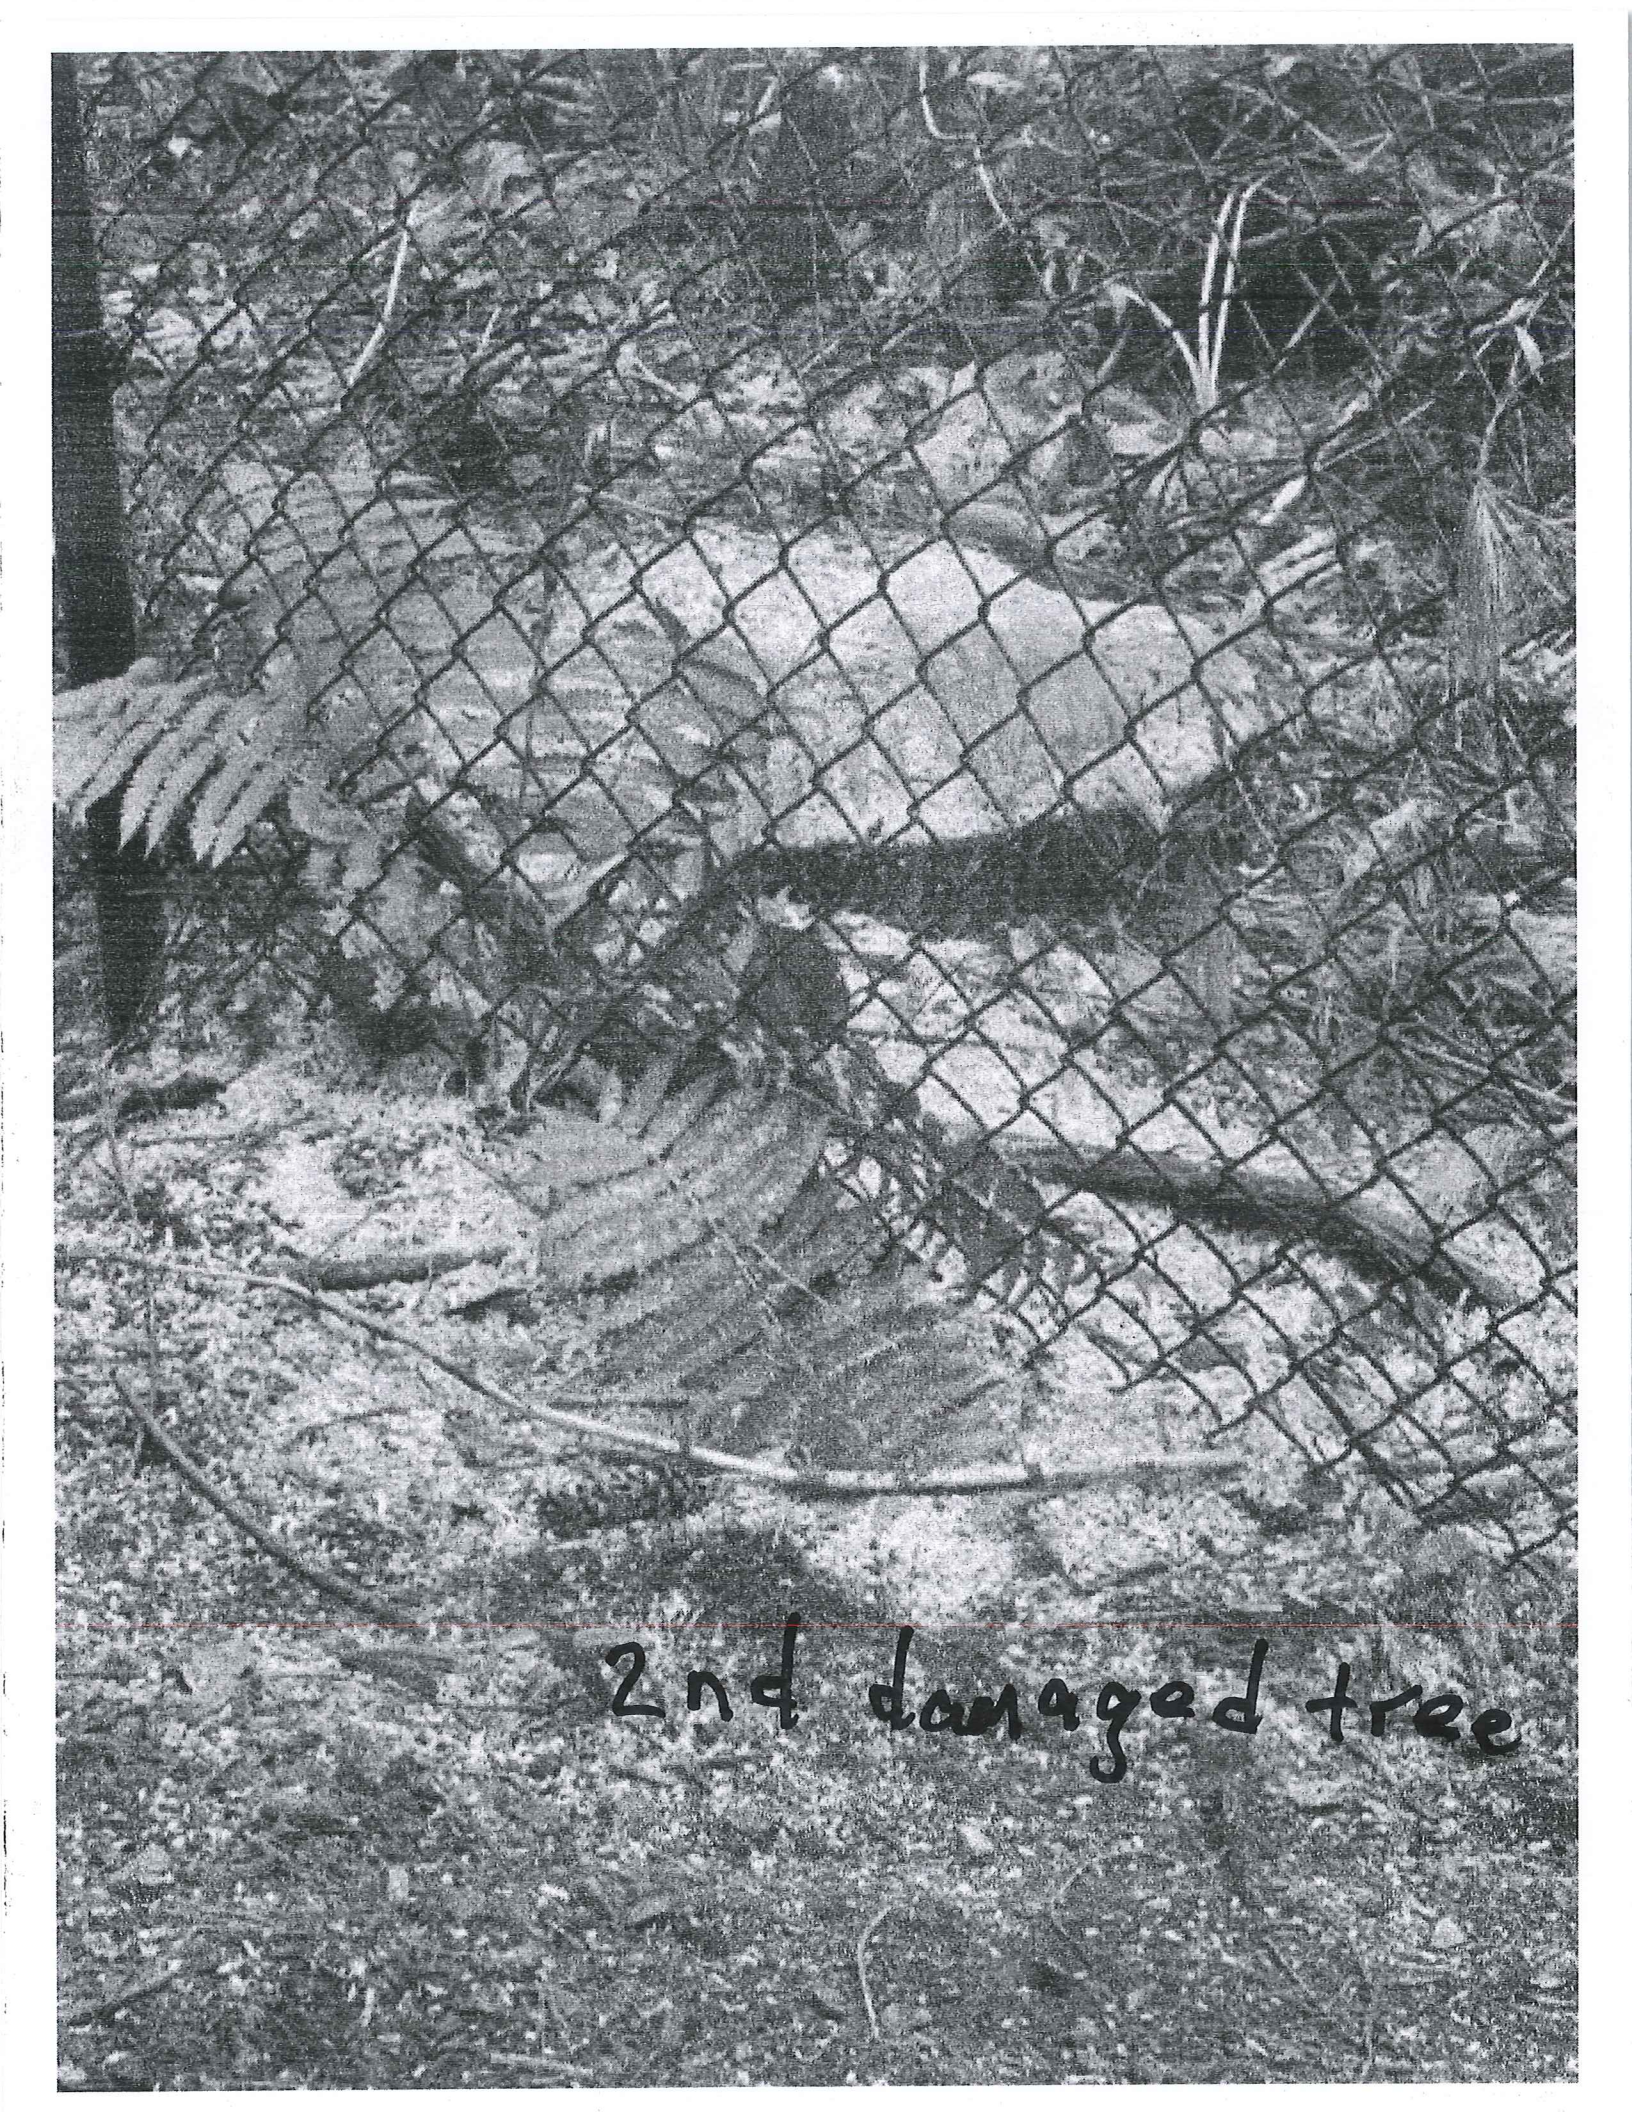
2nd damaged tree

FENCE DAMAGE  
45 FT OR E WALL ON  
LOT LINE

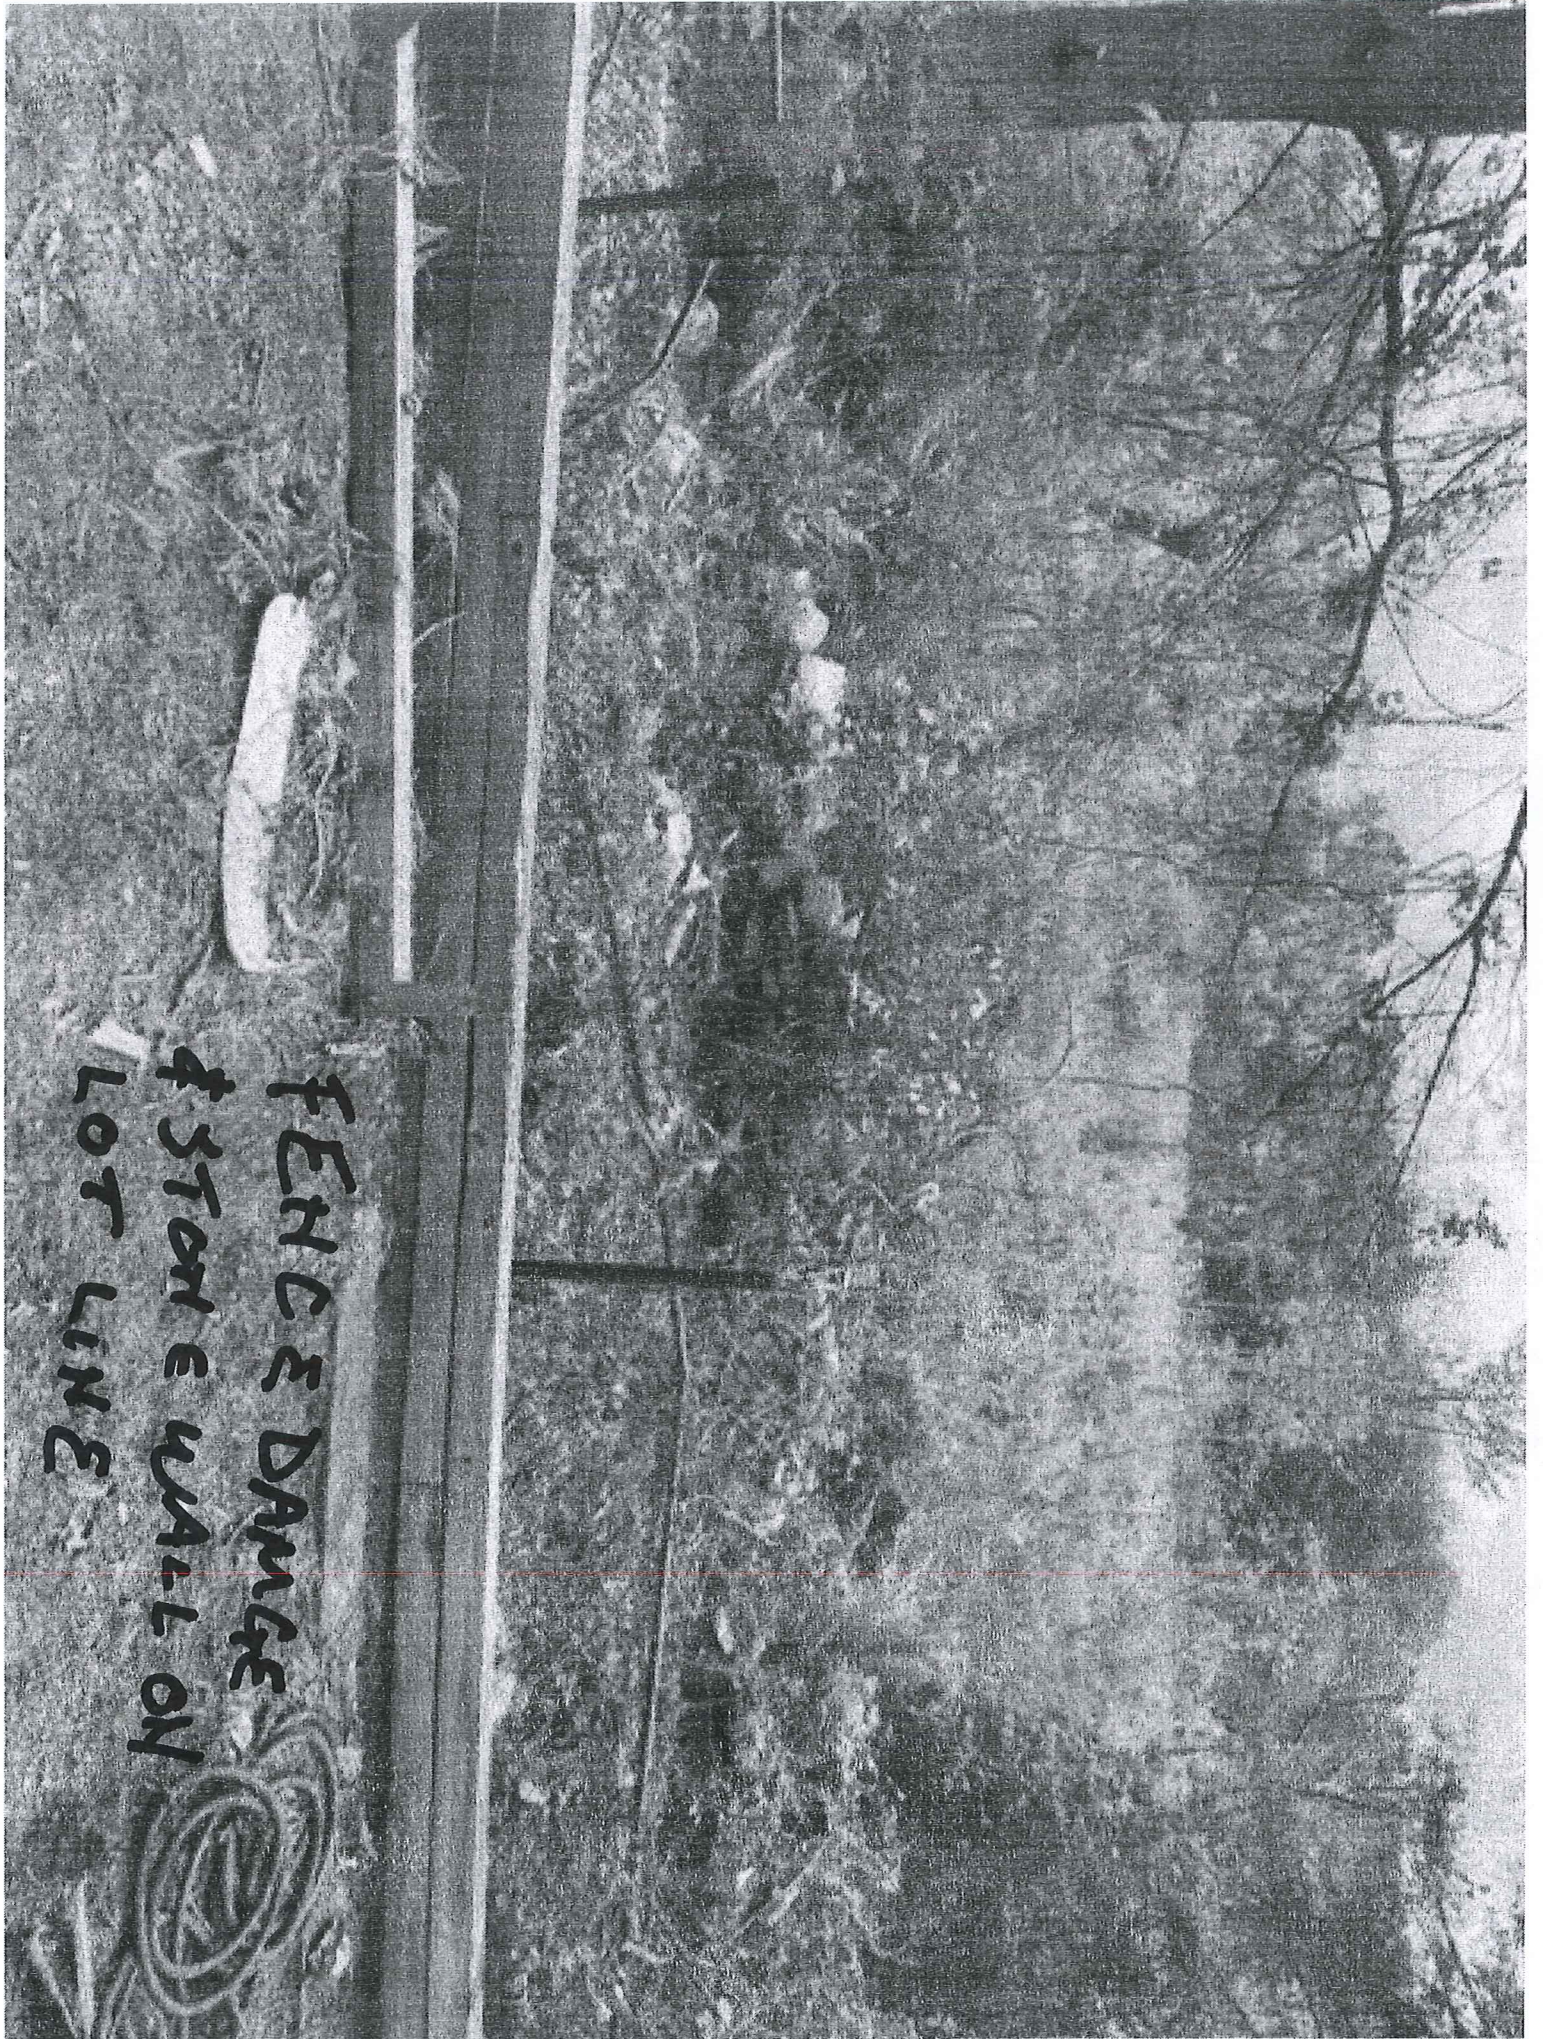
FENCE DAMAGE &  
STONE WALL LOT LINE

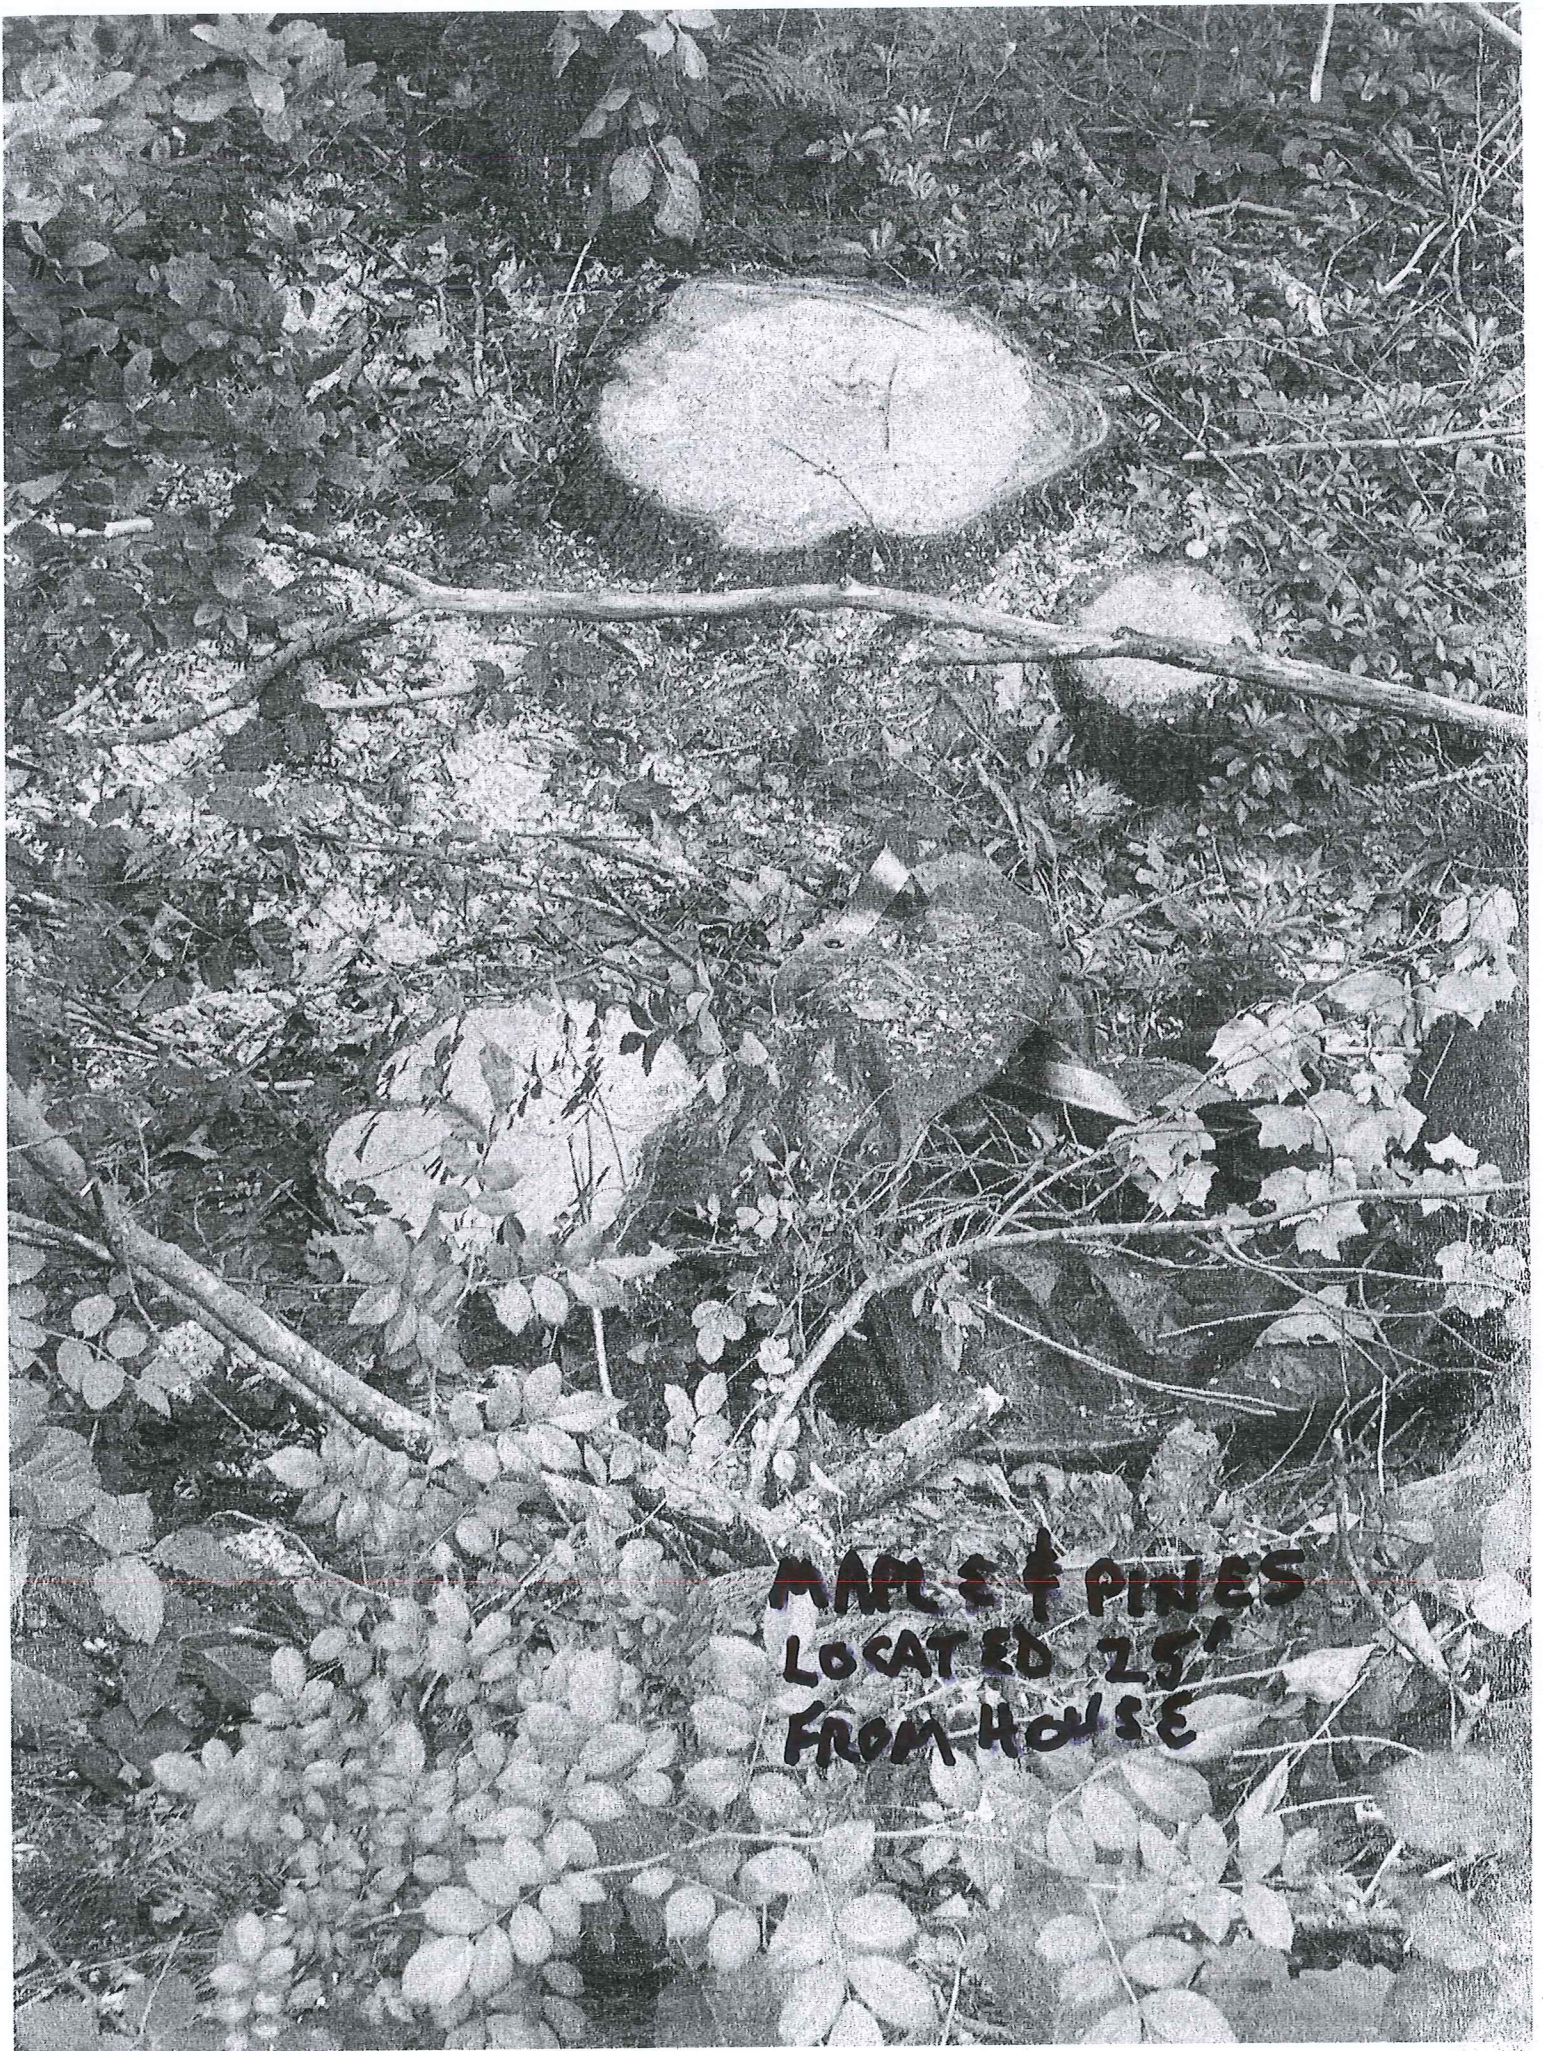
MAPLE & PINES  
LOCATED 25'  
FROM HOUSE

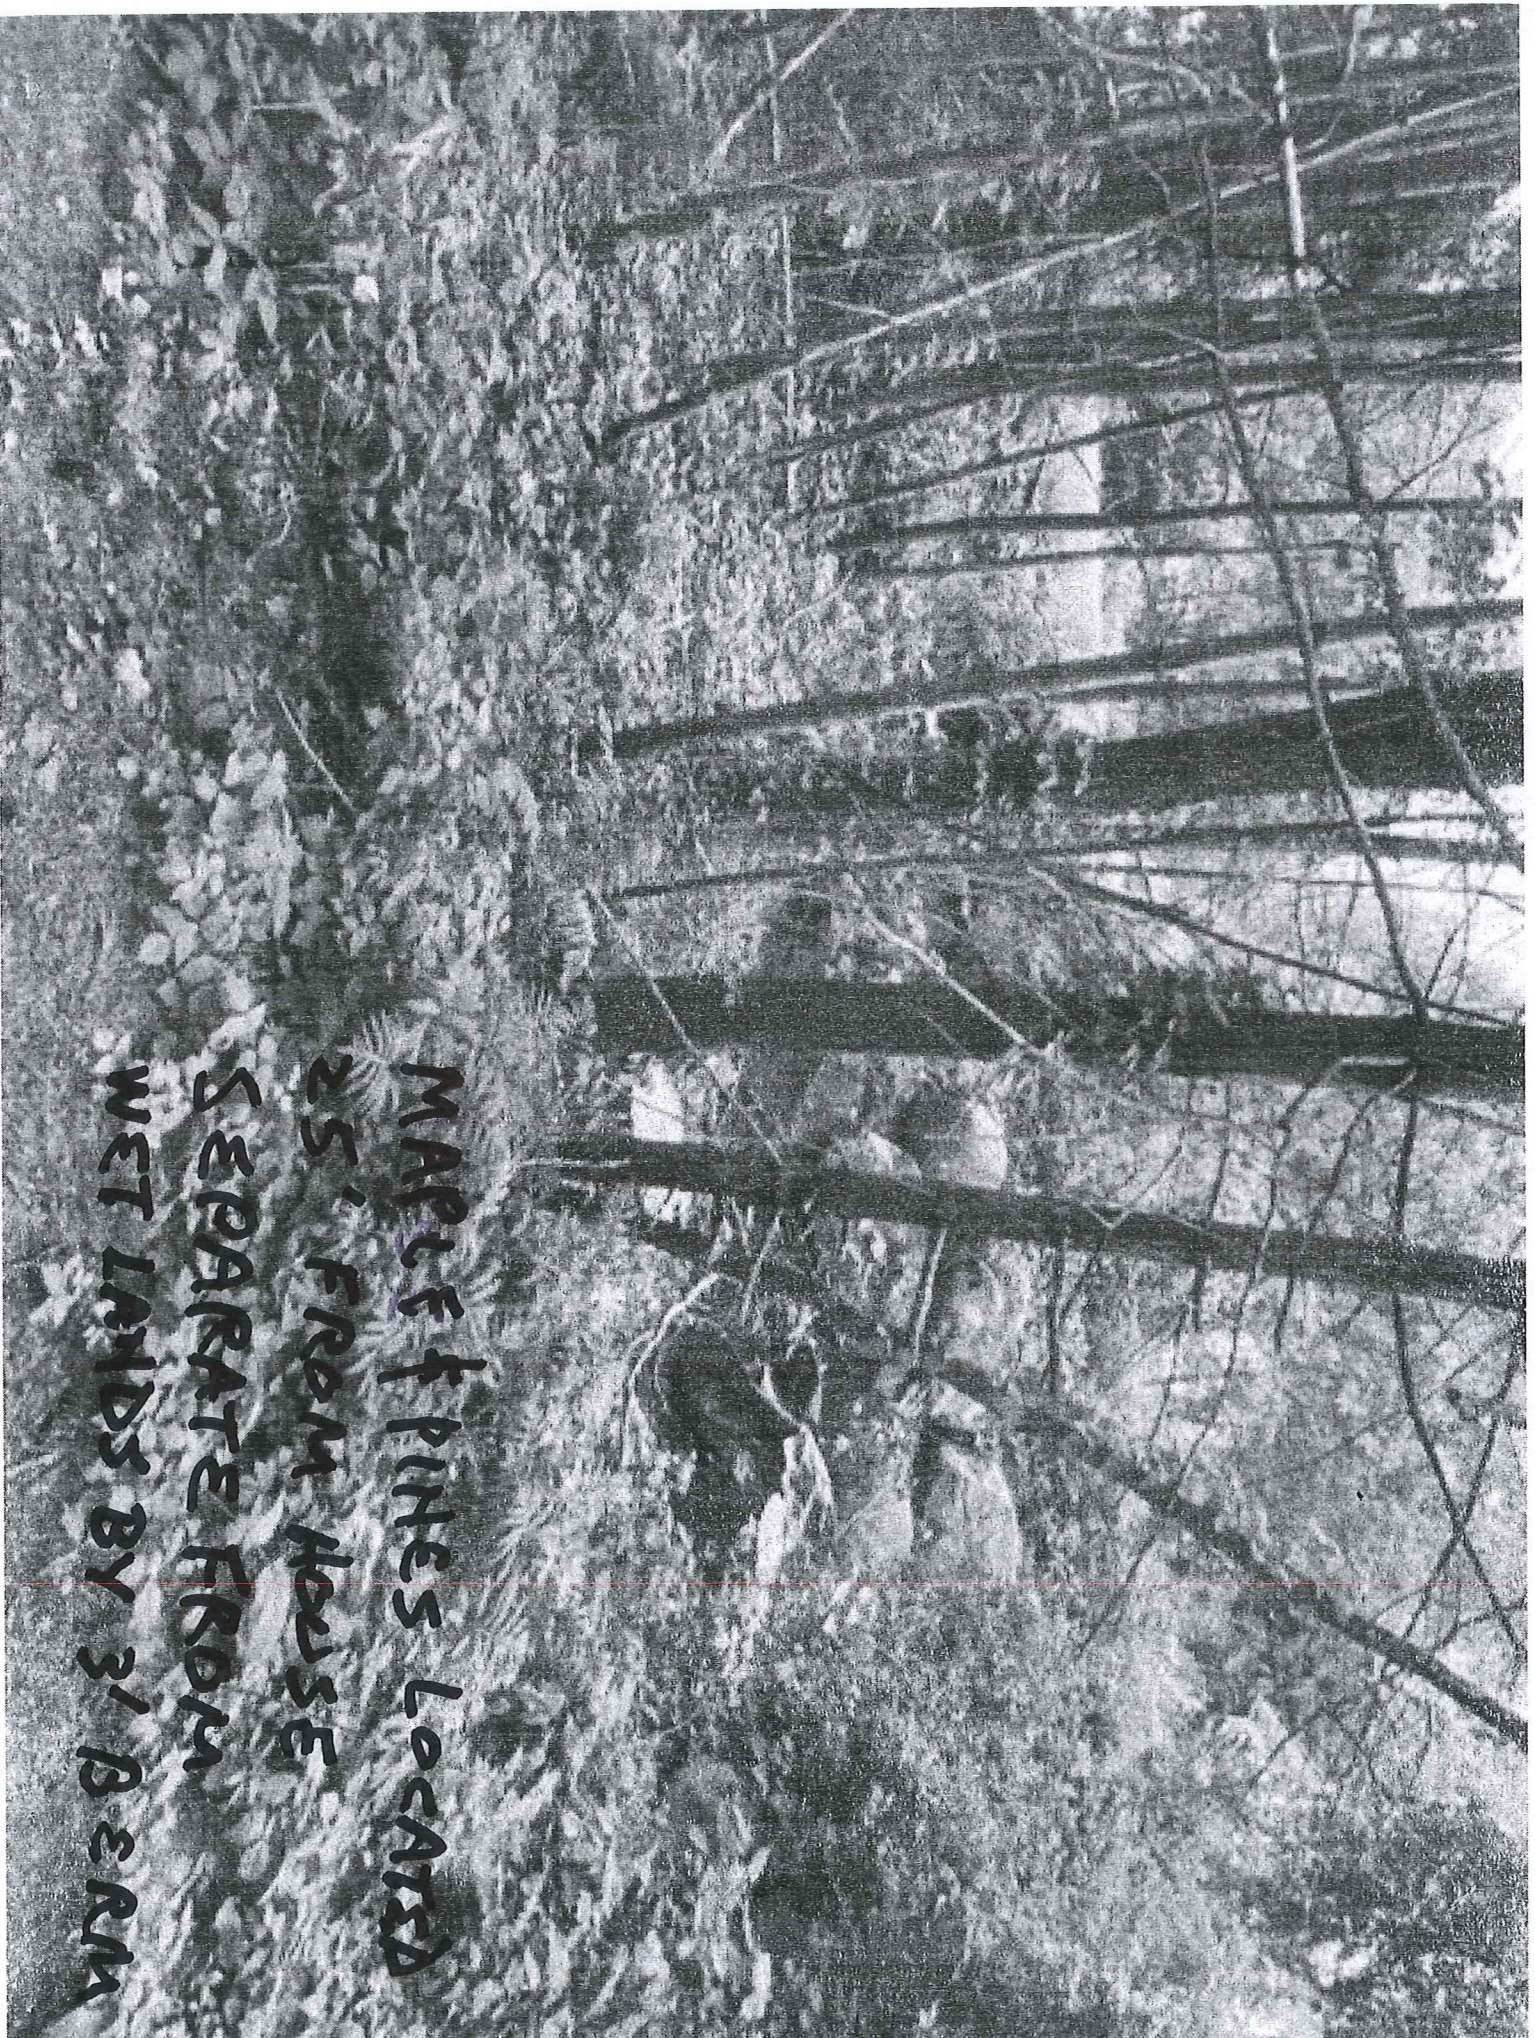
MAPLE & PINES LOCATED  
25' FROM HOUSE  
SEPARATE FROM  
WET LANDS BY 3' BERM
