Application for Minor Buffer Zone Activity at 11 Mount St Franklin MA..
March 15, 2024
Prepared by Homeowner Gregg Surdi

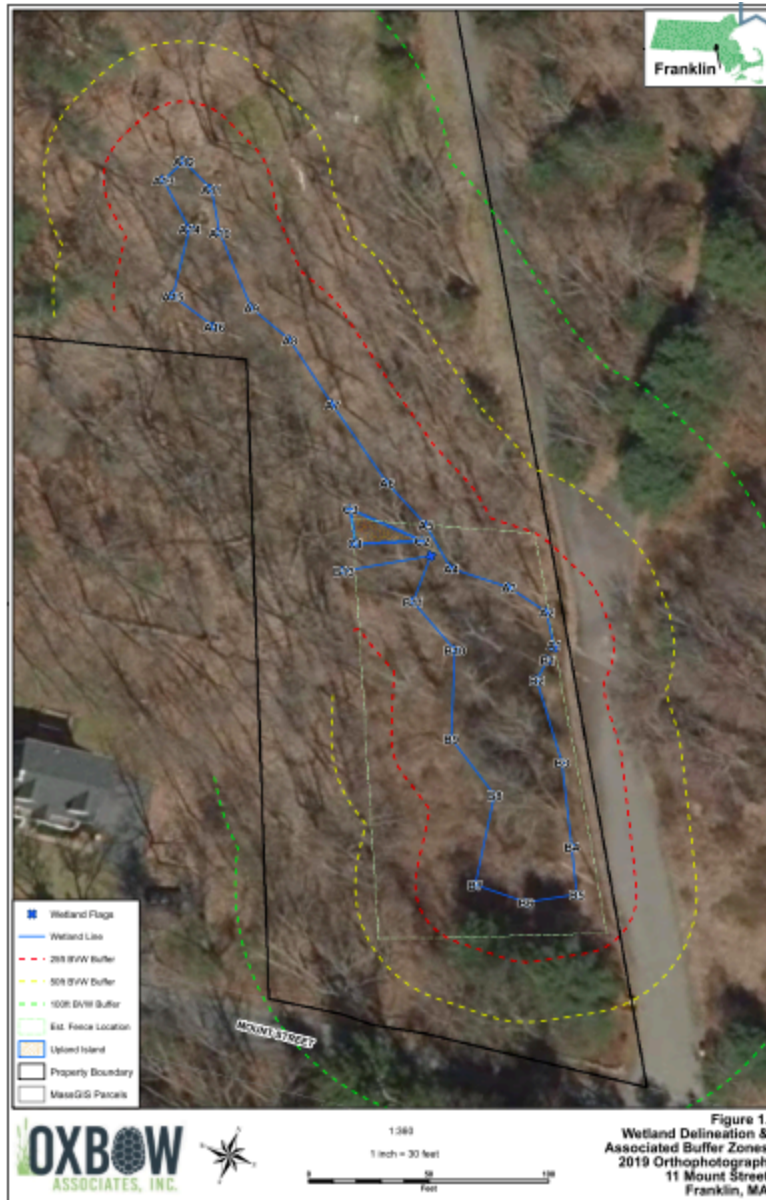
Figure 1. The area within the black line and top left border of the picture is the proposed area of work.

As mentioned in the description of the property, drainage is from the North and Northwest and exits the area through a culvert under the driveway. The culvert is located at wetland flag A1 in

figure 1. There is a steep slope from the driveway down to the wetland area as well as along Mount St.

The proposed work is to remove the dead ash trees as well as the invasive shrubs and replant with native trees and shrubs. The intention is to restore the neglected land to a more natural state as well as agri-forestry. The proposed area of work is within the property border show in the figure below (Fig. 1)

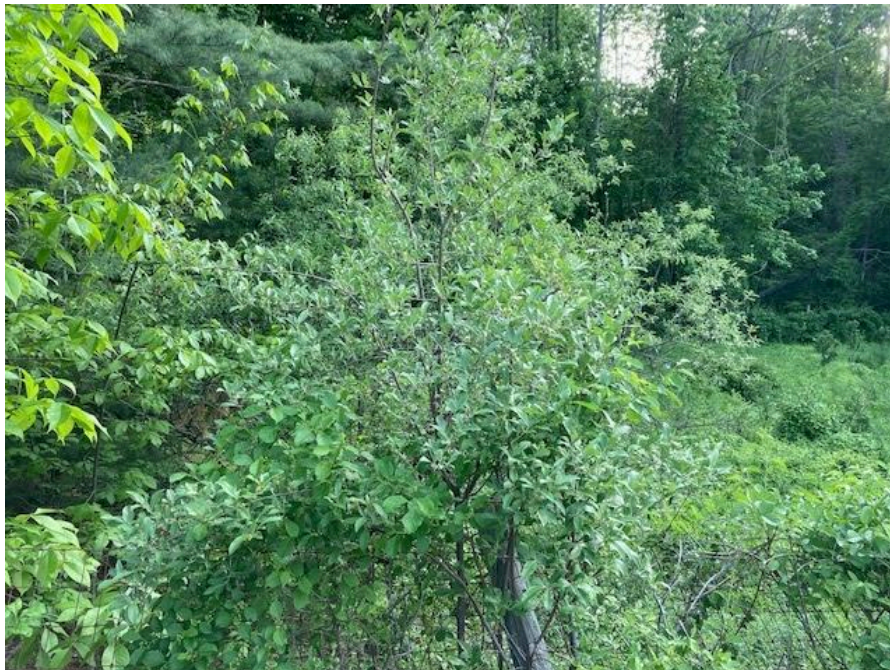
Figure 2: The tree in the proposed area of work is a previously unmentioned non-native Autumn Olive (*Elaeagnus umbellata*).

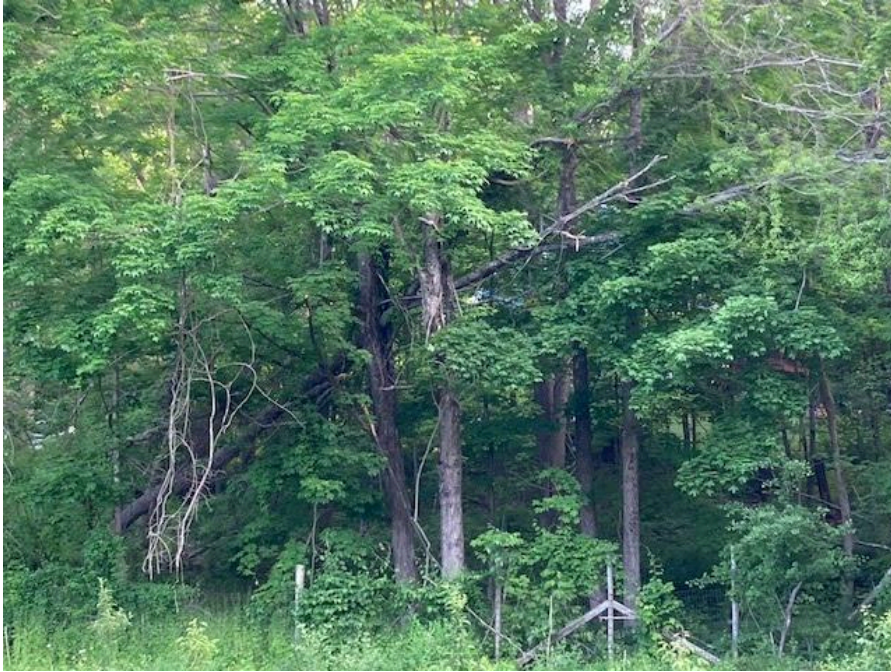
Figure 3. A view of the Westside of the pasture in 2021. The picture was taken facing West. Notice the fallen ash tree hung up. Since this picture was taken, more ash trees have fallen, damaging the post and wire fence that is planned to be replaced under the existing MBZA.

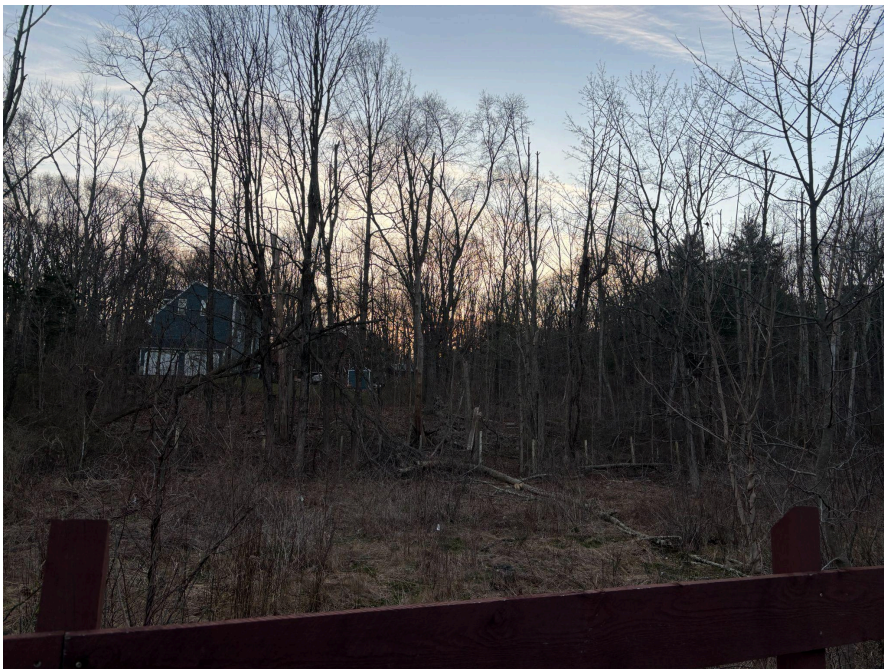
Figure 4. A current view of the area pictured in figure showing additional downed trees, including more trees that have fallen and damaged the pasture fence. Falling trees have also damaged the newer trees planted during the wetland restoration.

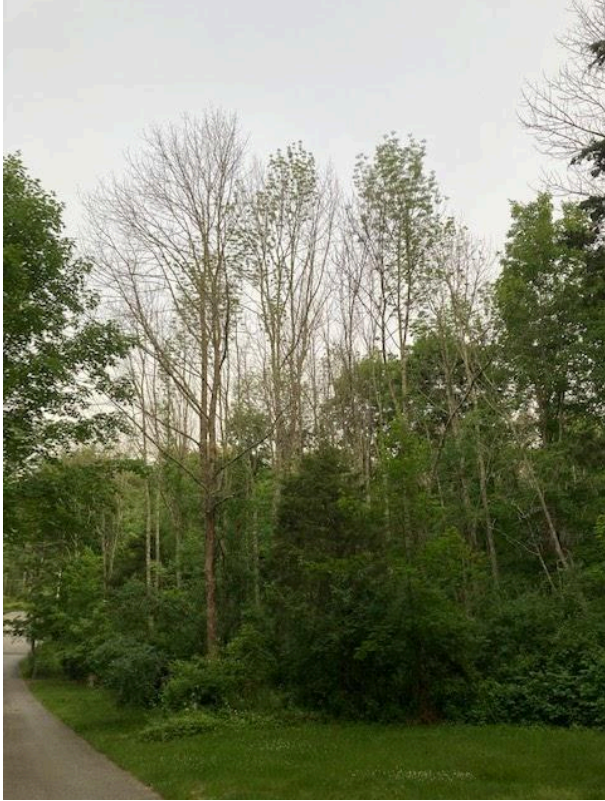
Figure 5. View from the North, looking South of the area North of the fenced pasture. The picture shows a large number (30-40) of dead ash trees that should be taken down. Another example of the damage caused by emerald ash borers. The majority of the understory is invasive honeysuckle, multiflora rose, glossy buckthorn and oriental bittersweet that should also be removed and replaced with native species.

Ash trees will be cut down by professional arborists. The trees will be chipped, cut and split for firewood or hauled away. Chipped material may be used for mulch. The stumps will be cut close to the ground and not mechanically ground. The invasive shrubs will be manually removed or mechanically cut to ground level. Waste material will be chipped or possibly burned during legal brush burning time.

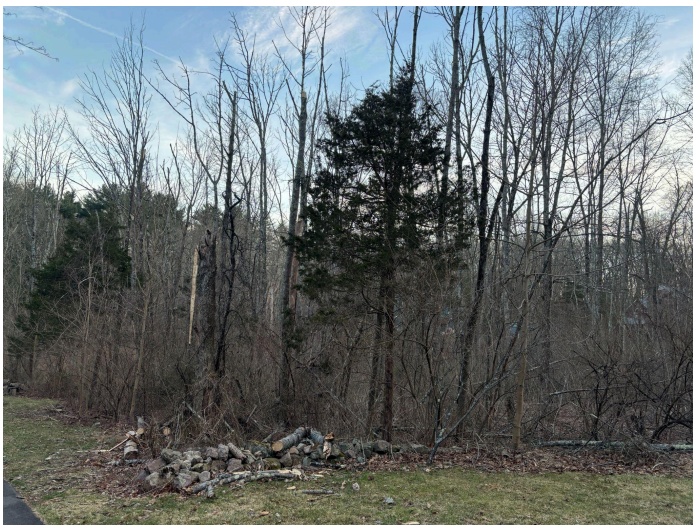
Figure 6. Similar view as figure 5. The prominent dead ash tree from figure 5 fell across the driveway this past winter.

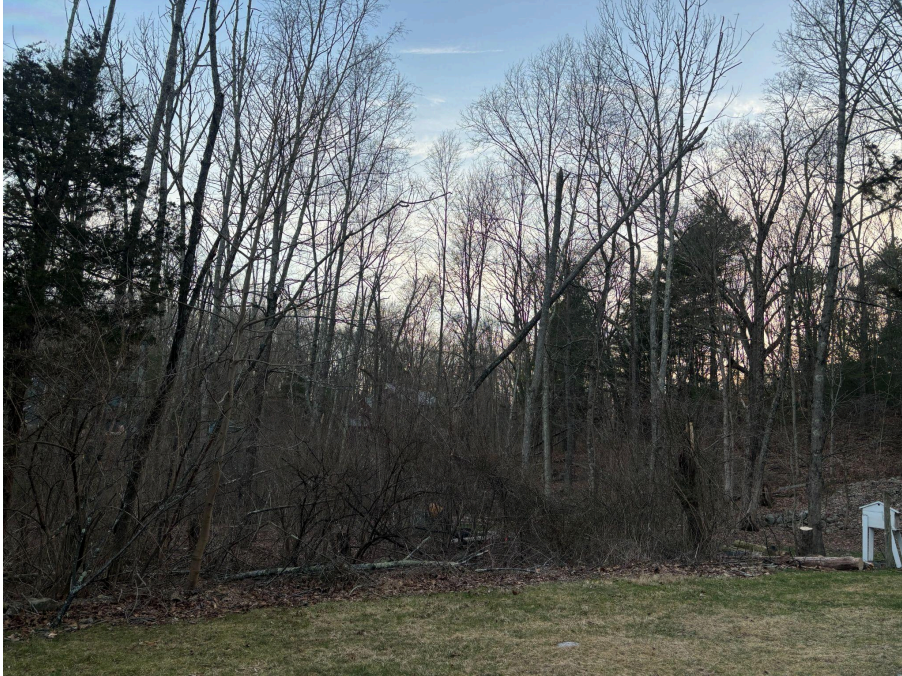
Figure 7. View is Southwest from the Northeast corner of the proposed work site. More dead ash trees as well as another unsafe hung-up tree. This hung-up tree is over a groomed portion of the property and is denying the homeowner access and use of the area below it.
