**NORTHEAST
GEOTECHNICAL, INC.**
Delivering Practical Engineering Solutions

Project No. O542.00

SUBJECT: In-Situ Soil Permeability Testing Summary Report
Stormwater Management Basins for NEAG
126 Grove Street
Franklin, MA

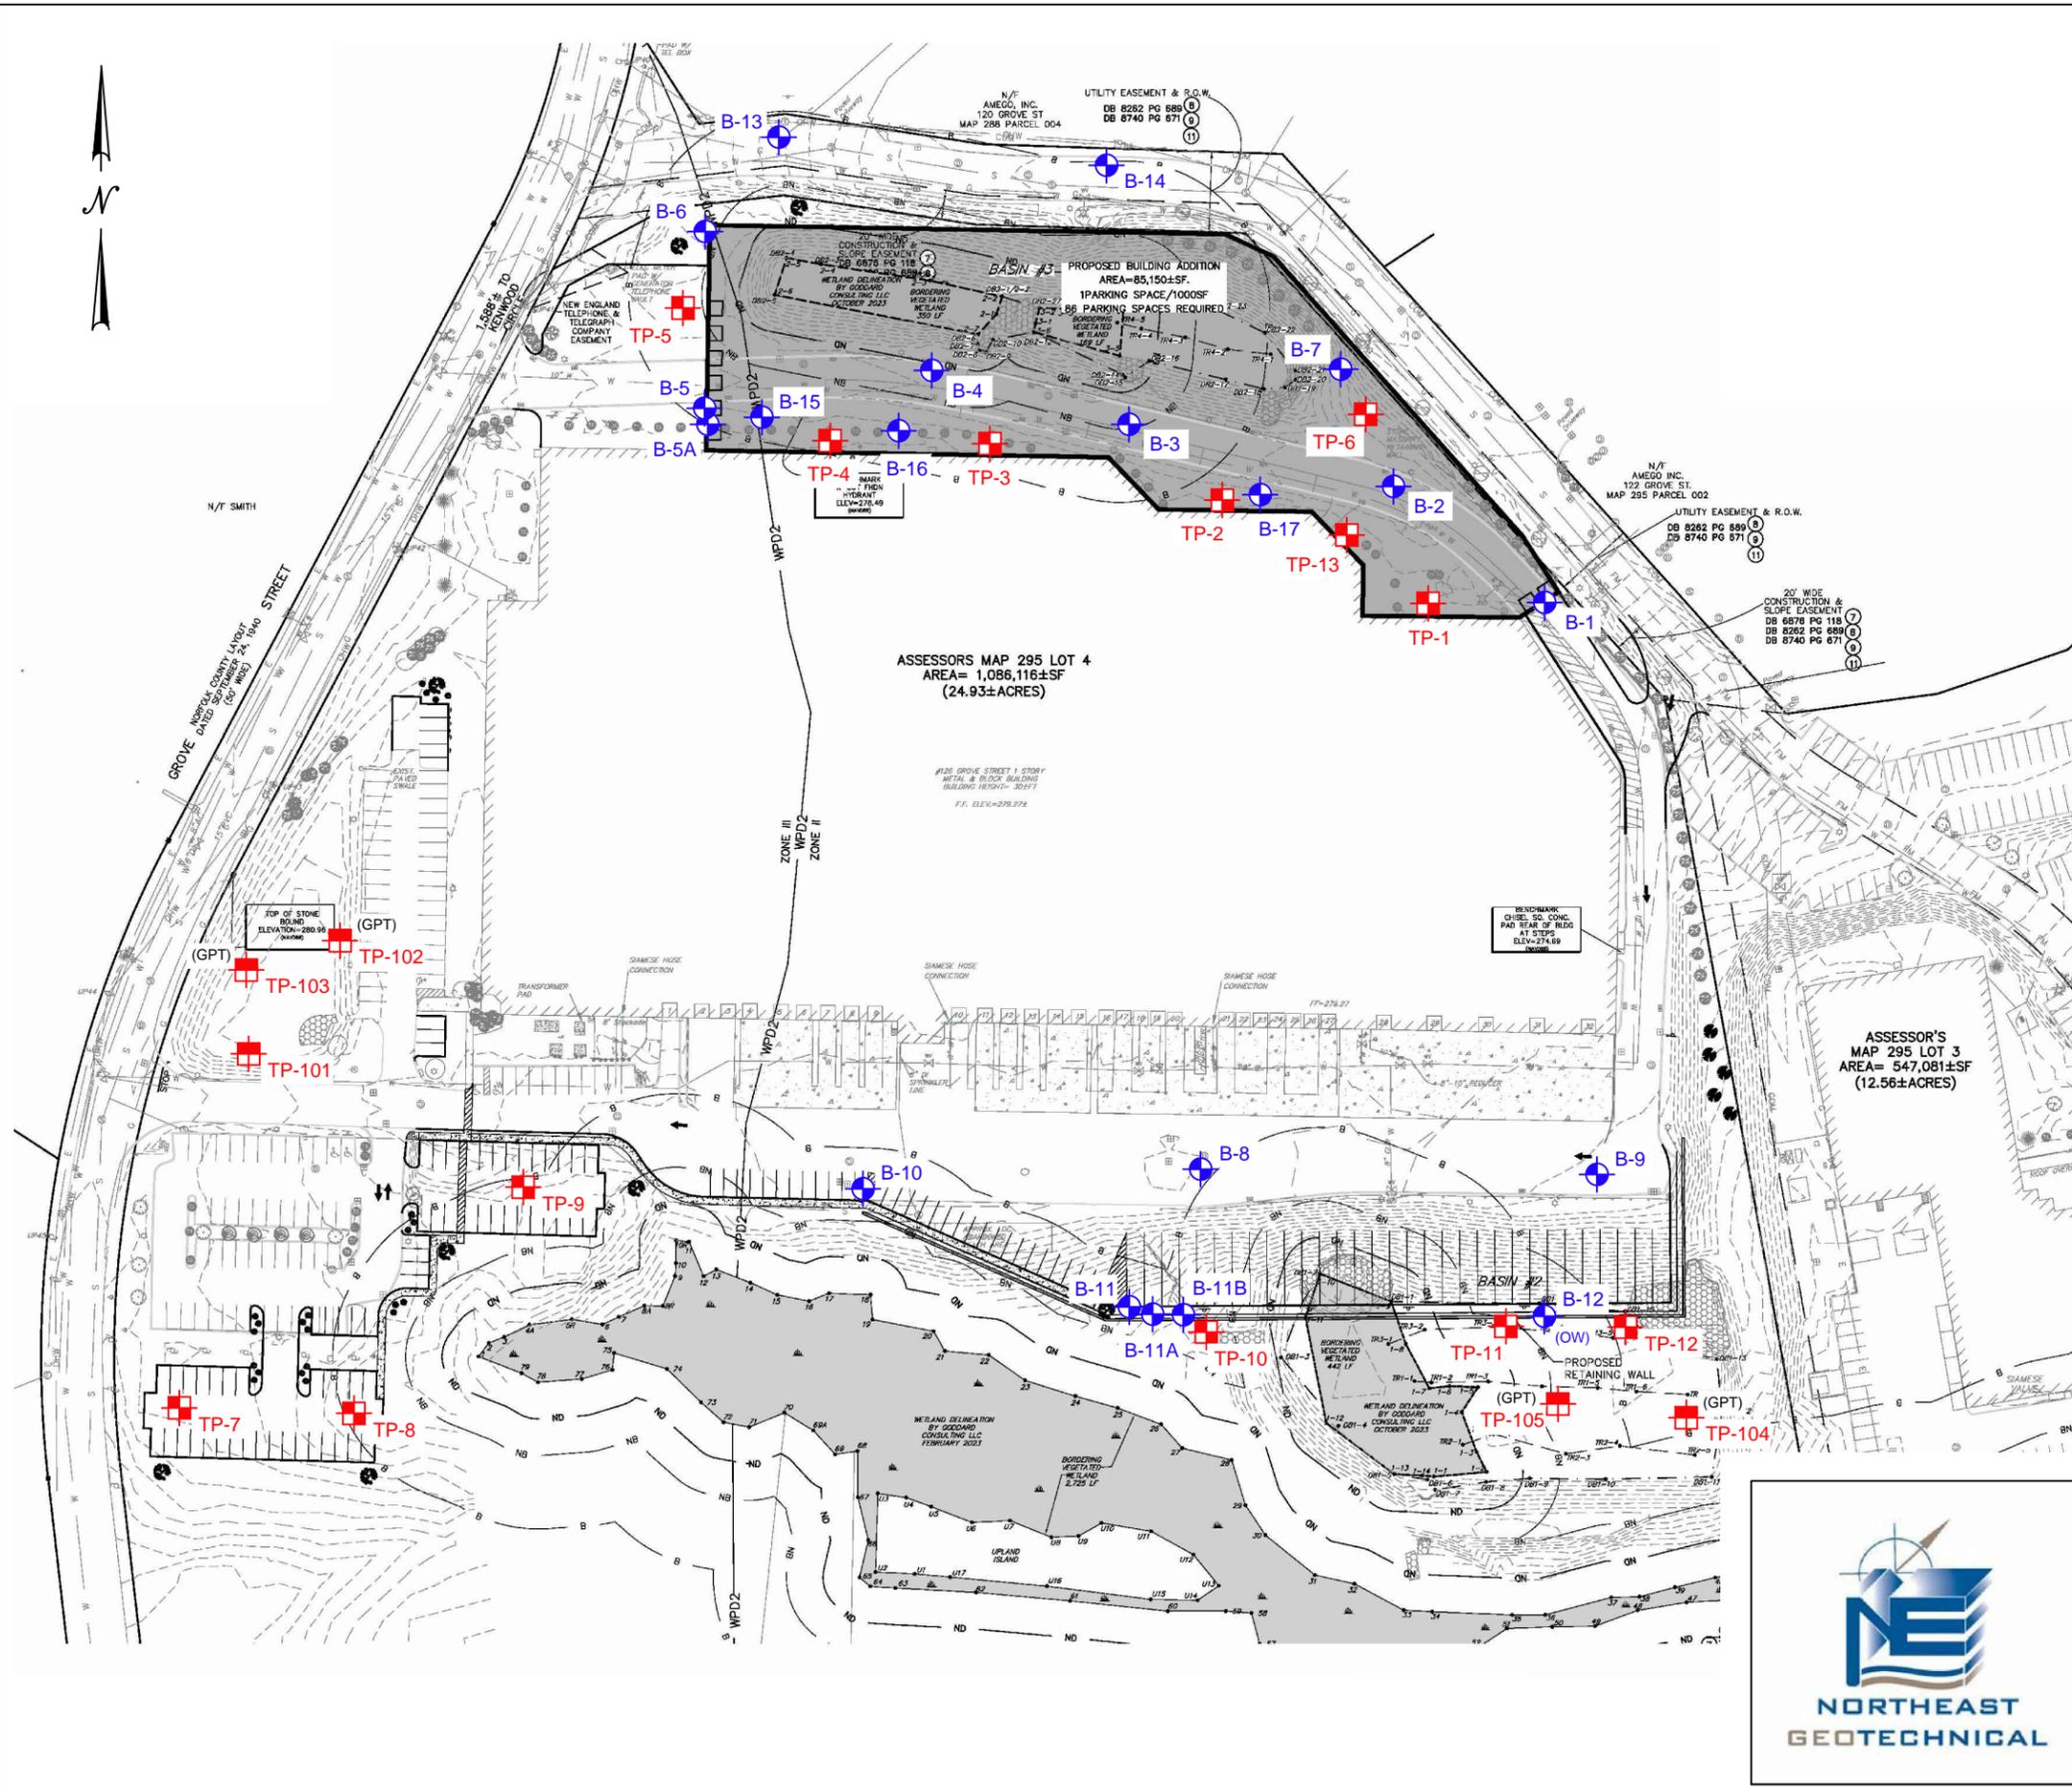
NORTHEAST GEOTECHNICAL, INC.		
NEW ENGLAND APPLIANCE GROUP WAREHOUSE ADDITION		
126 GROVE STREET		FRANKLIN, MA
SUBSURFACE EXPLORATION LOCATION PLAN		
Project No.: O542.00	Drawn By: CBR	Reviewed By: G. OLSON, P.E.
Date: 3/5/2025	Scale: 1"=120'	Figure No.: 1

The test pit locations were survey located at the site by G&H in advance of our field work. The approximate test pit locations are shown on the Subsurface Exploration Location Plan, which is attached to this report as Figure No. 1. The existing ground surface elevations depicted on the individual test pit logs were estimated from G&H's Drainage Plan. The elevations shown on the test pit logs and referenced throughout this report should be considered approximate.

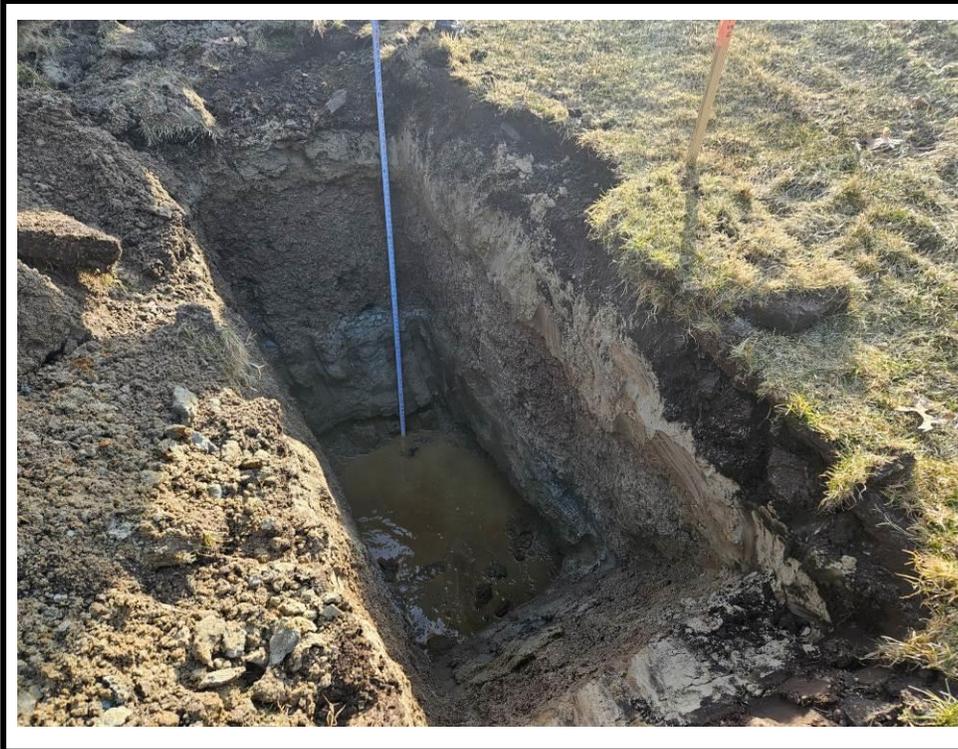
Photograph #1

Description of Photograph:

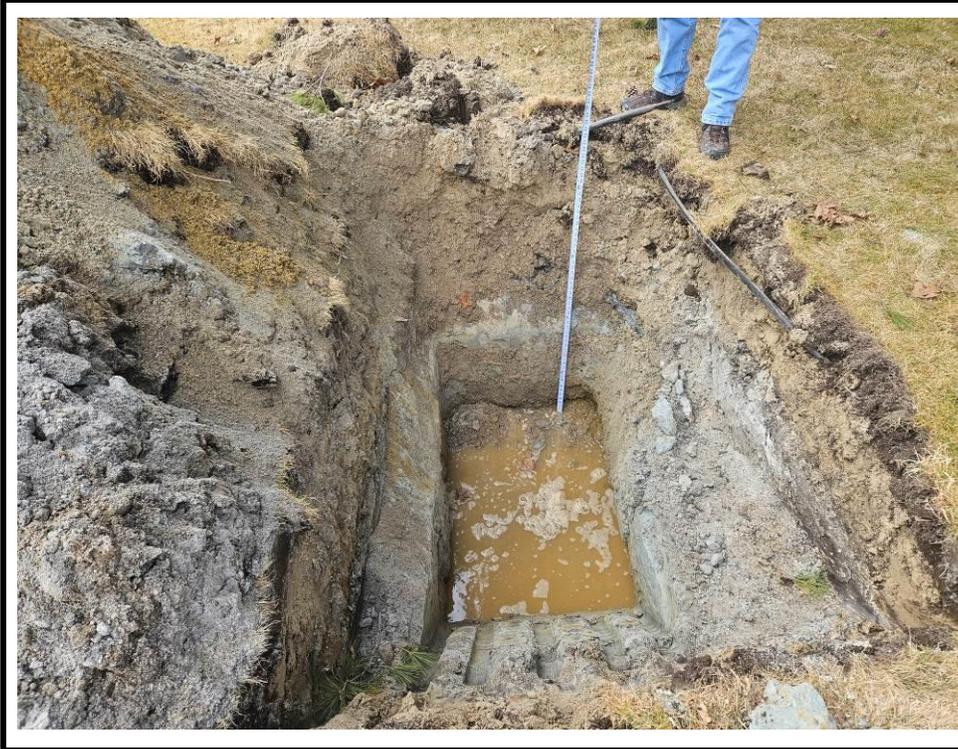
Photograph #2

Description of Photograph:

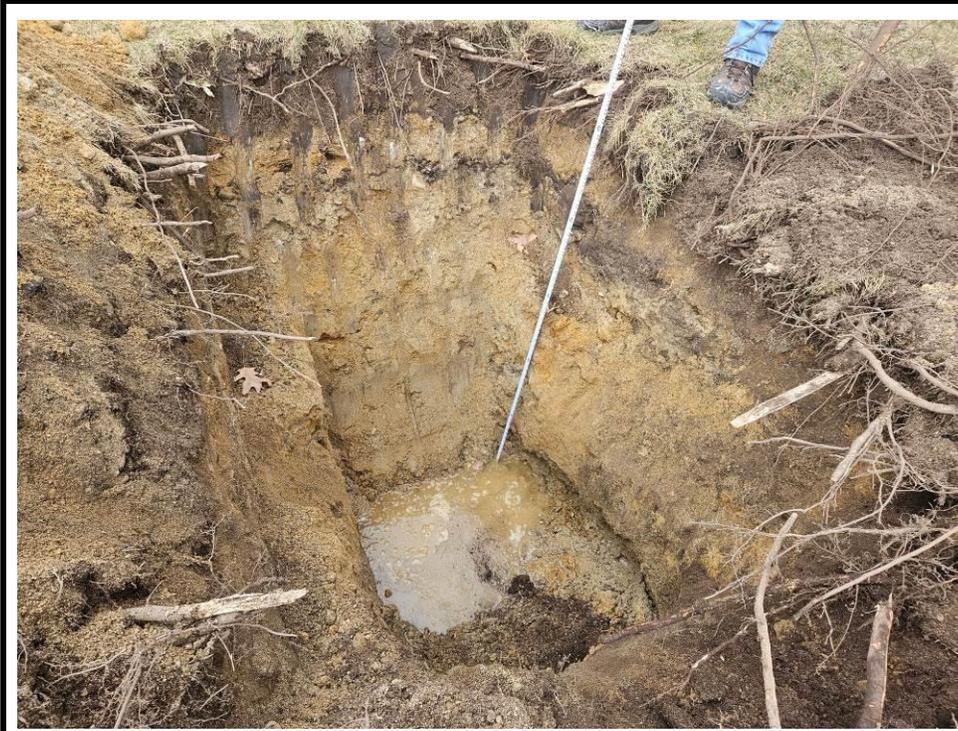
Photograph #3

Description of Photograph:

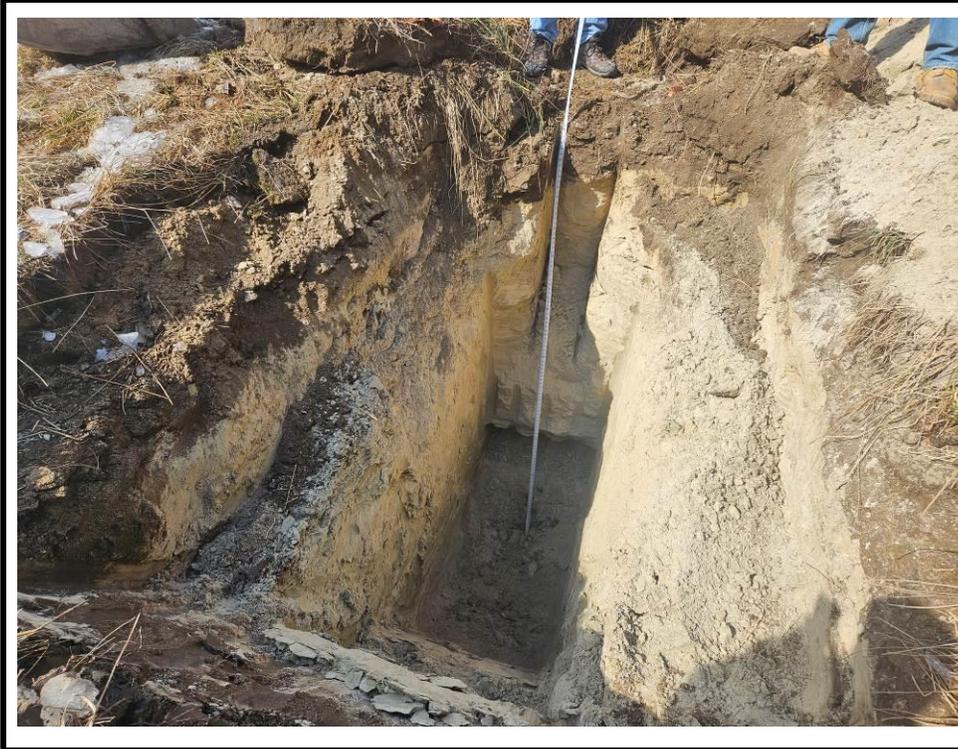
Photograph #4

Description of Photograph:

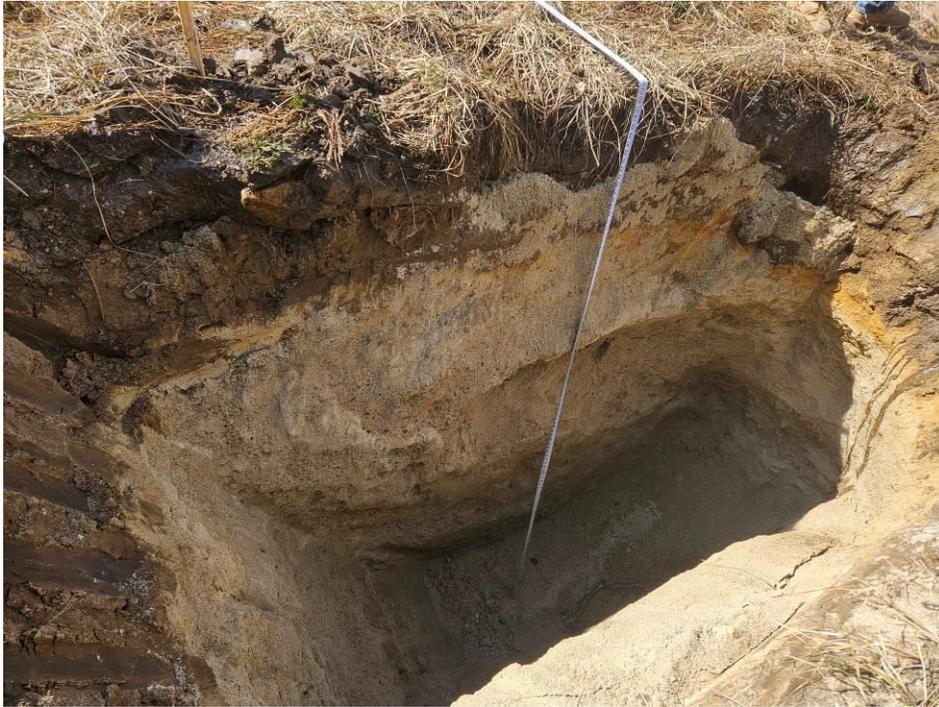
Photograph #5

Description of Photograph:

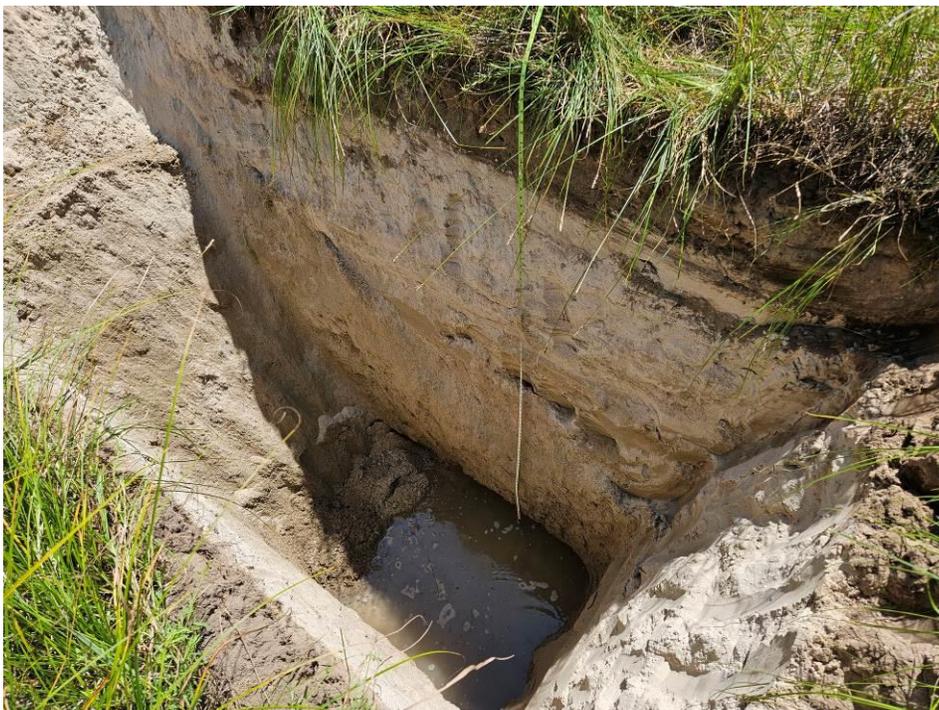
Photograph #6

Description of Photograph:

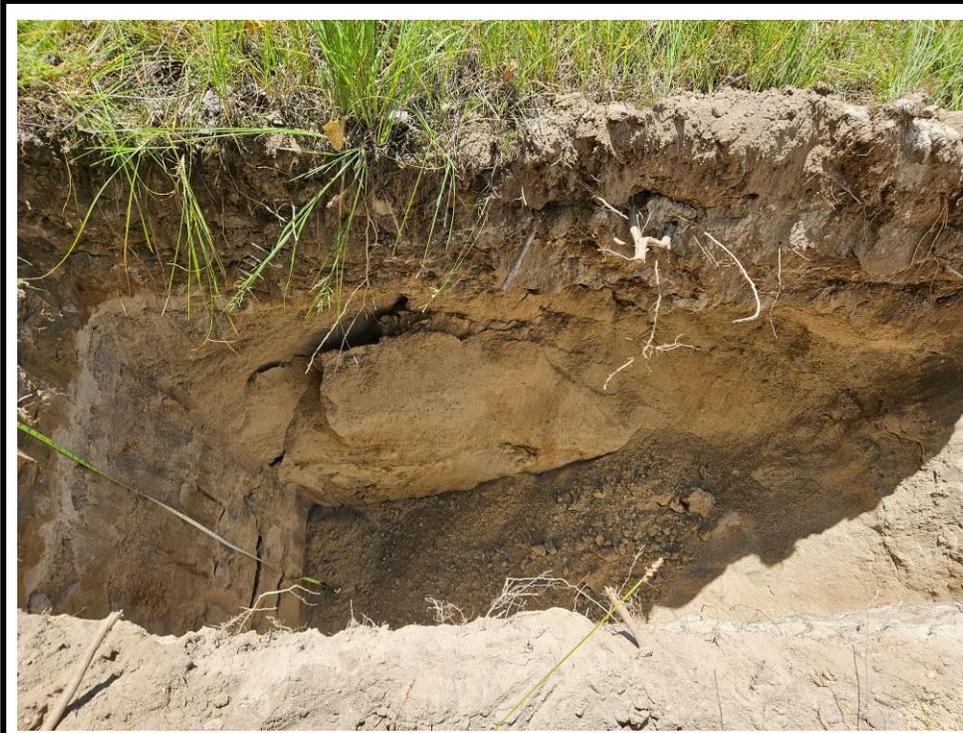
Photograph #7

Description of Photograph:

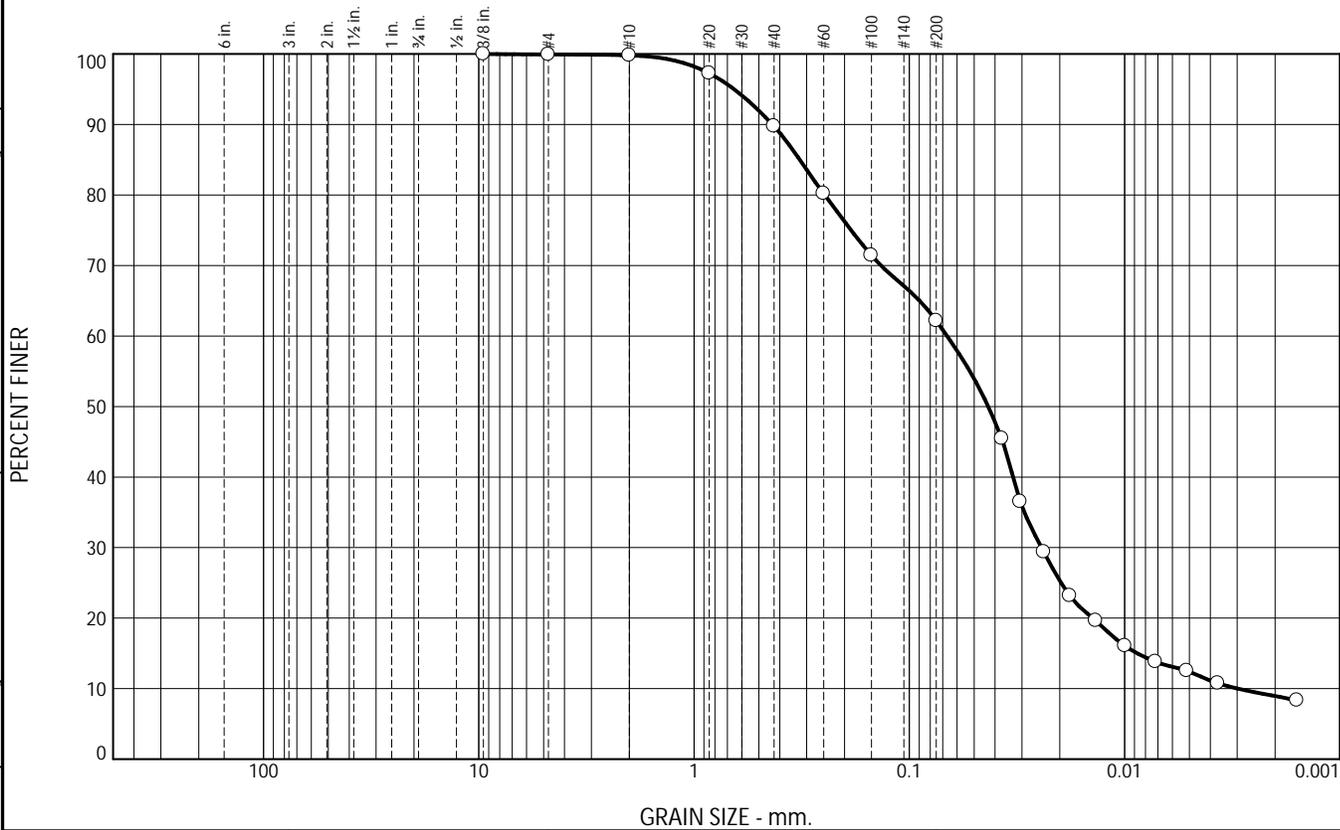
Particle Size Distribution Report

% +3"	% Gravel		% Sand			% Fines	
	Coarse	Fine	Coarse	Medium	Fine	Silt	Clay
0.0	0.0	0.1	0.1	10.1	27.5	53.3	8.9

SIEVE SIZE OR DIAMETER	PERCENT FINER	SPEC.* PERCENT	PASS? (X=NO)
3/8"	100.0		
#4	99.9		
#10	99.8		
#20	97.3		
#40	89.7		
#60	80.2		
#100	71.4		
#200	62.2		
0.0372 mm.	45.4		
0.0305 mm.	36.5		
0.0237 mm.	29.4		
0.0180 mm.	23.1		
0.0136 mm.	19.6		
0.0100 mm.	16.0		
0.0072 mm.	13.8		
0.0051 mm.	12.5		
0.0037 mm.	10.7		
0.0016 mm.	8.3

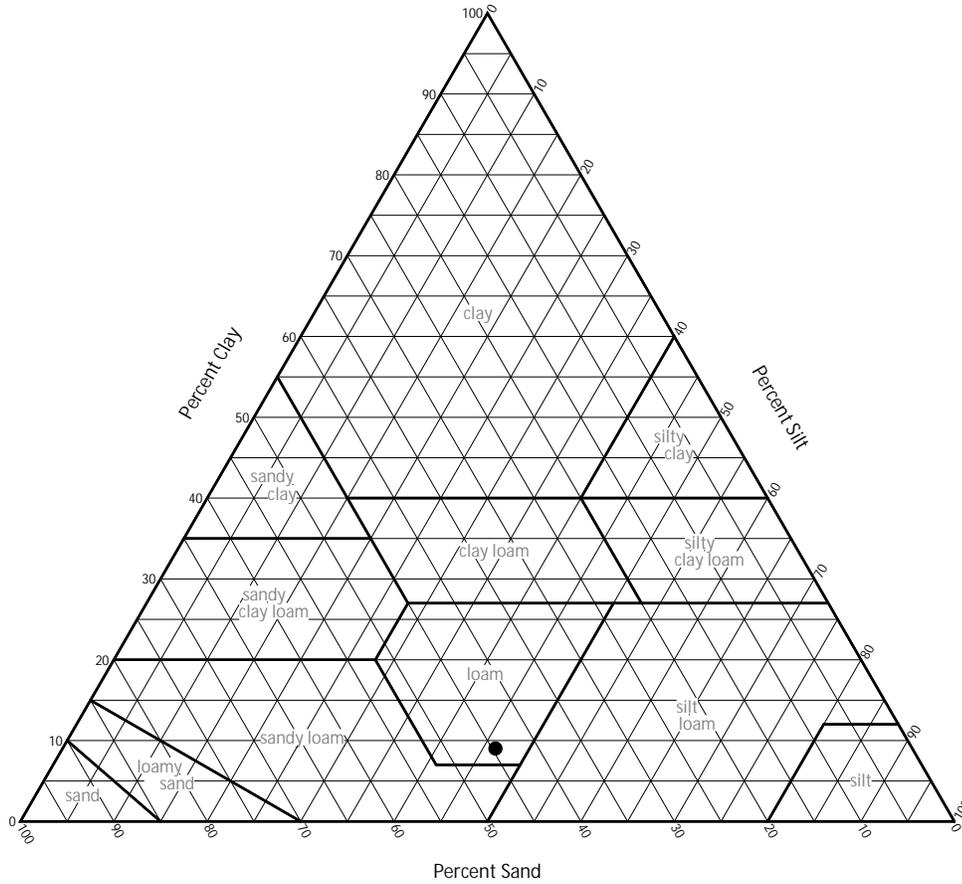
USDA Soil Classification

SOIL DATA							
	Source	Sample No.	Depth	Percentages From Material Passing a #10 Sieve			Classification
				Sand	Silt	Clay	
●	Test Pit	TP-102 / GS-1	1.2-3.0'	44.6	46.5	8.9	Loam

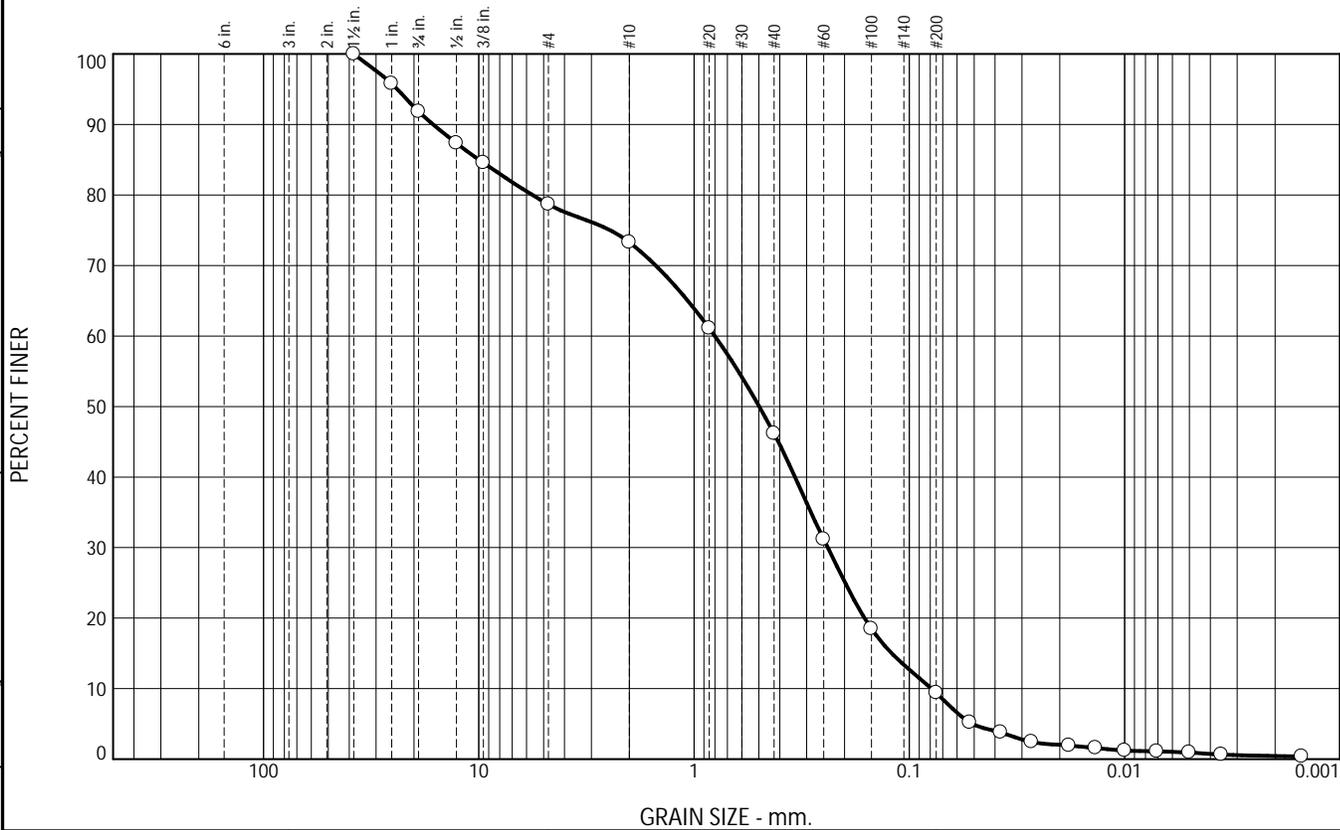
Particle Size Distribution Report

% +3"	% Gravel		% Sand			% Fines	
	Coarse	Fine	Coarse	Medium	Fine	Silt	Clay
0.0	8.2	13.1	5.4	27.1	36.8	9.0	0.4

SIEVE SIZE OR DIAMETER	PERCENT FINER	SPEC.* PERCENT	PASS? (X=NO)
1 1/2"	100.0		
1"	95.8		
3/4"	91.8		
1/2"	87.4		
3/8"	84.6		
#4	78.7		
#10	73.3		
#20	61.1		
#40	46.2		
#60	31.2		
#100	18.5		
#200	9.4		
0.0524 mm.	5.2		
0.0376 mm.	3.8		
0.0270 mm.	2.4		
0.0181 mm.	1.9		
0.0136 mm.	1.6		
0.0100 mm.	1.2		
0.0071 mm.	1.1		
0.0050 mm.	0.9		
0.0036 mm.	0.6		
0.0015 mm.	0.4

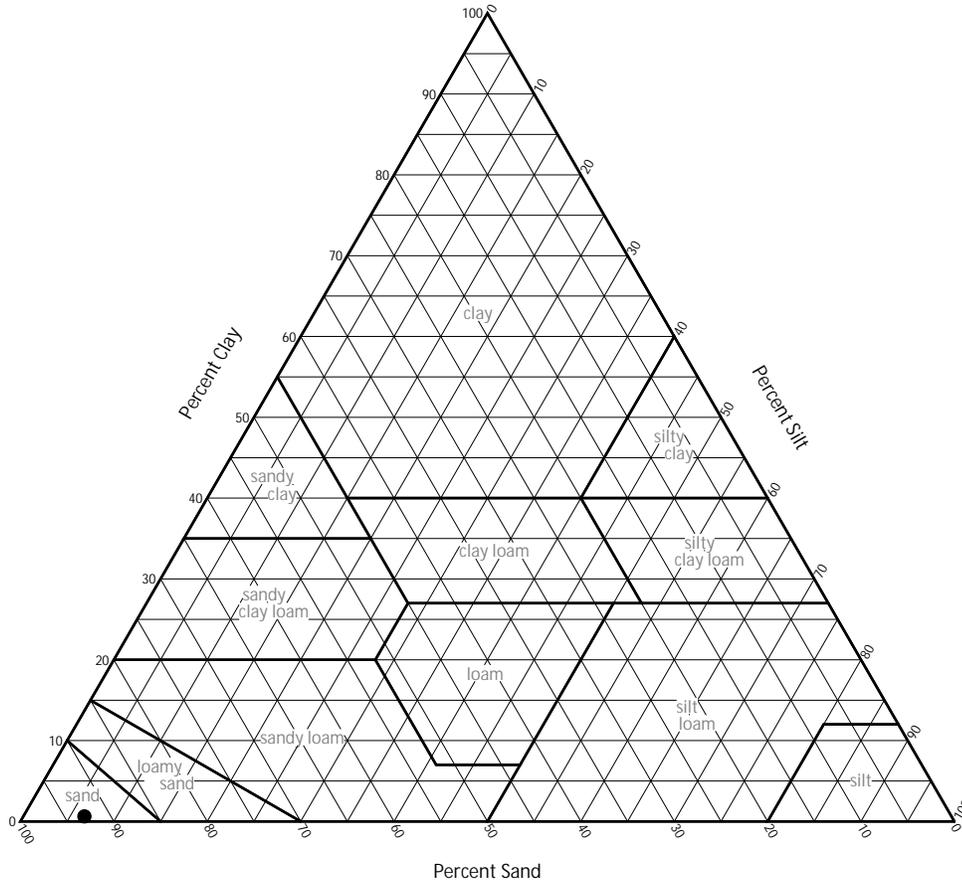
USDA Soil Classification

SOIL DATA							
	Source	Sample No.	Depth	Percentages From Material Passing a #10 Sieve			Classification
				Sand	Silt	Clay	
●	Test Pit	TP-103 / GS-1	2.3-3.3'	92.8	6.7	0.5	Sand

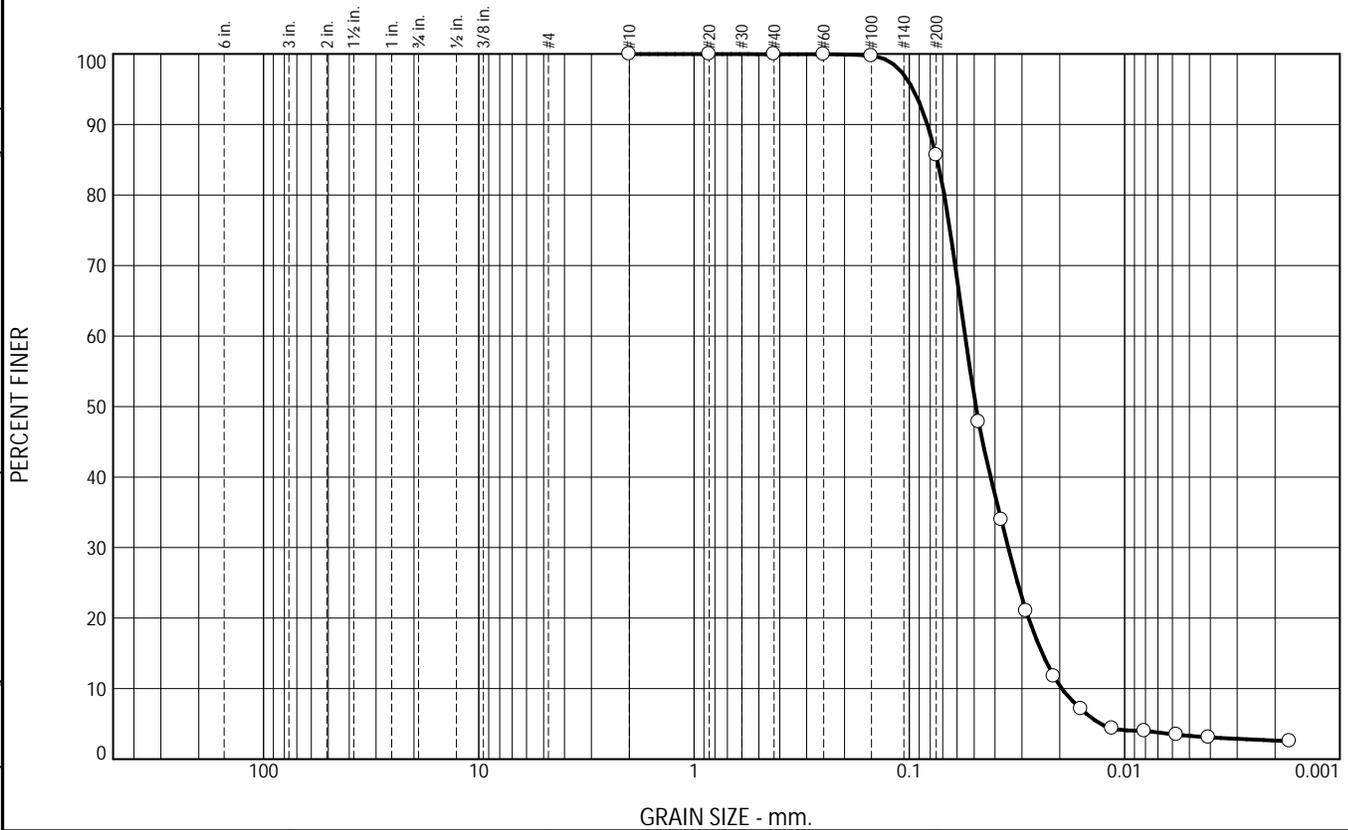
Particle Size Distribution Report

% +3"	% Gravel		% Sand			% Fines	
	Coarse	Fine	Coarse	Medium	Fine	Silt	Clay
0.0	0.0	0.0	0.0	0.0	14.3	83.1	2.6

SIEVE SIZE OR DIAMETER	PERCENT FINER	SPEC.* PERCENT	PASS? (X=NO)
#10	100.0		
#20	100.0		
#40	100.0		
#60	100.0		
#100	99.7		
#200	85.7		
0.0477 mm.	47.8		
0.0374 mm.	34.0		
0.0287 mm.	21.0		
0.0213 mm.	11.8		
0.0160 mm.	7.1		
0.0114 mm.	4.3		
0.0081 mm.	4.0		
0.0057 mm.	3.5		
0.0041 mm.	3.1		
0.0017 mm.	2.5

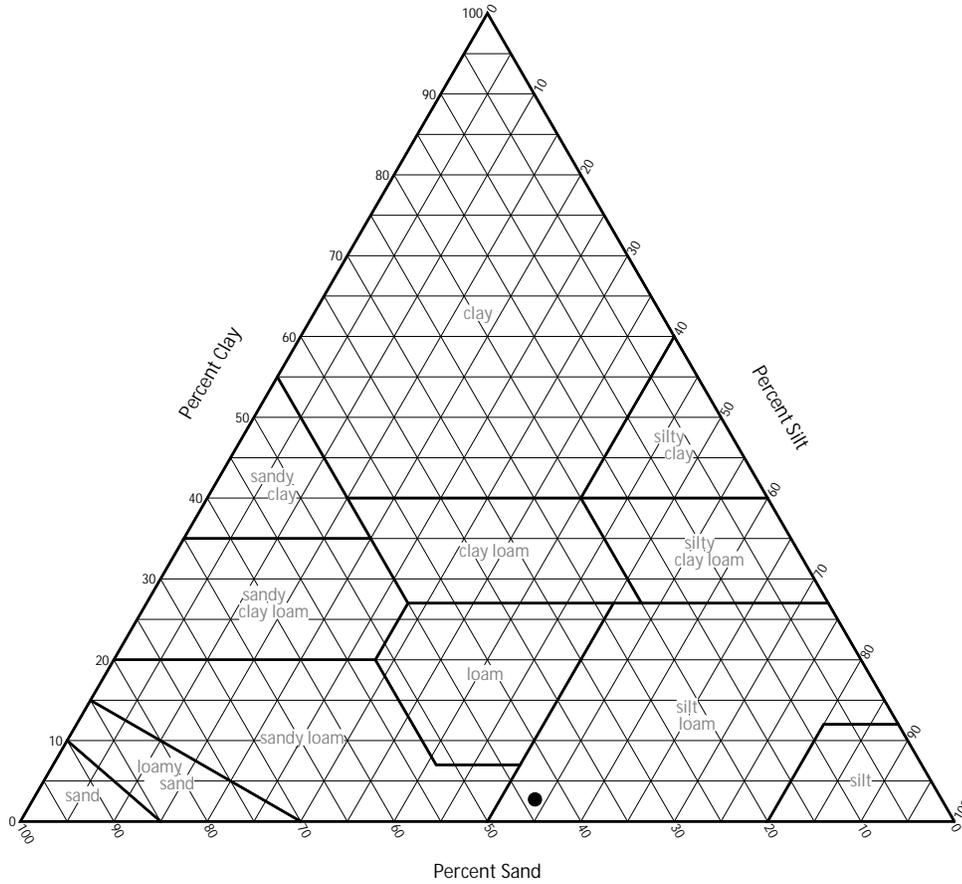
USDA Soil Classification

SOIL DATA							
	Source	Sample No.	Depth	Percentages From Material Passing a #10 Sieve			Classification
				Sand	Silt	Clay	
●	Test Pit	TP-104 / GS-1	2.3-3.5'	43.5	53.9	2.6	Silt loam

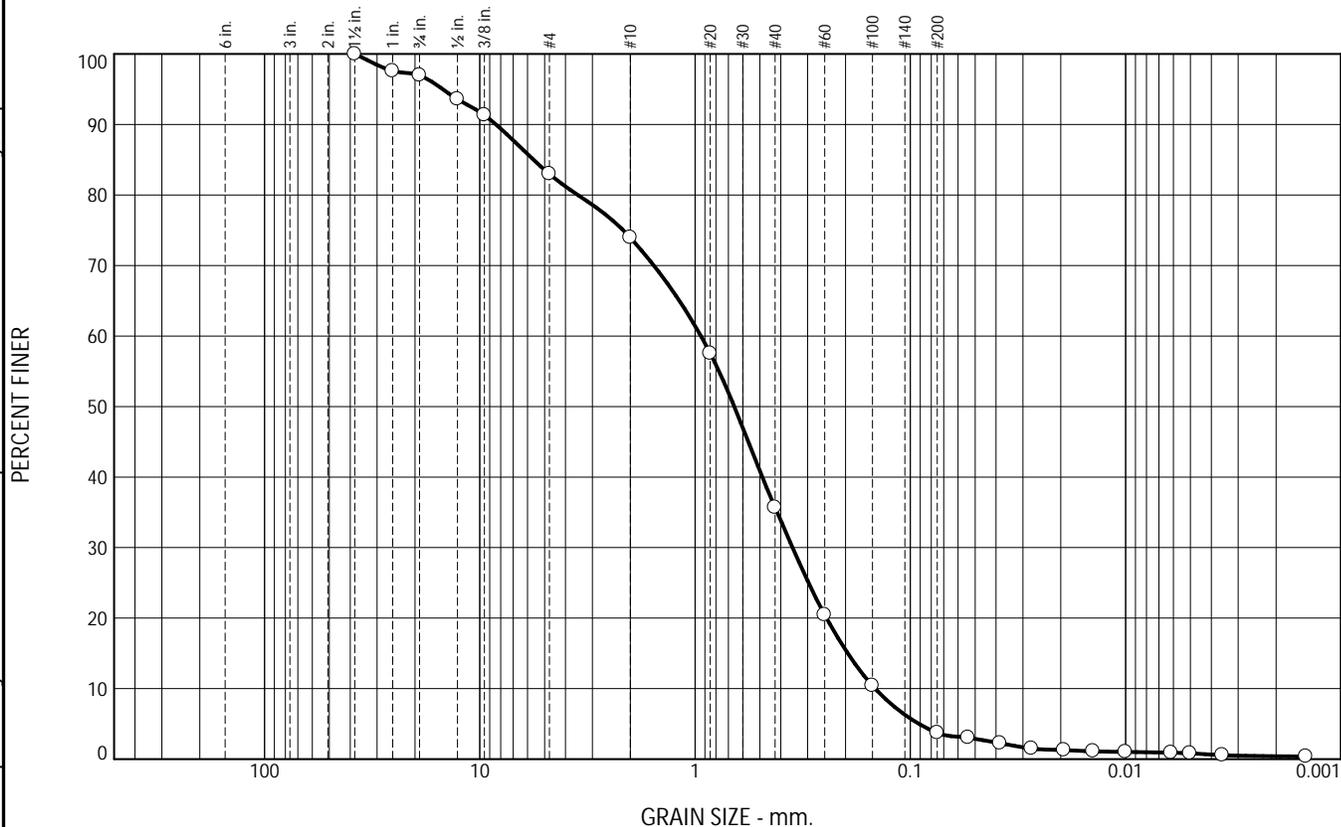
Particle Size Distribution Report

% +3"	% Gravel		% Sand			% Fines	
	Coarse	Fine	Coarse	Medium	Fine	Silt	Clay
0.0	3.0	14.0	9.0	38.3	32.0	3.3	0.4

SIEVE SIZE OR DIAMETER	PERCENT FINER	SPEC.* PERCENT	PASS? (X=NO)
1 1/2"	100.0		
1"	97.6		
3/4"	97.0		
1/2"	93.6		
3/8"	91.3		
#4	83.0		
#10	74.0		
#20	57.6		
#40	35.7		
#60	20.5		
#100	10.4		
#200	3.7		
0.0539 mm.	3.0		
0.0384 mm.	2.3		
0.0273 mm.	1.5		
0.0194 mm.	1.3		
0.0142 mm.	1.1		
0.0100 mm.	1.0		
0.0061 mm.	0.9		
0.0050 mm.	0.8		
0.0036 mm.	0.6		
0.0015 mm.	0.4

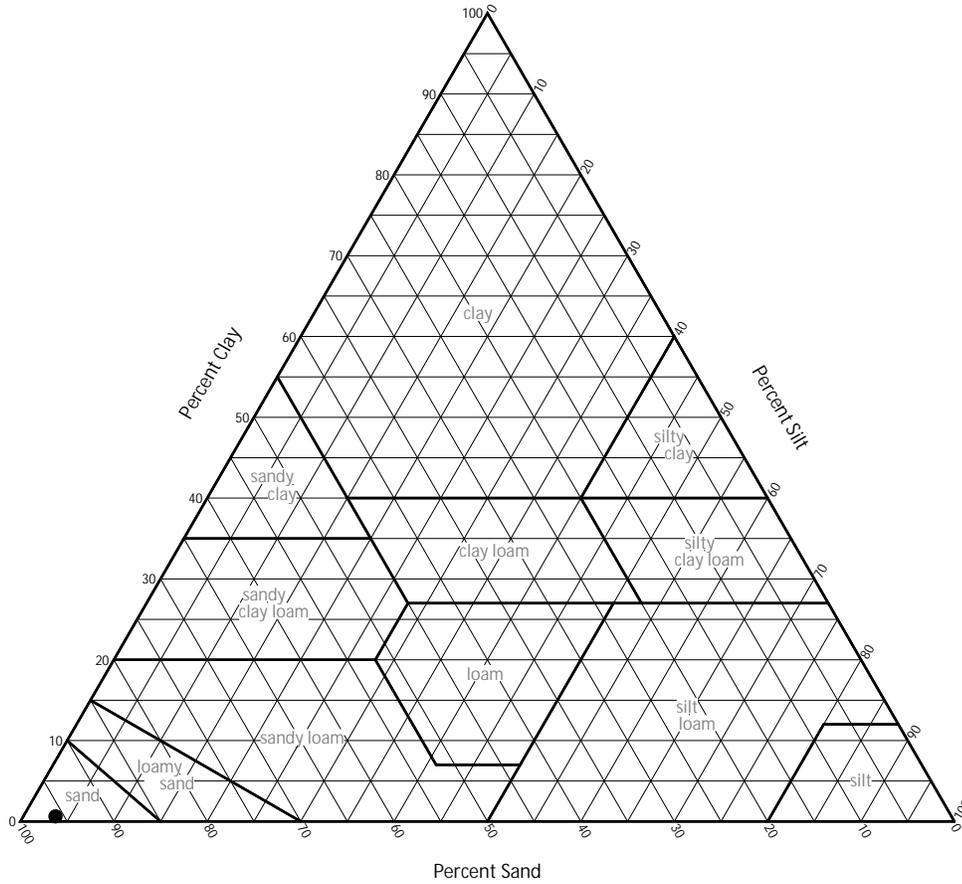
USDA Soil Classification

SOIL DATA							
	Source	Sample No.	Depth	Percentages From Material Passing a #10 Sieve			Classification
				Sand	Silt	Clay	
●	Test Pit	TP-105 / GS-1	2-3.5.0'	95.9	3.5	0.5	Sand

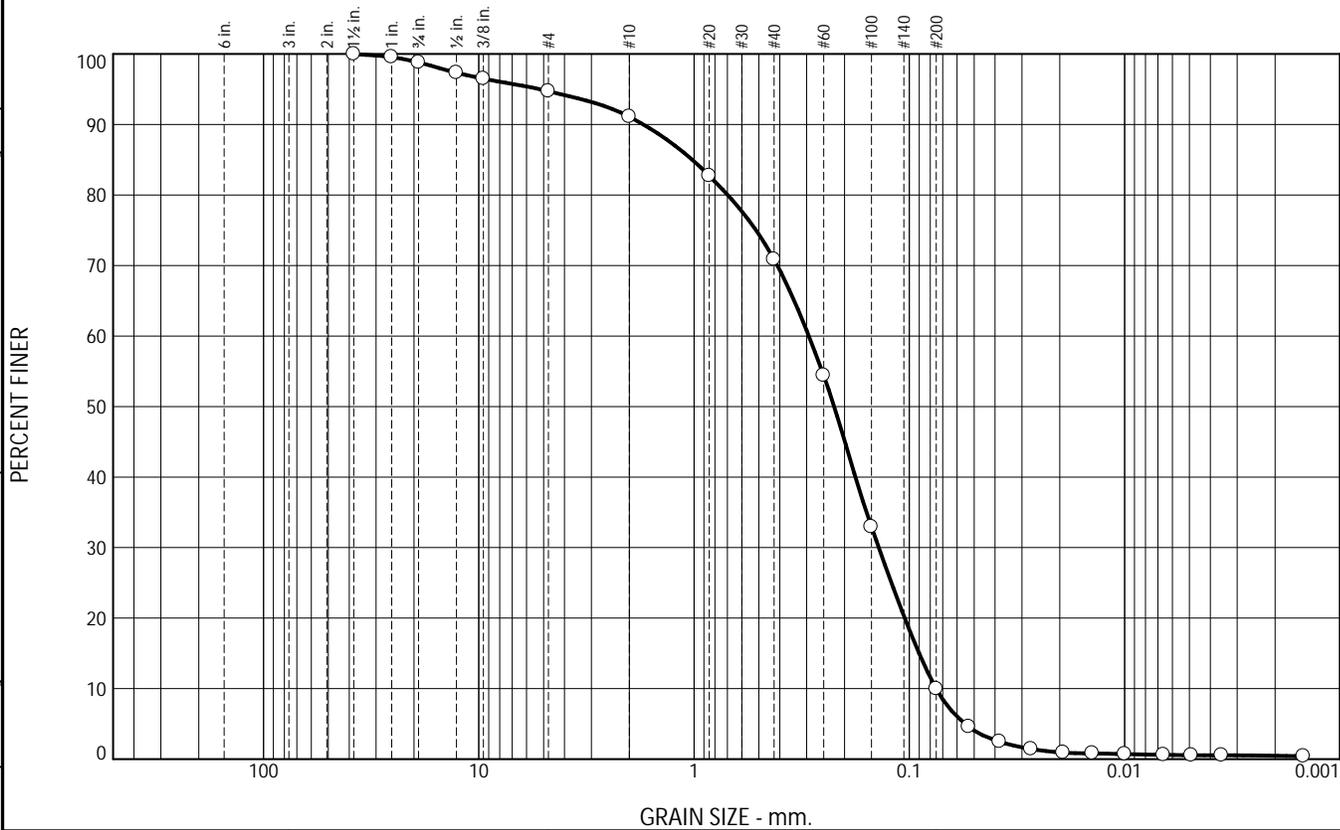
Particle Size Distribution Report

% +3"	% Gravel		% Sand			% Fines	
	Coarse	Fine	Coarse	Medium	Fine	Silt	Clay
0.0	1.2	4.1	3.6	20.2	60.9	9.5	0.5

SIEVE SIZE OR DIAMETER	PERCENT FINER	SPEC.* PERCENT	PASS? (X=NO)
1 1/2"	100.0		
1"	99.6		
3/4"	98.8		
1/2"	97.3		
3/8"	96.5		
#4	94.7		
#10	91.1		
#20	82.7		
#40	70.9		
#60	54.4		
#100	32.9		
#200	10.0		
0.0529 mm.	4.6		
0.0381 mm.	2.5		
0.0272 mm.	1.4		
0.0193 mm.	0.9		
0.0141 mm.	0.8		
0.0100 mm.	0.7		
0.0066 mm.	0.6		
0.0049 mm.	0.5		
0.0035 mm.	0.5		
0.0015 mm.	0.4

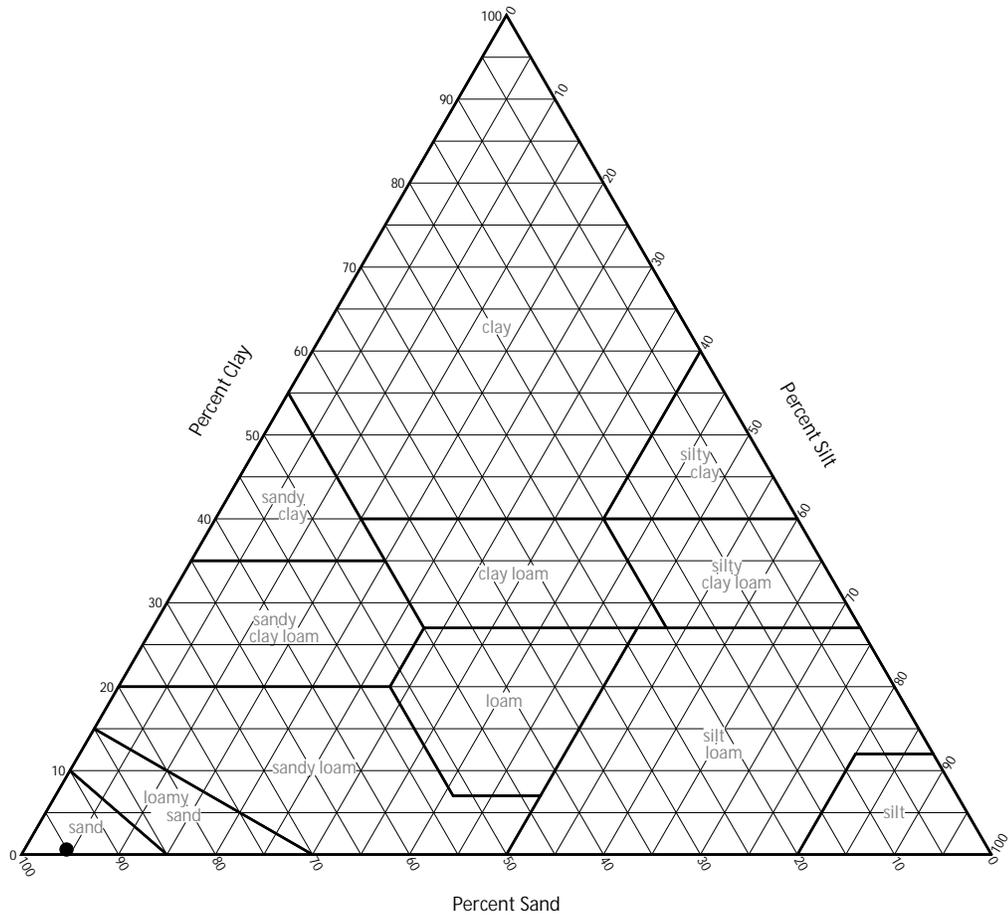
USDA Soil Classification

SOIL DATA							
	Source	Sample No.	Depth	Percentages From Material Passing a #10 Sieve			Classification
				Sand	Silt	Clay	
●	Test Pits	TP-11 / GS-1	2-4'	95.0	4.5	0.5	Sand
