Re: Revised Restoration Plan  
The Villages at Oak Hill, DEP File #: CE 159-1164

Goddard Consulting is pleased to submit this revised restoration plan on behalf of The Villages at Oak Hill Condominium Trust with respect to Special Condition 23 from the Order of Conditions for DEP File #: CE 159-1164. Special Condition reads “The Commission must receive a written report with respect to a project’s conformance to Orders of Conditions every April and October from a registered professional until a Certificate of Compliance is issued. On September 9, 2021, the “Wetland Replication Enhancement Plan” titled September 1, 2021, by Goddard Consulting LLC, was approved by the Franklin Conservation Commission. The report was written regarding four areas of concern examined during a site walk between Goddard and Jen Delmore, the Franklin Conservation Agent on August 18, 2021. The report described the four main remaining areas of concern that held the project from being compliant with the Order of Conditions for DEP File #: CE 159-1164 and proposed a mitigation strategy for each.

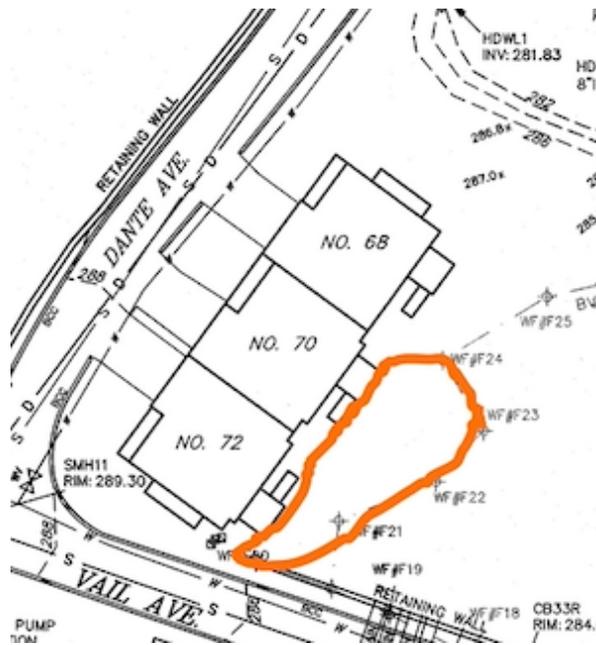
Photo 1: Area of concern circled in orange

This wetland area has successfully revegetated with wetland indicator species. The herbaceous layer has thickly revegetated with jewelweed, sensitive fern, and skunk cabbage. However, many of the proposed plantings in this area are missing, and so additional plantings are necessary. When decks were installed at the backs of the adjacent properties, trees were cut to avoid branches causing any problems. Due to the proximity of the decks, Goddard's plan proposes that most of the new plantings be shrub layer plantings, with the proposed red maple plantings at the back portion of the replication area so as not to interfere with the existing decks. As the herbaceous layer is fully revegetated, no seed mix will be required. Overall, 3 additional highbush blueberry shrubs are proposed to be planted, along with 6 winterberry shrubs and 4 red maple trees. In this area, the approved plantings from the 9/1/2021 plan remain the same.

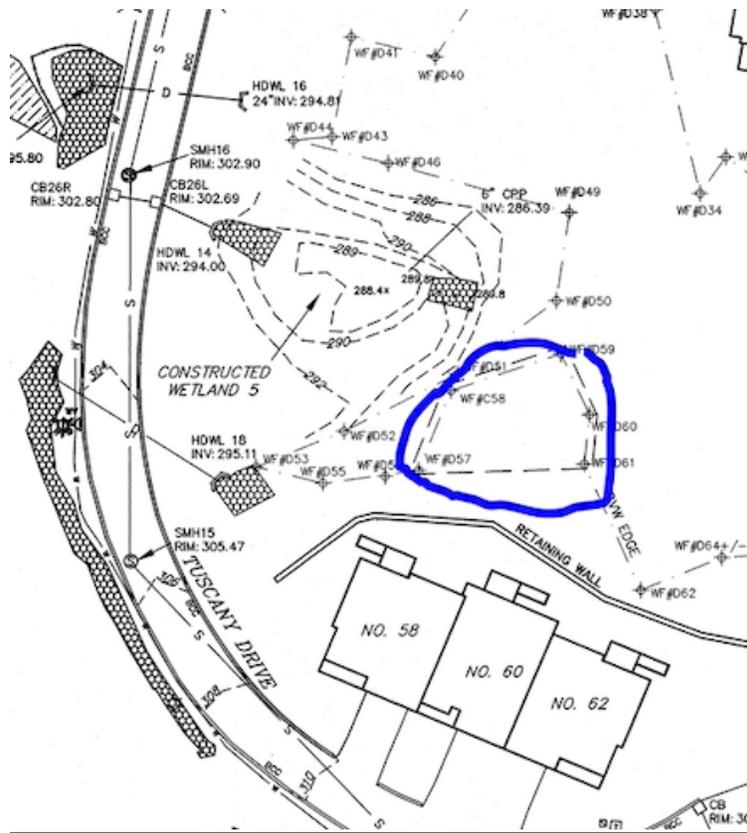
Photo 8: Area of concern circled in blue

Within Constructed Wetland 5, wetland hydrology and indicator species were found throughout the area of concern adjacent to Constructed Wetland 5, indicating a successful wetland ecosystem. The species most dominant within this area of concern include sensitive fern, joe pye weed, grapevine, blue vervain, sedges, and rushes. The area functions as a wet meadow as many of the proposed plantings in the construction plan were not found during the site walk. During the 2021 site walk, concerns were brought up over purple loosestrife found within the area. As a result, this area was brought up as an area of concern as proposed plantings were missing and purple loosestrife was found. Originally, the approved plan dated 9/1/2021 proposed the replanting of the missing plants to create a forested ecosystem. The plantings were not installed in 2021 and the area has continued to revegetate. Presently, on the August 4, 2022, site walk, Goddard and Breeka Li Goodlander observed a wet meadow ecosystem that was thickly vegetated with Joe-Pye Weed, Blue Vervain, Sensitive Fern, and multiple sedges and rushes. The purple loosestrife in the area has reduced in range and is not a concern over the native vegetation. A plethora of pollinators including Swallowtail Butterflies, Monarch Butterflies, and Honeybees filled the meadow due to the native pollinators. As Massachusetts continually loses meadow habitat, Goddard and Breeka Li Goodlander agreed that the meadow and pollinator habitat the area is now providing is more beneficial to the area than the originally proposed replanting into forested habitat. This area is now proposed to be left as meadow habitat.
