Summary of Observations

Table 1
Franklin, Ma
Summary of Observations
Made During Structural Inspection

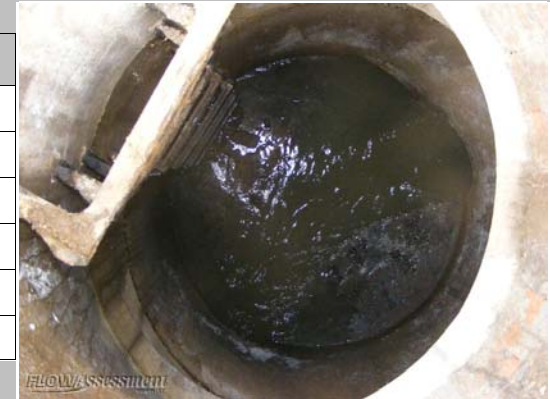
ITEM	MATERIAL	CONDITION	Leaks (gpm)	Photo	DEFECTS
FRAME	CAST	1			
CORBEL	BRICK	1			
STEPS	STEEL	2			Corroded
WALLS	BRICK	1			
FLOOR	BRICK/PARGED	1			
INVERT	BRICK	2			Holding 4" of debris

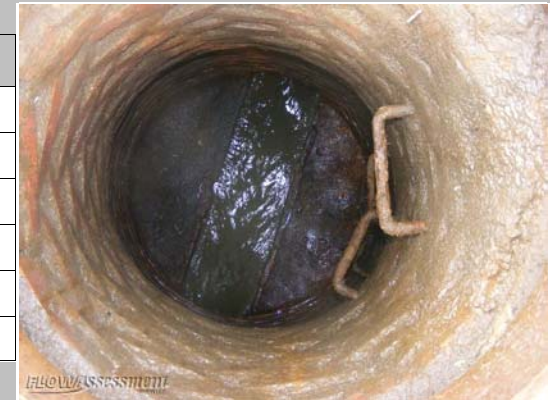
ITEM	MATERIAL	CONDITION	Leaks (gpm)	Photo	DEFECTS
FRAME	CAST	1			
CORBEL	BRICK	1			
STEPS	STEEL	2			Corroded
WALLS	BRICK	1			
FLOOR	BRICK/PARGED	1			
INVERT	BRICK	1

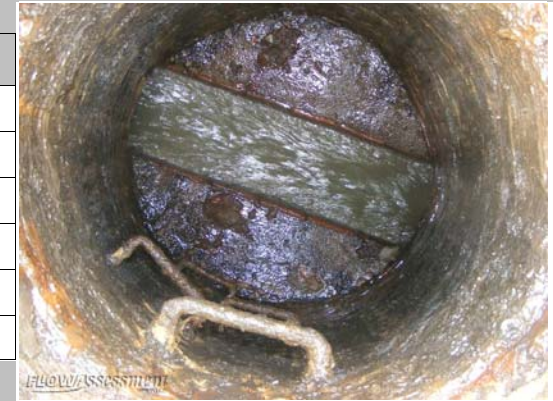
ITEM	MATERIAL	CONDITION	Leaks (gpm)	Photo	DEFECTS
FRAME	CAST	1			
CORBEL	BRICK	1			
STEPS	STEEL	2			Corroded
WALLS	BRICK	1			
FLOOR	BRICK/PARGED	1			
INVERT	BRICK	1

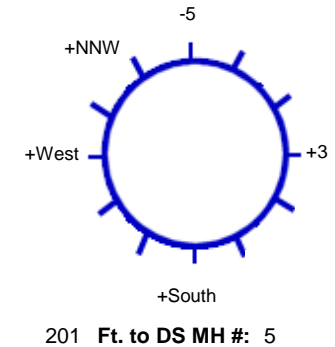
Municipality:	Franklin, Ma			Manhole No.:	4
Street:	Cottage Street at Saxon Street			Sub-System:	N/A
Inspection Date:	5/9/2013	Inspector:	EM/RV	Prefix #:	
Weather:	CLEAR	Temp:	0	Time:	15:27

COVER CHARACTERISTICS / COMMENTS		COVER INFLOW POTENTIAL			
Buried:	<input type="checkbox"/> CNL:	<input type="checkbox"/> CNI:	<input type="checkbox"/>		
Grade:	BELOW		3 In.		
Cracked pavement surrounding frame					
Drainage Area 1:		Drainage Area 2:		Holes In Cover	
10 X 5 X 0.9 = 45.0 (SQFT)		(if applicable)		QTY SIZE (In)	
X X 0.3 = (SQFT)				-- --

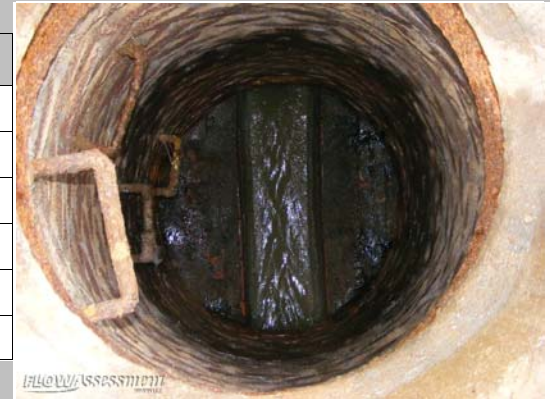
ITEM	MATERIAL	CONDITION	Leaks (gpm)	Photo	DEFECTS
FRAME	CAST	1			
CORBEL	BLOCK	1			
STEPS	STEEL	2			Corroded
WALLS	BRICK	1			
FLOOR	BRICK	1			
INVERT	BRICK	1

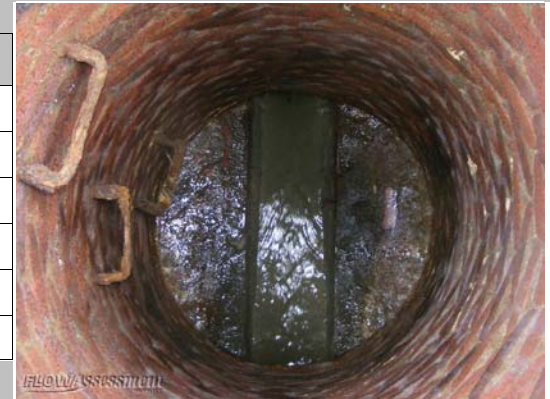
ITEM	MATERIAL	CONDITION	Leaks (gpm)	Photo	DEFECTS
FRAME	CAST	1			
CORBEL	BRICK	1			
STEPS	STEEL	2			Corroded
WALLS	BRICK	1			
FLOOR	PARGED/BRICK	1			
INVERT	BRICK	1

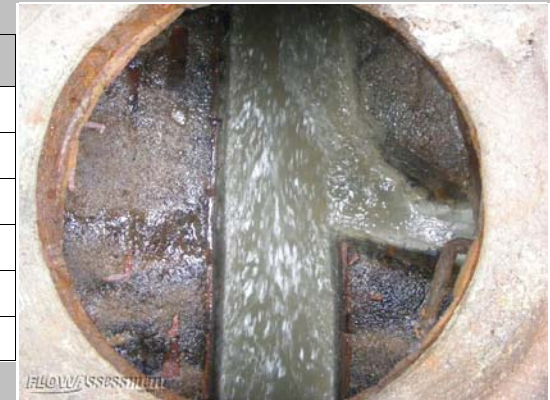
ITEM	MATERIAL	CONDITION	Leaks (gpm)	Photo	DEFECTS
FRAME	CAST	1			
CORBEL	BRICK	1			
STEPS	STEEL/BRICK	3			Corroded
WALLS	BRICK	1			
FLOOR	BRICK	1			
INVERT	BRICK	1

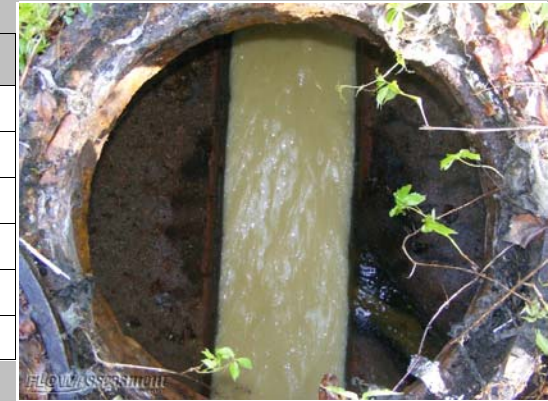
ITEM	MATERIAL	CONDITION	Leaks (gpm)	Photo	DEFECTS
FRAME	CAST	2			Corroded
CORBEL	BRICK	1			
STEPS	NONE	0			
WALLS	BRICK	1			
FLOOR	BRICK/PARGED	1			
INVERT	BRICK	1

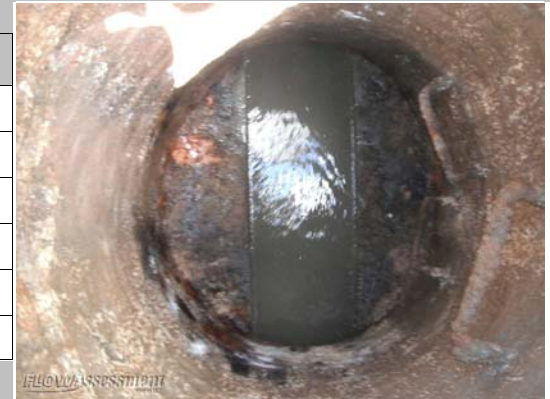
ITEM	MATERIAL	CONDITION	Leaks (gpm)	Photo	DEFECTS
FRAME	CAST	1			
CORBEL	BRICK/PARGED	1			
STEPS	STEEL	2			Corroded
WALLS	BRICK/PARGED	2			Mineral deposits
FLOOR	PARGED	1			
INVERT	BRICK	1

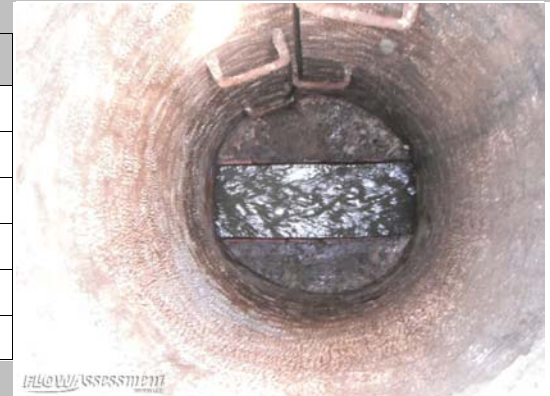
ITEM	MATERIAL	CONDITION	Leaks (gpm)	Photo	DEFECTS
FRAME	CAST	1			
CORBEL	BRICK	1			
STEPS	STEEL	2			Corroded
WALLS	BRICK/PARGED	1			
FLOOR	BRICK/PARGED	1			
INVERT	BRICK	1

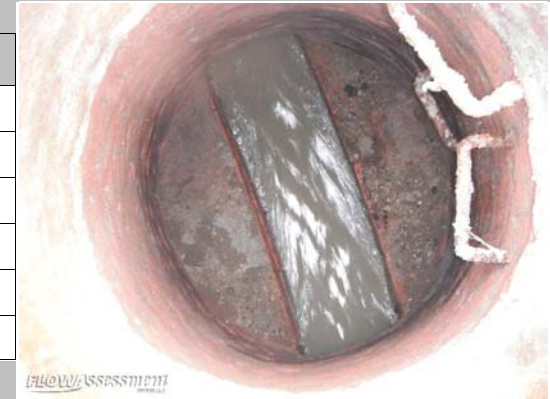
ITEM	MATERIAL	CONDITION	Leaks (gpm)	Photo	DEFECTS
FRAME	CAST	1			
CORBEL	BRICK	1			
STEPS	CAST	2			Corroded
WALLS	BRICK	1			
FLOOR	PIP	1			
INVERT	BRICK	1

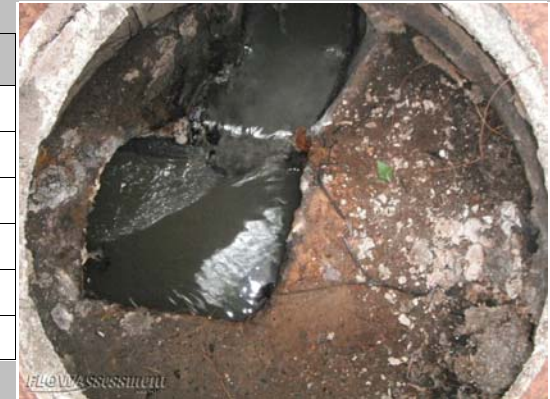
ITEM	MATERIAL	CONDITION	Leaks (gpm)	Photo	DEFECTS
FRAME	CAST	1			
CORBEL	BLOCK	2			Minor roots at frame seal
STEPS	NONE	0			
WALLS	BLOCK	2			Minor roots
FLOOR	PIP	1			
INVERT	CIP	1

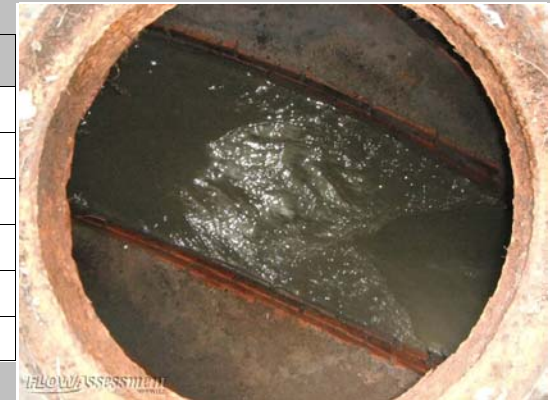
ITEM	MATERIAL	CONDITION	Leaks (gpm)	Photo	DEFECTS
FRAME	CAST	2			Corroded
CORBEL	BRICK	2			Roots, missing mortar
STEPS	NONE	0			
WALLS	BRICK	2			Roots
FLOOR	BRICK	1			
INVERT	BRICK	2			Missing mortar

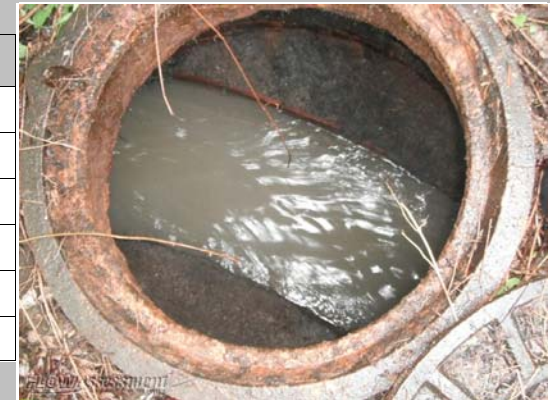
ITEM	MATERIAL	CONDITION	Leaks (gpm)	Photo	DEFECTS
FRAME	CAST	1			
CORBEL	BRICK	2			Roots
STEPS	NONE	0			
WALLS	BRICK	2			Roots
FLOOR	BRICK	1			
INVERT	BRICK	2			Missing mortar

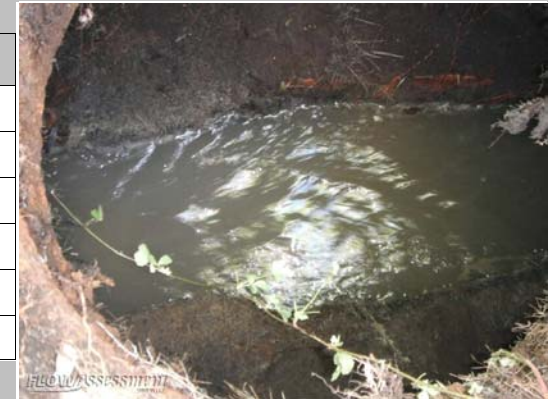
ITEM	MATERIAL	CONDITION	Leaks (gpm)	Photo	DEFECTS
FRAME	CAST	1			
CORBEL	BRICK	2			Light roots
STEPS	NONE	0			
WALLS	BRICK	2			Light roots
FLOOR	BRICK	2			Moderate roots
INVERT	BRICK	2			Moderate roots

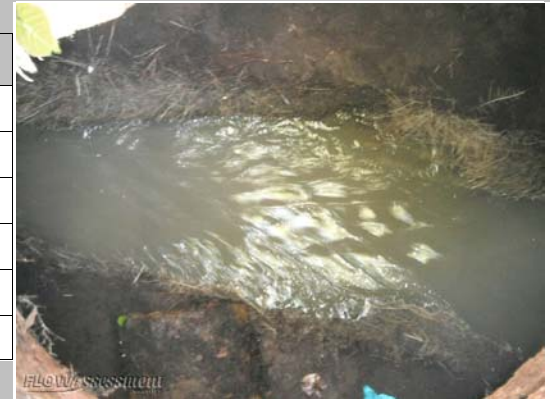
ITEM	MATERIAL	CONDITION	Leaks (gpm)	Photo	DEFECTS
FRAME	CAST	1			
CORBEL	BRICK	2			Moderate roots
STEPS	NONE	1			
WALLS	BRICK	2			Heavy roots
FLOOR	BRICK	2			Heavy roots
INVERT	BRICK	1

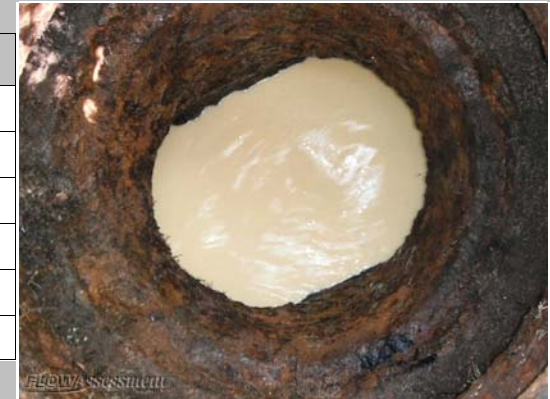
ITEM	MATERIAL	CONDITION	Leaks (gpm)	Photo	DEFECTS
FRAME	CAST	1			
CORBEL	BRICK	2			Missing mortar, light roots
STEPS	NONE	0			
WALLS	CAST IRON	2			Tuberculated
FLOOR	NONE	0			
INVERT	CAST IRON	2			Tuberculated

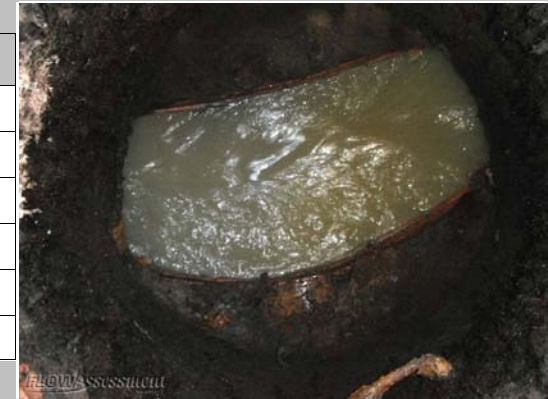
ITEM	MATERIAL	CONDITION	Leaks (gpm)	Photo	DEFECTS
FRAME	CAST	1			
CORBEL	BRICK	2			Moderate roots
STEPS	STEEL	3			Corroded
WALLS	BRICK	2			Moderate roots
FLOOR	BRICK	2			Light roots
INVERT	BRICK	1

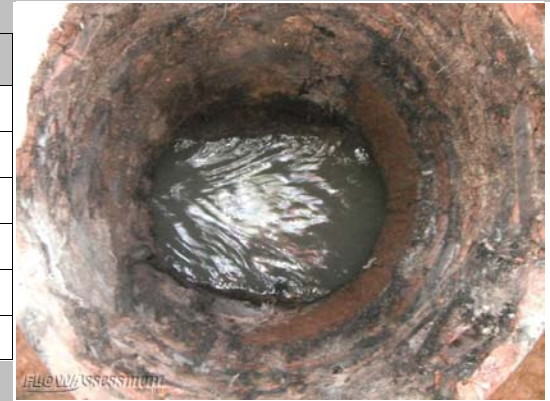
ITEM	MATERIAL	CONDITION	Leaks (gpm)	Photo	DEFECTS
FRAME	CAST	3			Missing mortar to corbel
CORBEL	BRICK	3			Missing mortar, light roots, broken brick
STEPS	NONE	0			
WALLS	BRICK/CAST IRON	2			Light roots, tuberculated
FLOOR	CAST IRON	2			Tuberculated
INVERT	CAST IRON	2			Tuberculated

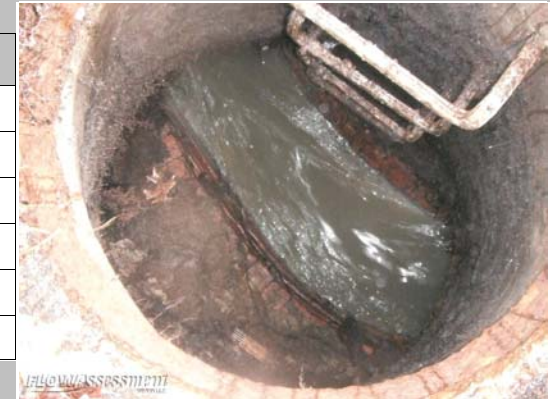
ITEM	MATERIAL	CONDITION	Leaks (gpm)	Photo	DEFECTS
FRAME	CAST	1			
CORBEL	PRECAST	2			Missing mortar at frame
STEPS	ALUM	1			
WALLS	PRECAST/PIP	2			Light roots through barrel joints
FLOOR	BRICK	2			Light roots
INVERT	BRICK	1

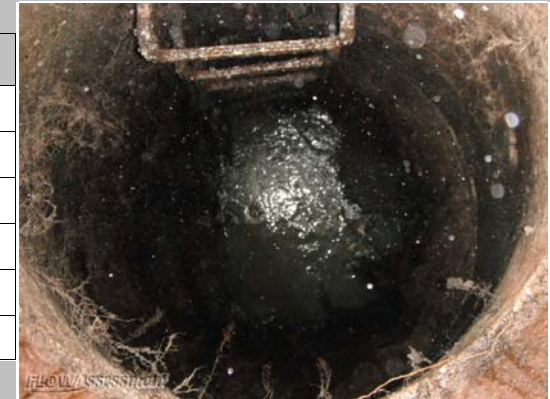
Municipality:	Franklin, MA			Manhole No.:	41
Street:	Beaver Street R.O.W. At railroad tracks and I-495			Sub-System:	N/A
Inspection Date:	5/9/2013	Inspector:	GW/JS	Prefix #:	
Weather:	CLEAR	Temp:	0	Time:

ITEM	MATERIAL	CONDITION	Leaks (gpm)	Photo	DEFECTS
FRAME	CAST	1			
CORBEL	PRECAST	2			Missing mortar at frame seal
STEPS	ALUM	2			Corroded
WALLS	PRECAST/PIP	2			Light roots
FLOOR	CNI	2			Light roots, missing mortar, underwater
INVERT	CNI	3			Moderate roots, underwater

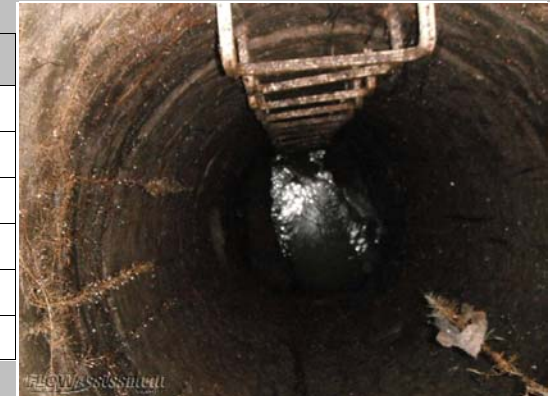
ITEM	MATERIAL	CONDITION	Leaks (gpm)	Photo	DEFECTS
FRAME	CAST	1			
CORBEL	BLOCK	1			
STEPS	STEEL/ALUM	1			
WALLS	PRECAST/PIP	2			Roots
FLOOR	PIP	1			
INVERT	BRICK	1

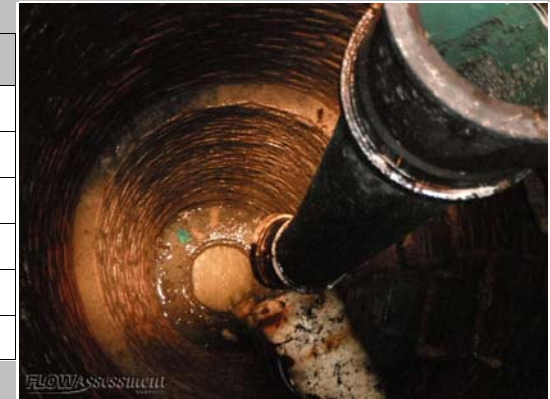
ITEM	MATERIAL	CONDITION	Leaks (gpm)	Photo	DEFECTS
FRAME	CAST	1			
CORBEL	BRICK	1			
STEPS	STEEL	4			Corroded
WALLS	BRICK	1			
FLOOR	PIP	1			
INVERT	CIP	1

LINE CONDITIONS											Image Path:
Direction (In / Out)	Connect MH #	Rim To Invert Depth	Pipe Dia. (In.)	Pipe Material	Joint Length	Flow Depth (In.)	Debris Depth (In.)	Pipe Conn Leak (gpm)	Photo	Line Cond 1-5	Line Comments
IN FRO	East	04' 07"	6	PVC		0.10	0			0	Inside drop
IN FRO	ESE	02' 11"	6	PVC		0.10	0			0	Inside drop
IN FRO	SSE	12' 02"	8	PVC		3.00	0			0	Inside drop
IN FRO	42	44' 02"	24	CIP		10.00	0			0	
OUT TO	44	44' 02"	24	CIP		10.00	0			0

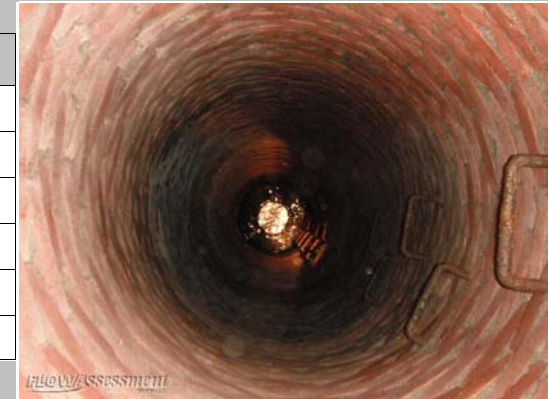
ITEM	MATERIAL	CONDITION	Leaks (gpm)	Photo	DEFECTS
FRAME	CAST	1			
CORBEL	BRICK	1			
STEPS	VINYL COATED	1			
WALLS	BRICK/PRECAST	3	0.2		Brick portion wet with mineral deposits to 8' above invert
FLOOR	PIP	1			
INVERT	PIP	1

Direction (In / Out)	Connect MH #	Rim To Invert Depth	Pipe Dia. (In.)	Pipe Material	Joint Length	Flow Depth (In.)	Debris Depth (In.)	Pipe Conn Leak (gpm)	Photo	Line Cond 1-5	Line Comments
IN FRO	43	46' 03"	24			9.00	0			1	Manhole frame at crown level obscures view into pipe, could not lamp pipe
OUT TO	45	46' 03"	24			9.00	0			1	Manhole frame at crown level obscures view into pipe, could not lamp pipe

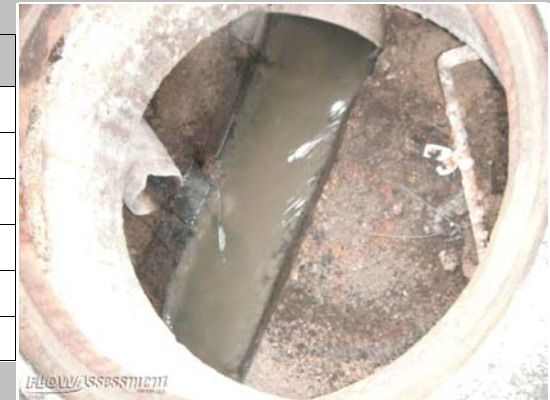
ITEM	MATERIAL	CONDITION	Leaks (gpm)	Photo	DEFECTS
FRAME	CAST	1			
CORBEL	PRECAST	1			
STEPS	NONE	0			
WALLS	PRECAST	1			
FLOOR	PIP	1			
INVERT	PIP	1

LINE CONDITIONS											Image Path:
Direction (In / Out)	Connect MH #	Rim To Invert Depth	Pipe Dia. (In.)	Pipe Material	Joint Length	Flow Depth (In.)	Debris Depth (In.)	Pipe Conn Leak (gpm)	Photo	Line Cond 1-5	Line Comments
IN FRO	NE	03' 05"	15	ACP		5.00	0			0	
IN FRO	NW	02' 06"	4	ACP		0.10	0			0	Moderate roots at pipe connection
OUT TO	32	03' 05"	15	ACP		5.00	0			0

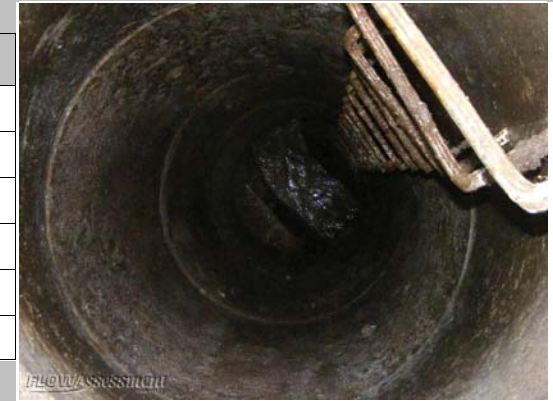
ITEM	MATERIAL	CONDITION	Leaks (gpm)	Photo	DEFECTS
FRAME	CAST	2			Corroded
CORBEL	BRICK/PARGED	1			
STEPS	ALUM	1			
WALLS	PRECAST	1			
FLOOR	PARGED/BRICK	1			
INVERT	PARGED/BRICK	1

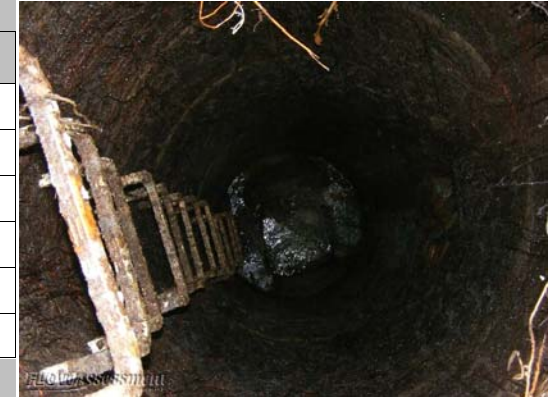
ITEM	MATERIAL	CONDITION	Leaks (gpm)	Photo	DEFECTS
FRAME	CAST	2			Corroded
CORBEL	BRICK	2			Roots
STEPS	ALUM	1			
WALLS	PRECAST	1			
FLOOR	PARGED	1			
INVERT	PARGED	1

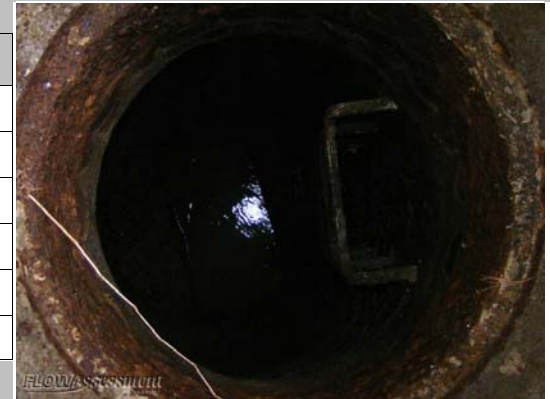
ITEM	MATERIAL	CONDITION	Leaks (gpm)	Photo	DEFECTS
FRAME	CAST	2			Corroded
CORBEL	BRICK/BLOCK/PARGED	1			
STEPS	ALUM	1			
WALLS	PRECAST	1			
FLOOR	PARGED/BRICK	1			
INVERT	PARGED/BRICK	1

Surcharge From Invert: Currently: Feet Marks To: 12 Feet

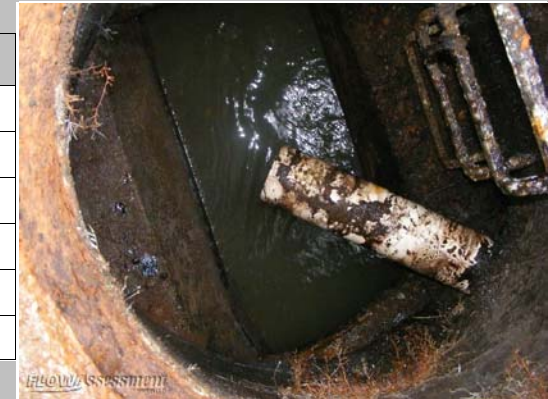
ITEM	MATERIAL	CONDITION	Leaks (gpm)	Photo	DEFECTS
FRAME	CAST	2			Corroded
CORBEL	PARGED	2			Roots
STEPS	ALUM	1			
WALLS	PRECAST	1			
FLOOR	PIP	1			
INVERT	PIP	1

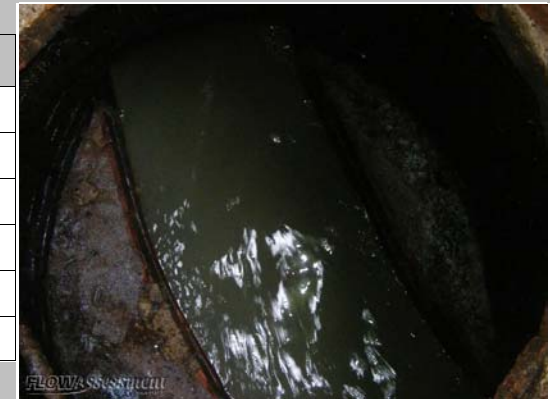
ITEM	MATERIAL	CONDITION	Leaks (gpm)	Photo	DEFECTS
FRAME	CAST	1			
CORBEL	BRICK	2			Roots
STEPS	STEEL	2			Corroded
WALLS	BRICK	2			Roots
FLOOR	BRICK/PARGED	2			Roots
INVERT	BRICK	1

Direction (In / Out)	Connect MH #	Rim To Invert Depth	Pipe Dia. (In.)	Pipe Material	Joint Length	Flow Depth (In.)	Debris Depth (In.)	Pipe Conn Leak (gpm)	Photo	Line Cond 1-5	Line Comments
IN FRO	47A	05' 02"	24	VCP	4	6.00	0			2	Roots at all joints
OUT TO	49	05' 03"	24	VCP	4	6.00	0			1	Very light roots

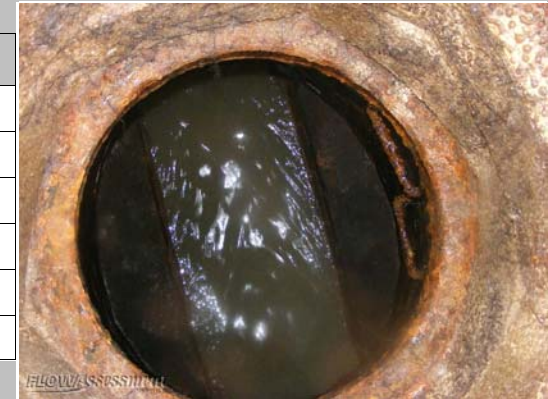
ITEM	MATERIAL	CONDITION	Leaks (gpm)	Photo	DEFECTS
FRAME	CAST	2			Corroded
CORBEL	BLOCK	1			Very light roots
STEPS	STEEL	2			Corroded
WALLS	BRICK	1			Very light roots
FLOOR	BRICK/PARGED	1			
INVERT	BRICK	1

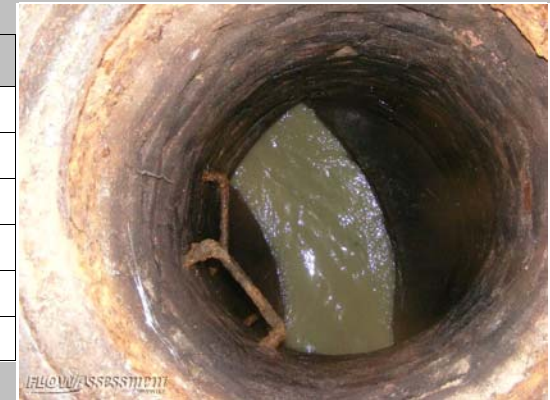
ITEM	MATERIAL	CONDITION	Leaks (gpm)	Photo	DEFECTS
FRAME	CAST	1			
CORBEL	BRICK	2			Very light roots
STEPS	STEEL	2			Corroded
WALLS	BRICK	1			
FLOOR	BRICK/PARGED	1			
INVERT	BRICK	1

Direction (In / Out)	Connect MH #	Rim To Invert Depth	Pipe Dia. (In.)	Pipe Material	Joint Length	Flow Depth (In.)	Debris Depth (In.)	Pipe Conn Leak (gpm)	Photo	Line Cond 1-5	Line Comments
IN FRO	49	09' 04"	24	VCP	4	7.00	0			2	Very light roots at second joint
OUT TO	51.1	09' 05"	24	VCP	4	7.00	0			1

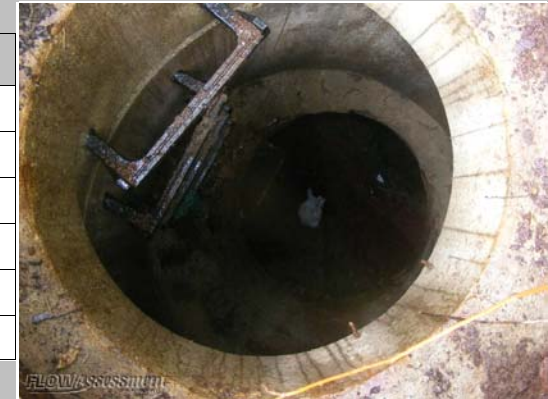
ITEM	MATERIAL	CONDITION	Leaks (gpm)	Photo	DEFECTS
FRAME	CAST	1			
CORBEL	PRECAST	1			
STEPS	VINYL COATED/ALUM	1			
WALLS	PRECAST	1			
FLOOR	BRICK	1			
INVERT	BRICK	1

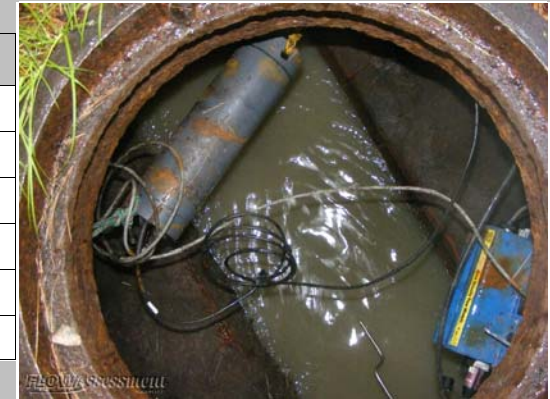
ITEM	MATERIAL	CONDITION	Leaks (gpm)	Photo	DEFECTS
FRAME	CAST	1			
CORBEL	BRICK	1			
STEPS	NONE	0			
WALLS	BRICK	2			Very light roots
FLOOR	BRICK	2			Very light roots
INVERT	BRICK	1

Direction (In / Out)	Connect MH #	Rim To Invert Depth	Pipe Dia. (In.)	Pipe Material	Joint Length	Flow Depth (In.)	Debris Depth (In.)	Pipe Conn Leak (gpm)	Photo	Line Cond 1-5	Line Comments
IN FRO	50	04' 05"	24	VCP	4	7.00	0			2	Very light roots at all joints except second joint which has moderate roots
OUT TO	51	04' 06"	24	VCP	4	7.00	0			1	Very light roots at all joints

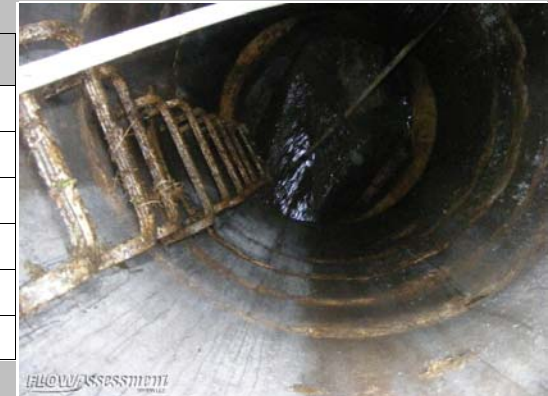
ITEM	MATERIAL	CONDITION	Leaks (gpm)	Photo	DEFECTS
FRAME	CAST	2			3" offset
CORBEL	PRECAST	1			
STEPS	ALUM	1			
WALLS	PRECAST	1			
FLOOR	BRICK	1			
INVERT	BRICK	1
