**A Comprehensive Investigation & Analysis of
Existing Conditions
at the
South Franklin Congregational Meeting House
762 Washington St
Franklin, MA**

Prepared for
The Town of Franklin, MA
by

CIVITECTS

11 May 2015

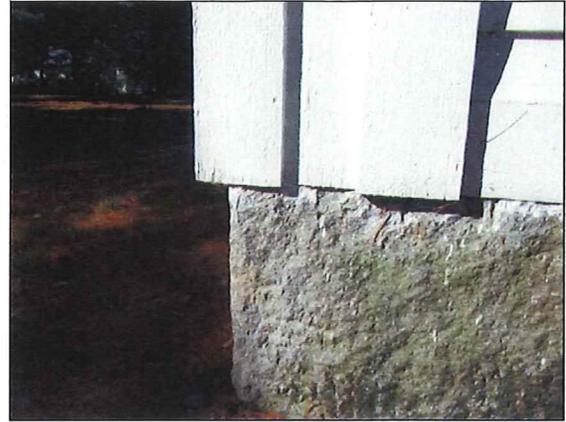
Exterior walls consist of wood framing with white painted clapboard siding and corner boards at each of the building's four corners (Photo C.1). Both the wood framing and siding appear to be in good condition. The foundation wall is comprised of large granite slabs over stone rubble (Photo C.2). The joints between the granite slabs are not sealed and are open to the crawlspace below the first floor. The granite units themselves are in good condition with no visible cracks observed.

Photo C.2 – Corner Board and Granite Foundation

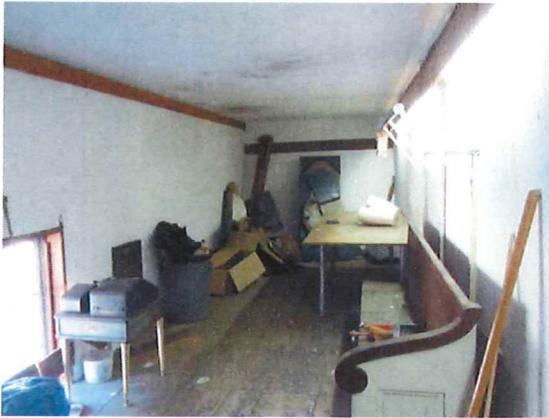
Photo E.1 – Mezzanine

Since the mezzanine is currently being underutilized as storage for non-essential items, it is recommended that this space be converted into a mechanical mezzanine to house the new air handling unit (AHU) proposed by RDK. Demolition of the existing stair to the mezzanine would allow for the construction of a new ship's ladder to provide access to the mezzanine.

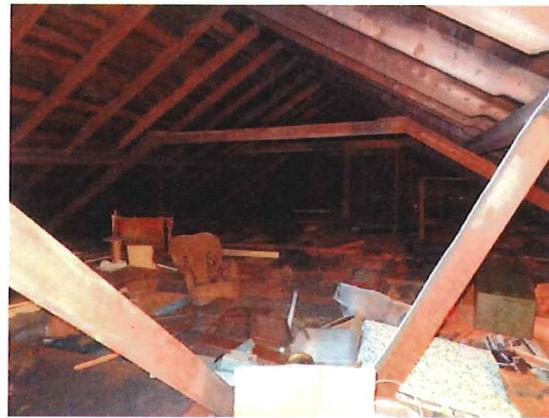
Photo E.2 – Attic above Meeting Room

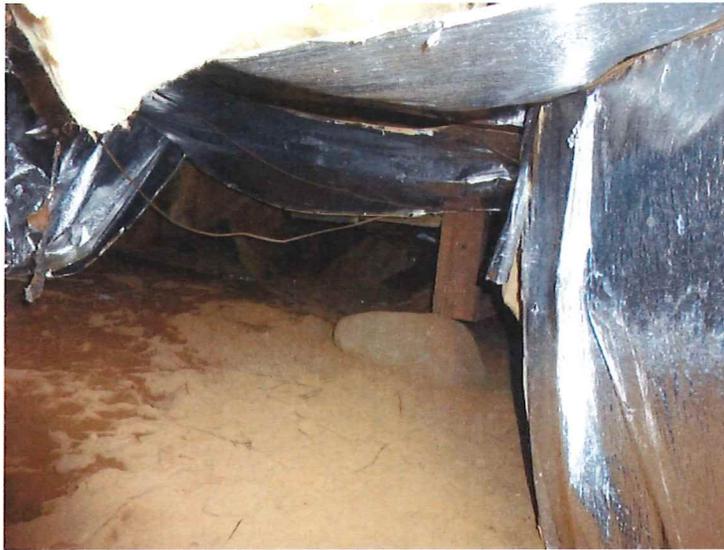
Photo 7

- We observed the insect damaged timber posts to be crushing and splitting at the base (Photo 4).
- We observed the timber posts to be bearing on loose stones. There is no connection from the posts to stones (Photos 5 and 6). At one post we observed the post to be supported only on one corner of the post (Photo 7).
- At the square interior post we observed the base to rotted with split and soft wood (Photo 8).
- We observed the ceiling plaster and ceiling joists are support from the bottom chord of the queen rod truss (Photo 9).
- We observed the roof purlins to be supported at its end on a diagonal strut that bears on the front exterior bearing wall (Photo 10).
