# South Franklin Congregational Meeting House

## Existing Conditions Report and Peer Review

762 Washington Street,  
Franklin, MA 02038

September 30, 2020

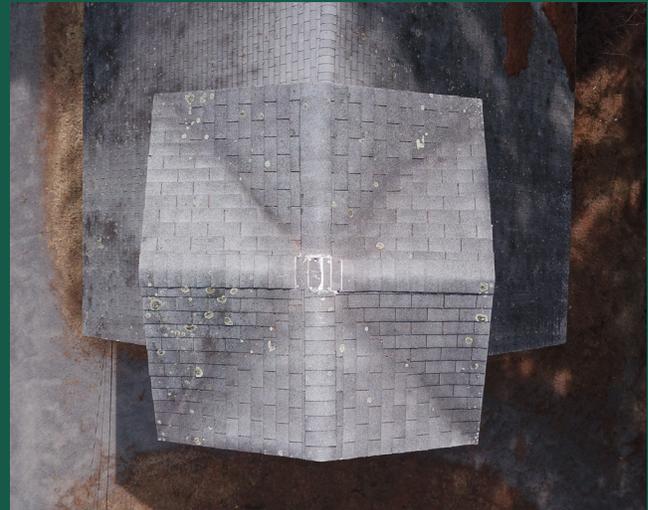
Algae, moss and lichens visible on the cupola roof.

Several areas of the roof were observed to have algae, moss and lichens, which over time can enhance water retention, and lead to premature deck rot. Algae grow fastest in shady, damp areas, such as under large trees, which this property has adjacent to the building (west). In addition, this large pine tree has a large volume of needle drop which has fallen and stayed on the south west portion of the roof. This clumping of needles remains wet after a rain event and holds moisture, adding to premature shingle and deck damage. Future renovations should consider this condition carefully and implement a seasonally appropriate cleaning schedule to remove debris from the roof.

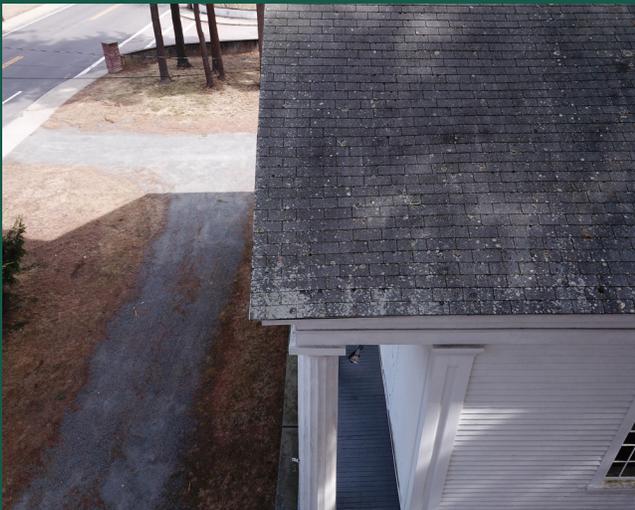
Algae, moss and lichens visible on the main roof, west side front.

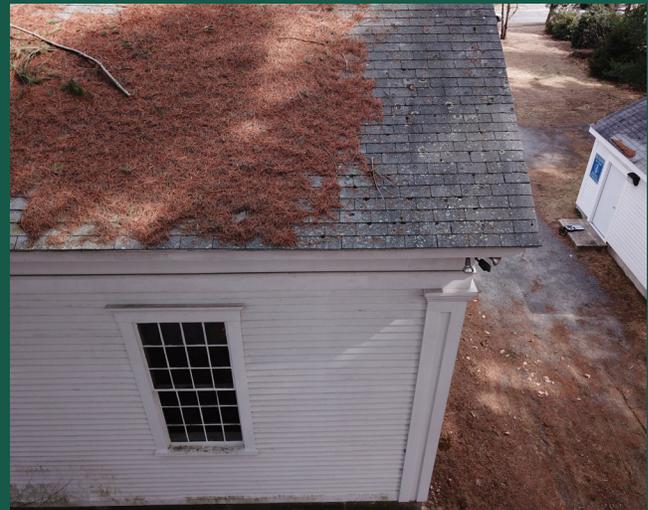
Significant pine needle and tree branches have fallen and are collecting on the west rear roof.

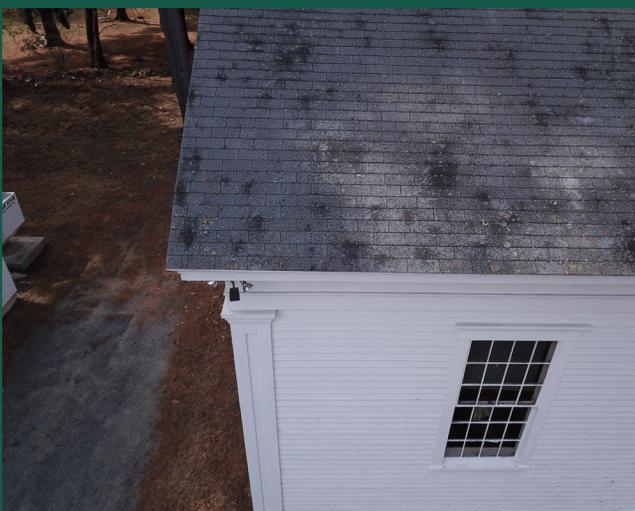
Algae, moss and lichens visible on the main roof, east side rear.

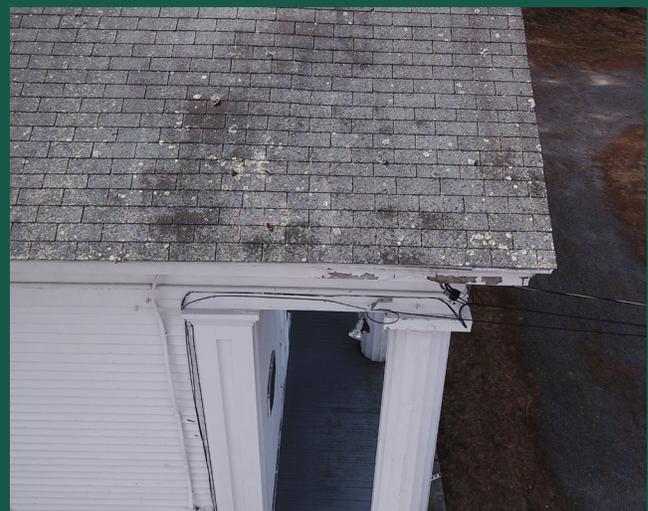
Algae, moss and lichens visible on the main roof, east side front.

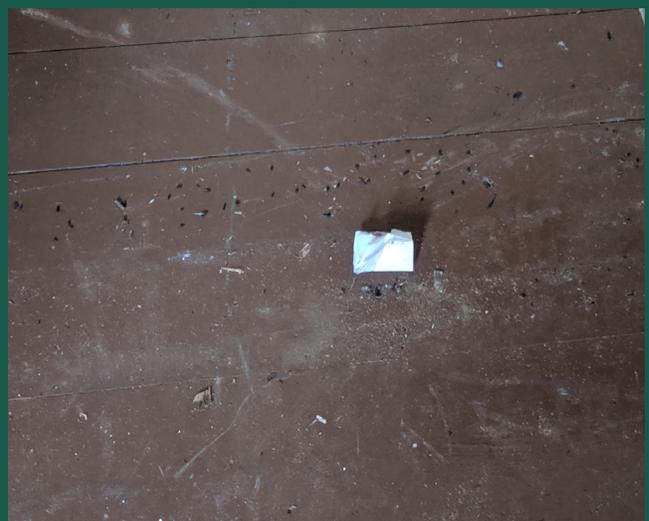
Evidence of mouse droppings.

The attic showed signs of bird, bat and mouse excrement on the stairs, and floors. On the first floor there was a deceased bat in the main lobby. Window sills show signs of mouse excrement as well as pests. Main assembly floor area also showed signs of animals having been inside for a period of time.

Animal waste that becomes airborne can transmit disease. It is recommended that a thorough cleaning be performed to remove all existing waste and a long term pest control plan be put into place to begin to get the situation under control.

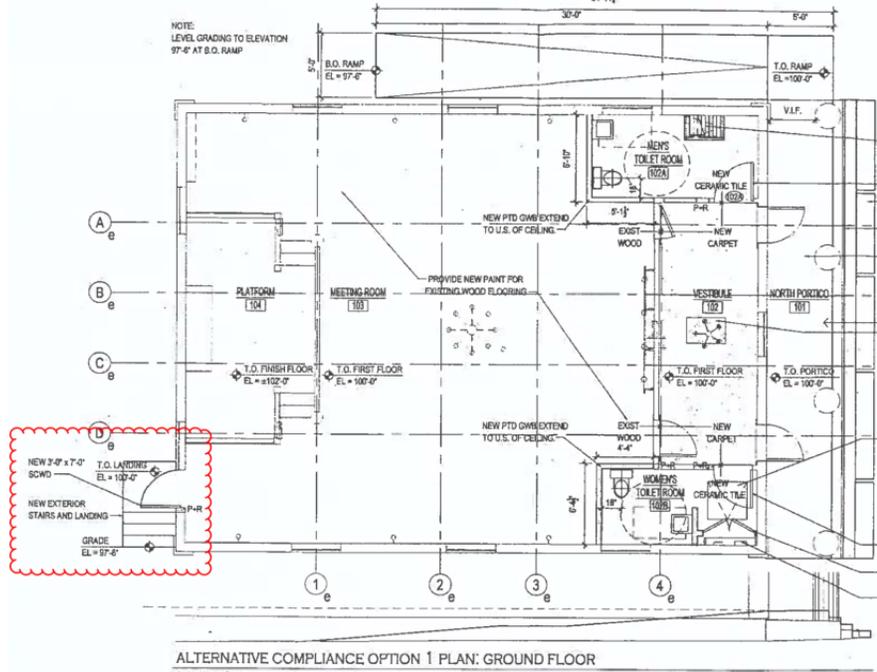
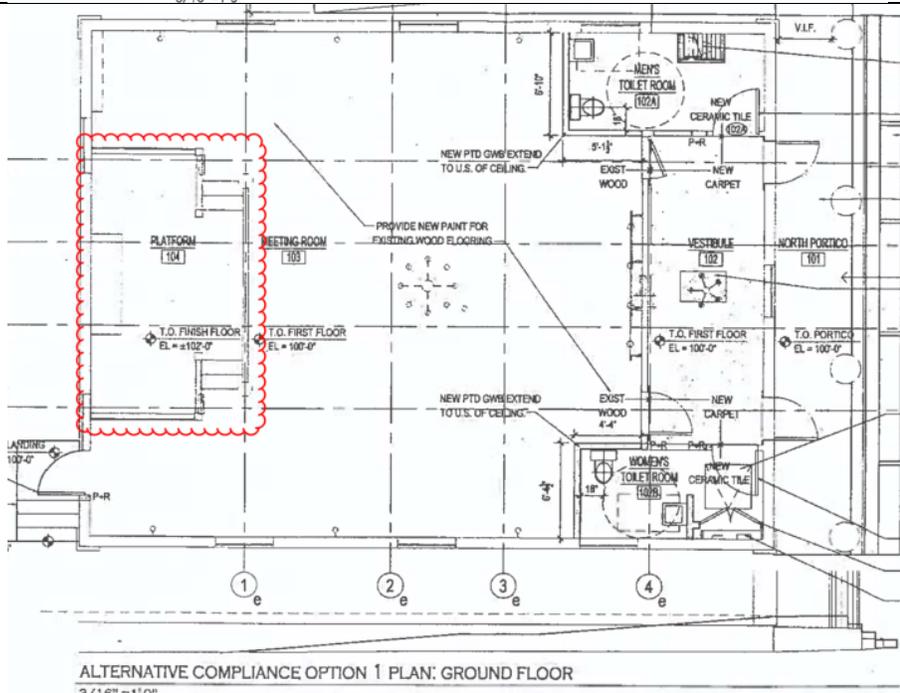
**Alternative Compliance Options**

This floor plan shows the building layout and proposed accessible route. 780 CMR Section 1009.1 Except for existing buildings. However, 521 CMR requires accessible means of egress anywhere that more than one person has been in the past, the provisions of 780 CMR have been updated. However, recent experience is that for certain spaces on the ground floor that do not have an accessible means of egress is required.

An accessible route is required to be provided (see the options).

being provided with only one accessible means of egress. Section 1 omits accessible means of egress in 521 CMR Section 20.11.1.a requires two accessible means of egress if more than one means of egress is provided. In the final rule, the provisions of 521 CMR have been applied to the stage area. Therefore, another means of egress is required to be provided from the space.

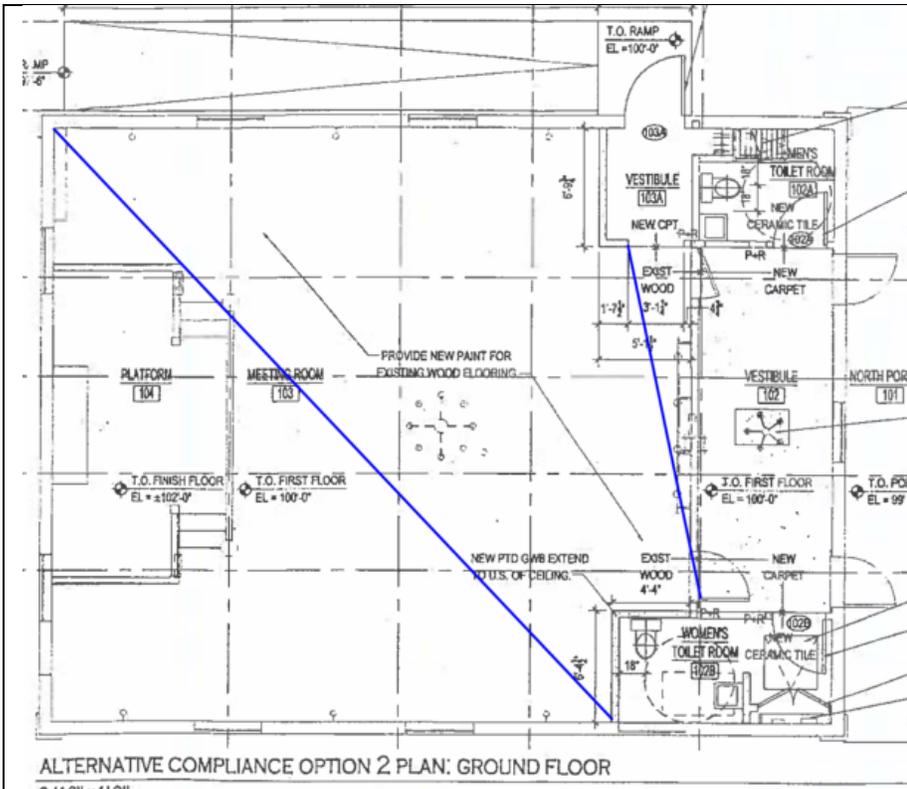
The existing egress points are not removed. The new egress path is along the diagonal of the floor. It is expected that the existing exit will be used.

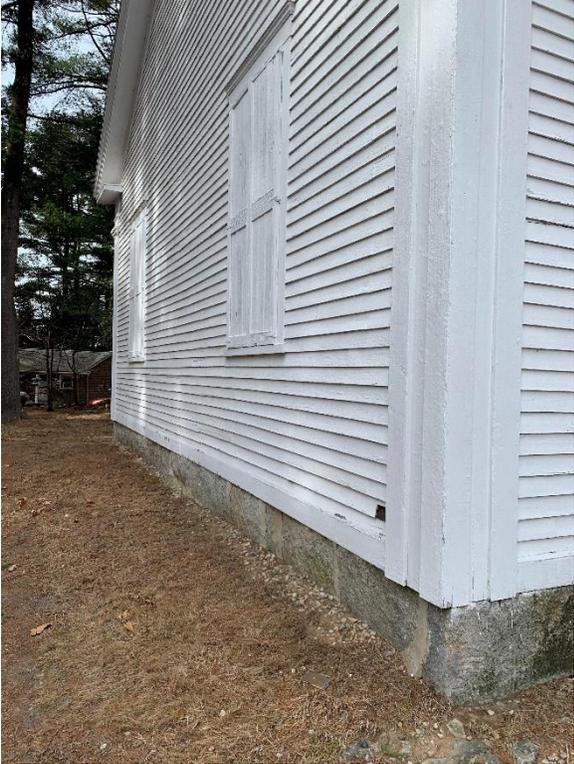
*Photo 1*

I first toured the perimeter of the building. The granite block, foundation wall is partially visible from the outside of building. No signs of cracking and or settlement was apparent. The foundation wall is in good condition. (See photo 1)

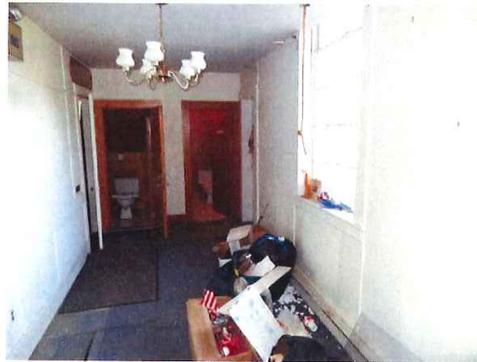
Photo A.3 – North Vestibule

First floor spaces include a vestibule at the north entrance with both male and female toilet rooms at the west end of the vestibule (Photo A.3). Electrical service is fed to a storage space at the east end of the vestibule where the electrical panel is located. To the southern of the vestibule is the meeting room with fixed pews and a raised platform at the south end of the space (Photos A.1 and A.2). Interior walls and ceiling finishes consist of painted plaster over wood lath. The existing wood floor boards are painted. The building also contains a crawlspace with a dirt floor which is accessed by removing several floor boards in the north vestibule. A detailed structural assessment of the condition of existing 1<sup>st</sup> floor framing members was completed by structural engineering consultant DM Berg and is included herein.

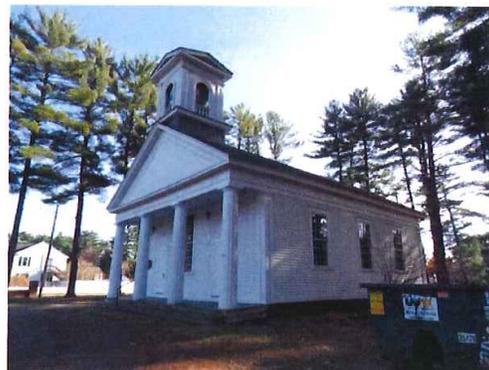
Photo B.2 – View from Washington Street

The parking area and driveway appears to consist primarily of gravel (Photo B.2). Pine needles scattered around the perimeter of the building obscure much of the site; no impervious paved surfaces were noted. Parking spaces are not identified; there is no striping delineating either accessible or non-accessible parking spaces. There is no signage identifying accessible parking spaces.

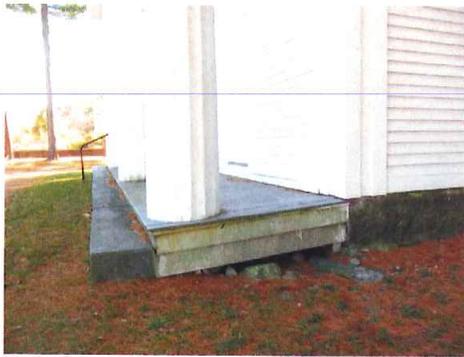
Photo D.1 – North portico

The main entrance to the Meeting House is located along the north elevation. Access to the first floor is by way of a painted wood-framed portico and granite risers which span the full width of the north façade (Photos C.4 and D.1). First floor egress is limited to two single doors which exit from the north vestibule to the portico; there are no other egress doors servicing the first floor. The overall condition of the portico framing, wood floor boards, and granite risers is good (Photo D.1).

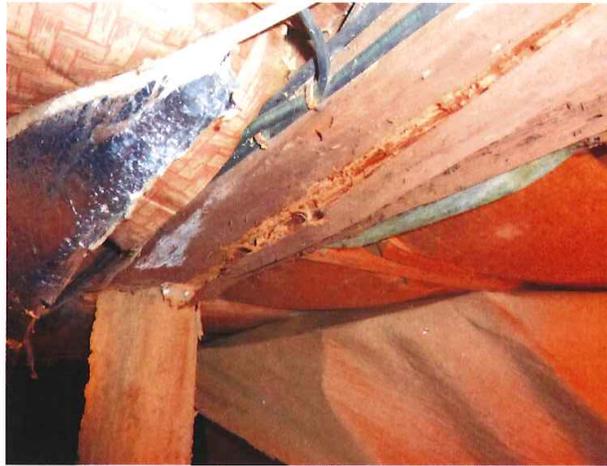
**Photo 1**

- We observed the first interior first floor girder line to have sections of girder with powder post beetle damage. We observed the beetle emergence holes along the girder as well as soft wood that could be pried loose with a screwdriver (Photos 1 and 2).
- We observed several timber posts to have powder post beetle damage. These posts seemed to be located towards the front of the building on the first interior girder line. We observed the beetle emergence holes on the entire length of the posts (Photos 3 and 4).

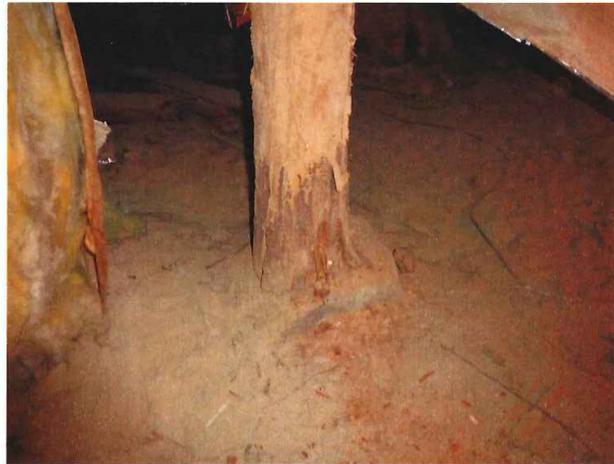
**Photo 4**

- We observed the insect damaged timber posts to be crushing and splitting at the base (Photo 4).
- We observed the timber posts to be bearing on loose stones. There is no connection from the posts to stones (Photos 5 and 6). At one post we observed the post to be supported only on one corner of the post (Photo 7).
- At the square interior post we observed the base to rotted with split and soft wood (Photo 8).
- We observed the ceiling plaster and ceiling joists are support from the bottom chord of the queen rod truss (Photo 9).
- We observed the roof purlins to be supported at its end on a diagonal strut that bears on the front exterior bearing wall (Photo 10).

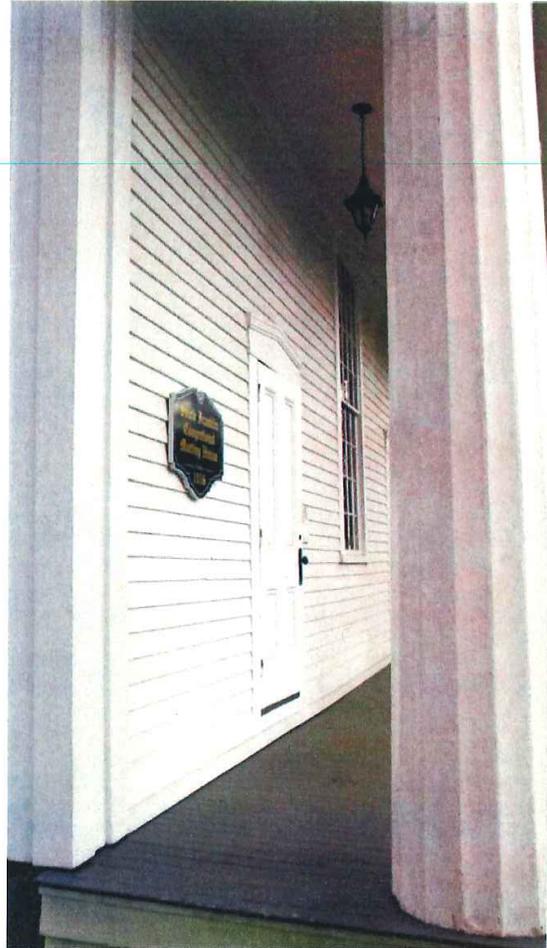
Detailed view of portico looking west

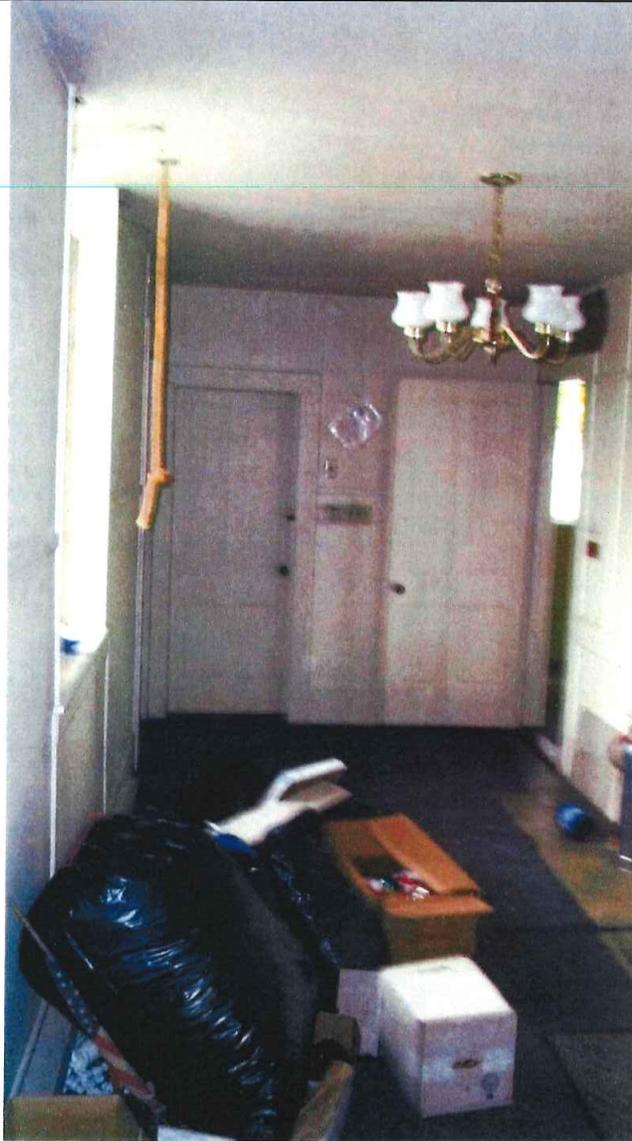
Front foyer with bell rope at left ....

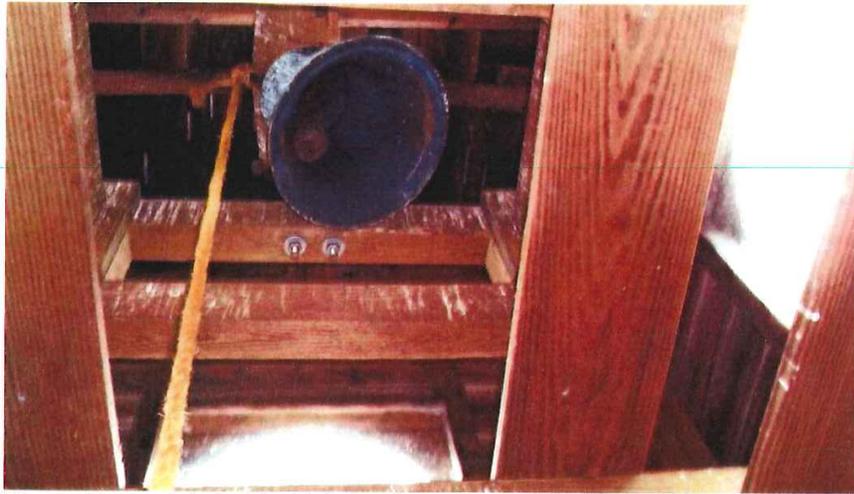
View looking up stairs in attic at interior of steeple, bell and bell rope

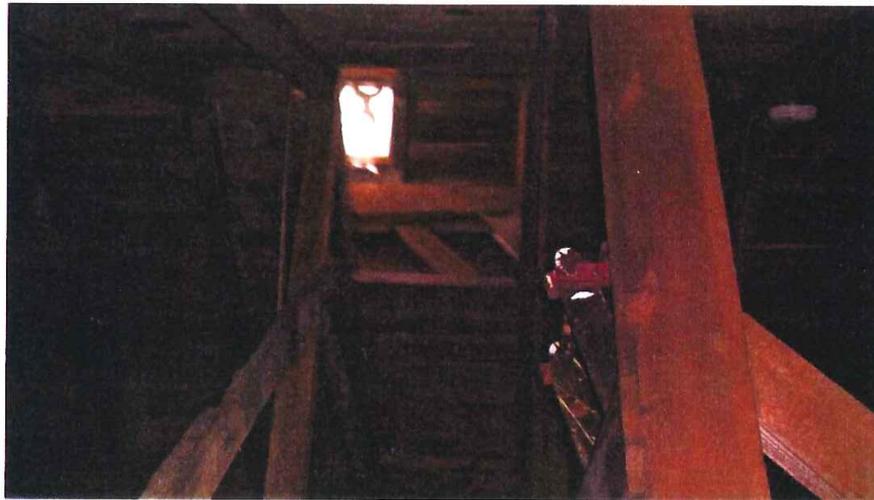
Attic interior looking toward belfry.
