Town of Franklin, MA

FINAL REPORT

Beaver Street Interceptor Alternatives Analysis

March 2021

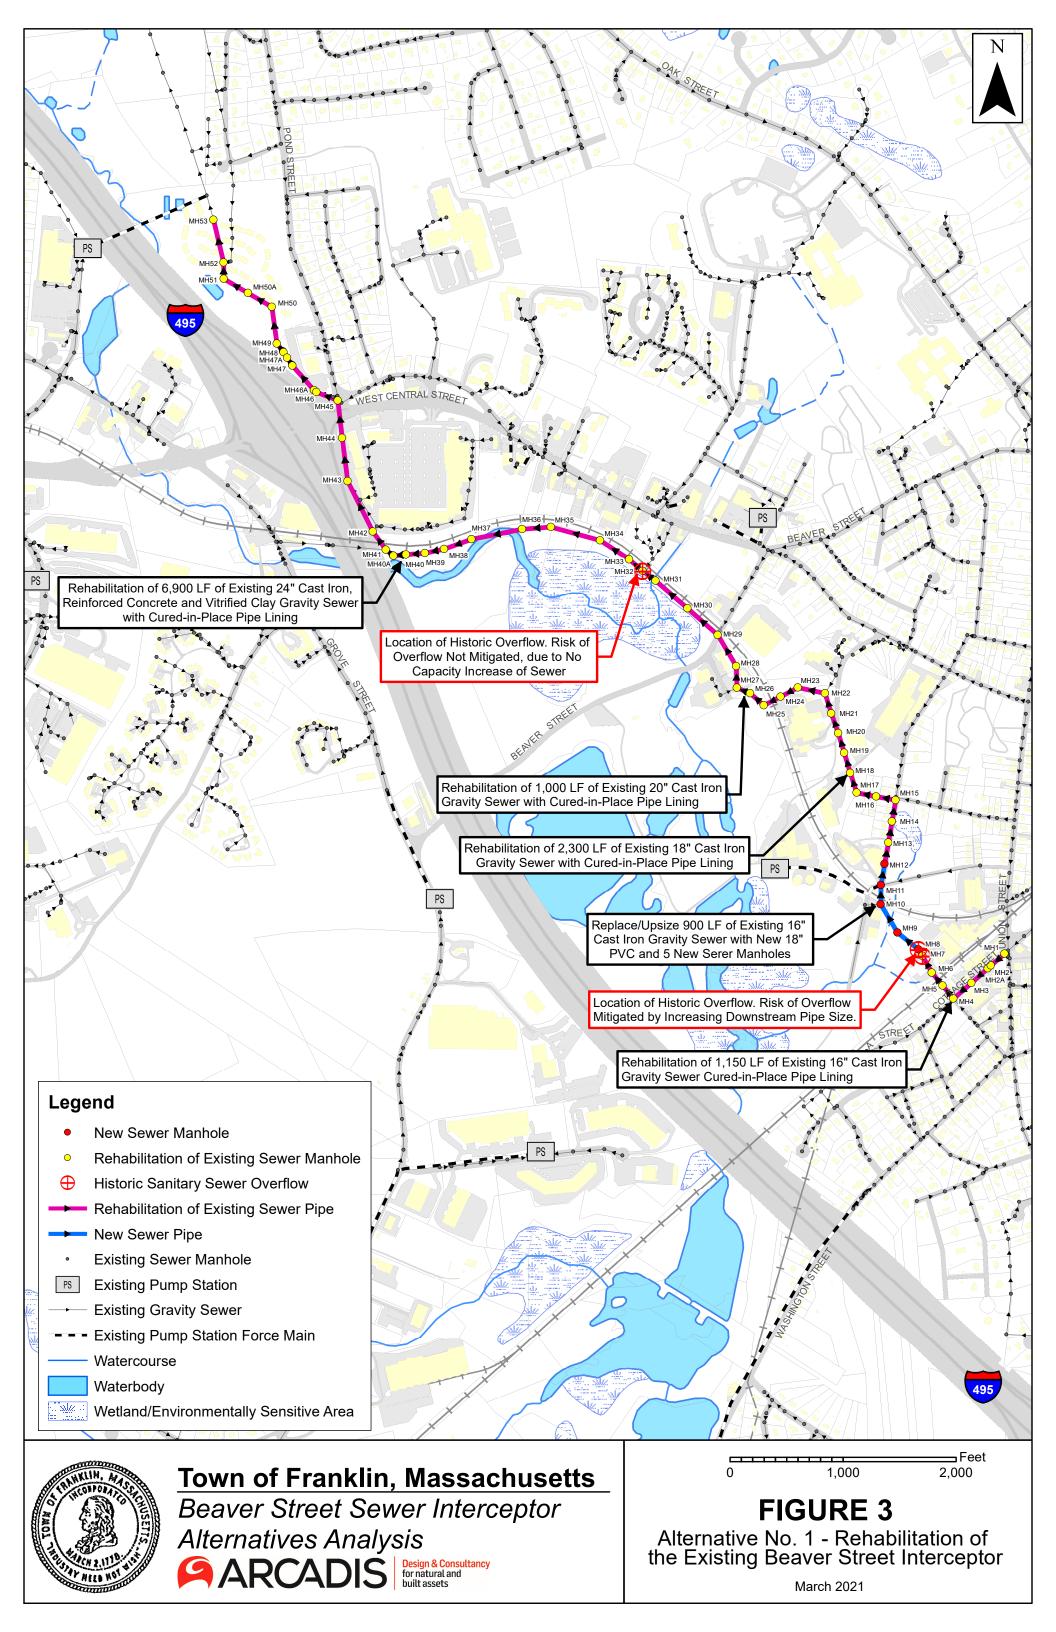
Recommended improvements for Alternative No. 1 are shown on Figure 3 and include:

- Cured-in Place Pipe Lining of approximately 11,350 LF of gravity sewer
- Replacement/upsizing of approximately 900 LF of gravity sewer with PVC pipe
- Construction of approximately 5 new sewer manholes and rehabilitation of 54 existing sewer manholes

Alternative No. 1 consists of replacement/upsizing of approximately 15% of the BSI from 16" to 18" with new PVC pipe and new sewer manholes from manhole MH8 to MH12, and rehabilitation of approximately 85% of the BSI with CIPPL and internal manhole rehabilitation.

As discussed in earlier sections, operation, and maintenance of the BSI in the existing alignment poses significant accessibility challenges through the Beaver Street Easement and along the Franklin Village Plaza. Additionally, rehabilitation of the existing pipes and manholes does not provide any additional capacity in the system, which can lead to surcharging of the sewer manholes and SSOs into environmentally sensitive areas. Due to the minimal capacity increase, the risk of SSOs occurring through the Beaver Street Easement and at the historic SSO location of MH31, as shown on **Figure 3**, is not mitigated by constructing Alternative No. 1.

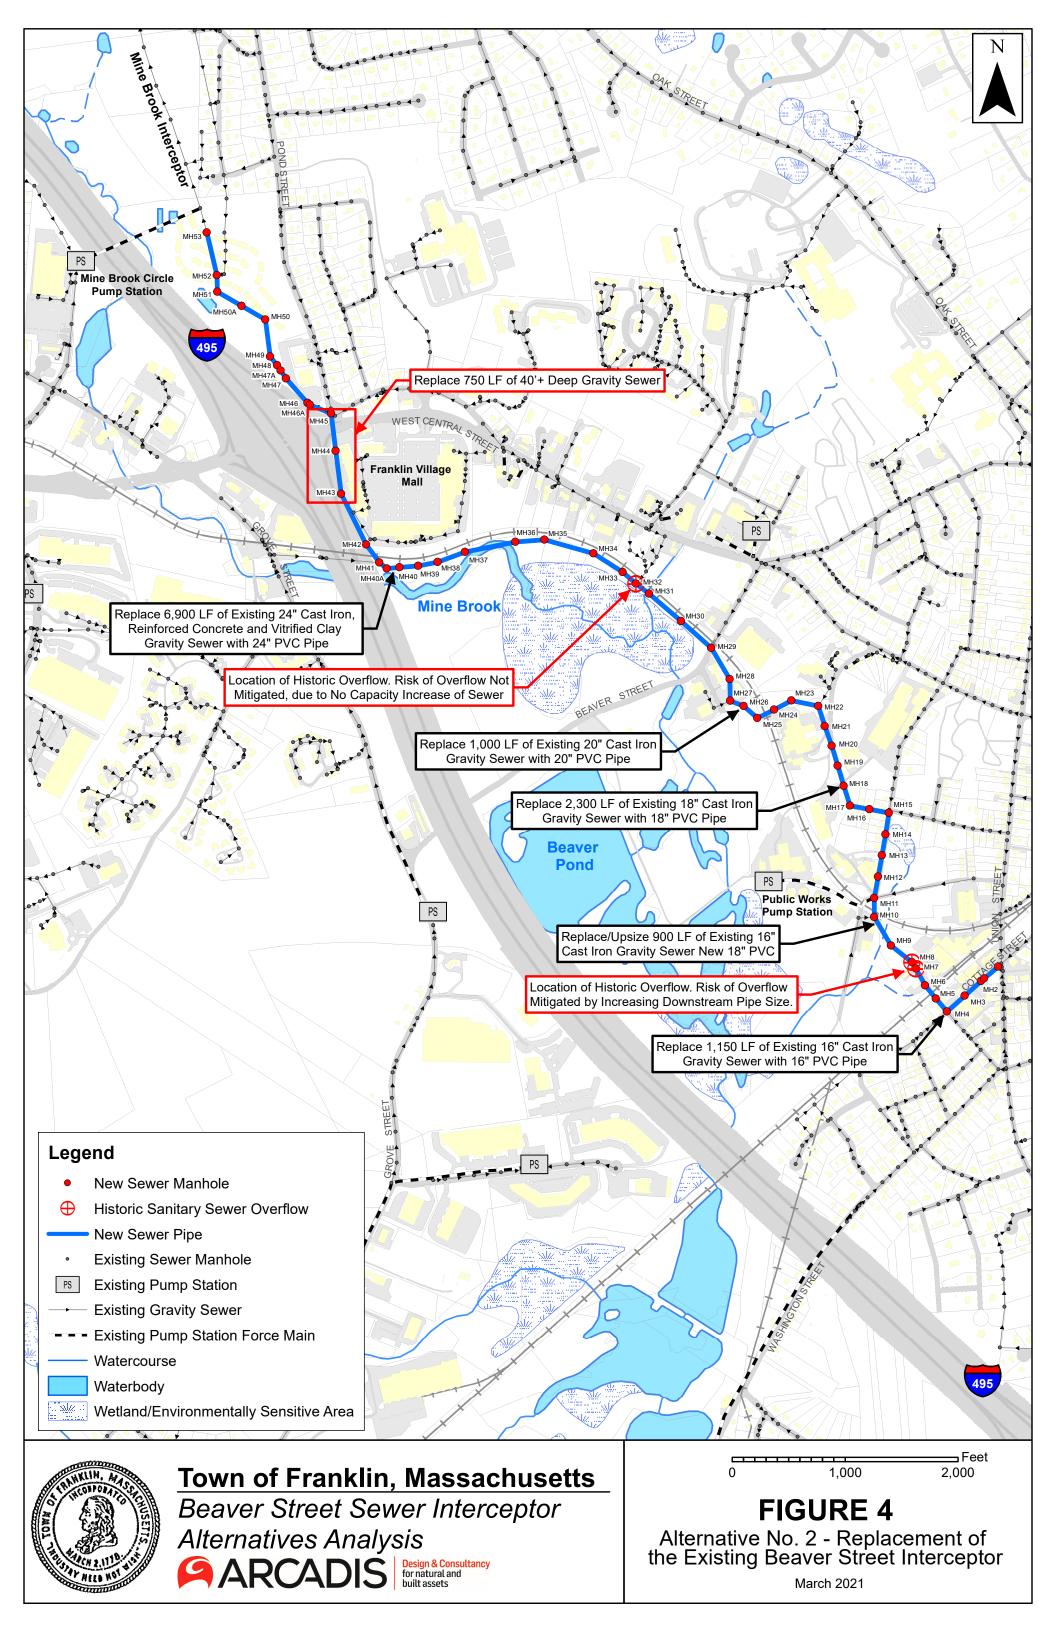
Recommended improvements for Alternative No. 2 are shown on **Figure 4** and include:

Aside from the sections of pipe that are recommended to be upsized from 16" to 18", which is also included in the Alternative No. 1 recommendations, there are no benefits in terms of accessibility, O&M, or capacity from replacing the pipes, as opposed to rehabilitation with CIPPL. As described in the Comparison of Alternatives section, Alternative No. 2 is the least desirable alternative and was evaluated more as a standard baseline for comparison of Alternative No. 1 and Alternative No. 3.

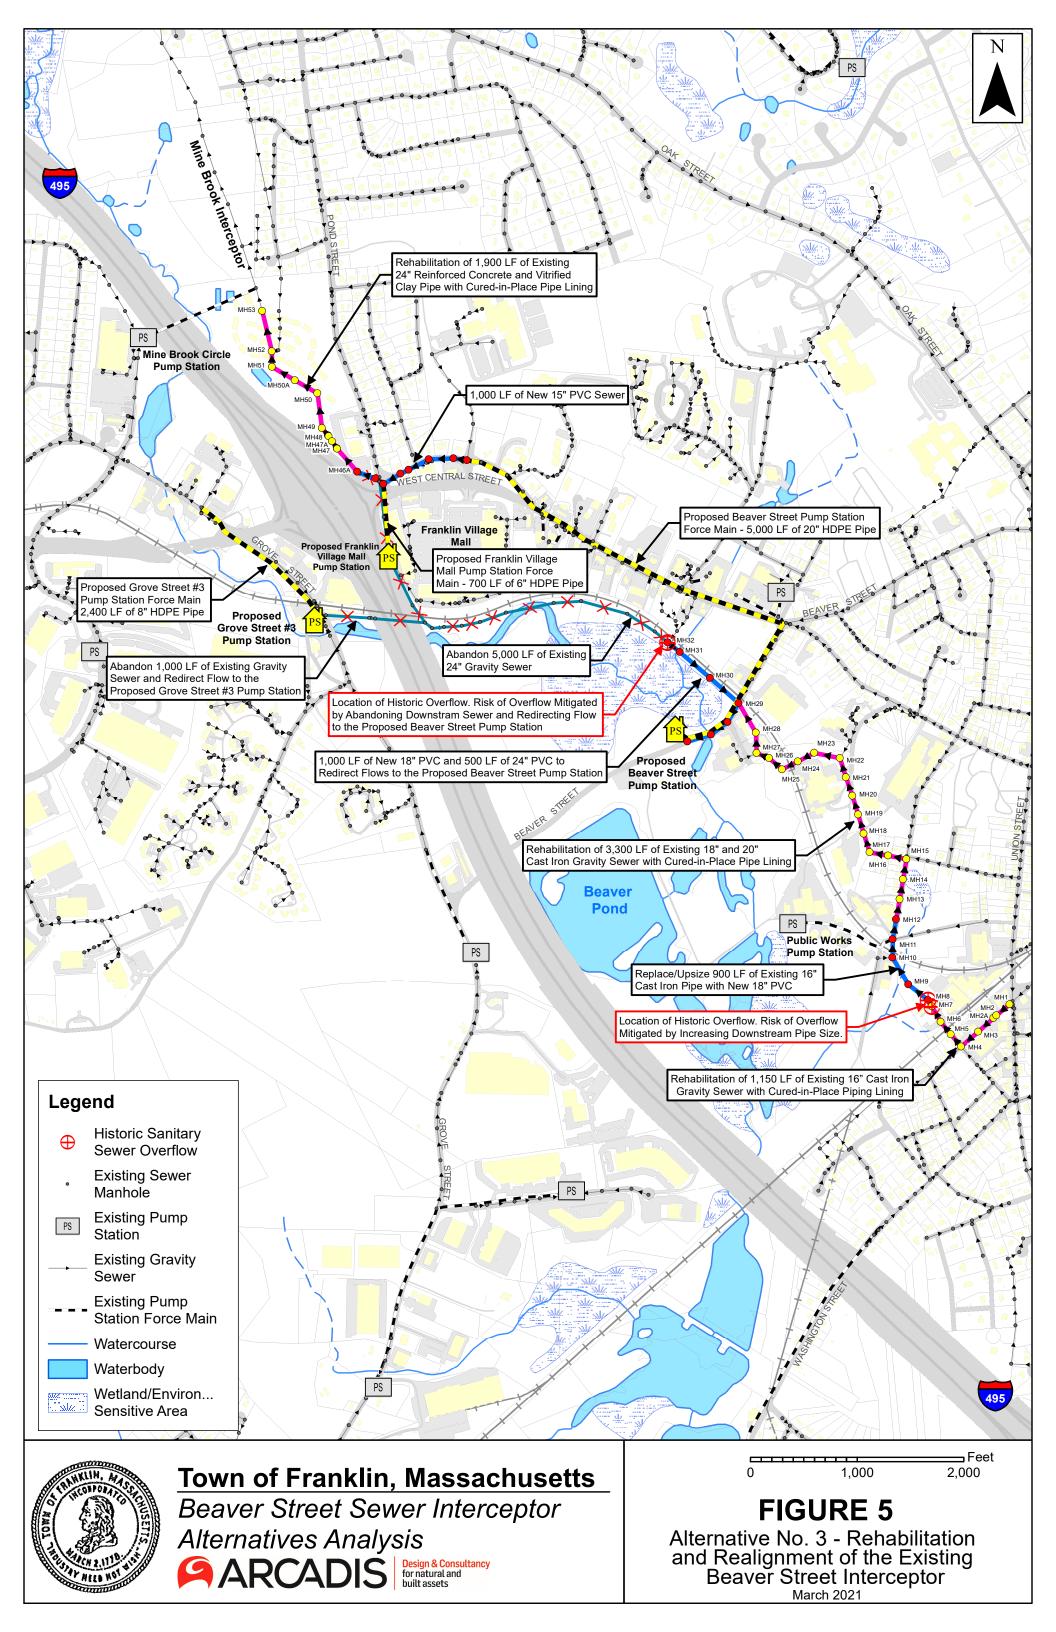
Recommended improvements for Alternative No. 3 are shown on **Figure 5** and includes:

Alternative No. 3 provides a long-term solution to the accessibility, O&M, and capacity challenges caused by the existing BSI alignment by abandoning and rerouting sewers in the most problematic and inaccessible areas. The proposed Beaver Street Pump Station (BSPS) would intercept flows that currently flow north through the Beaver Street Easement and also receive flows from Panther Way by way of a new gravity sewer. The BSPS would then pump flows from Beaver Street, then northerly along West Central Street (Rt. 140) through a new 20" force main, discharging to a new gravity sewer on Old West Central Street. The portion of the BSI that is proposed to be abandoned also currently receives tributary flow from Grove Street at the Interstate 495 crossing and from the Franklin Village Plaza. These tributary lines will be redirected to the proposed Grove Street Pump Station #3 and the proposed Franklin Village Plaza Pump Station, as shown on **Figure 5**.

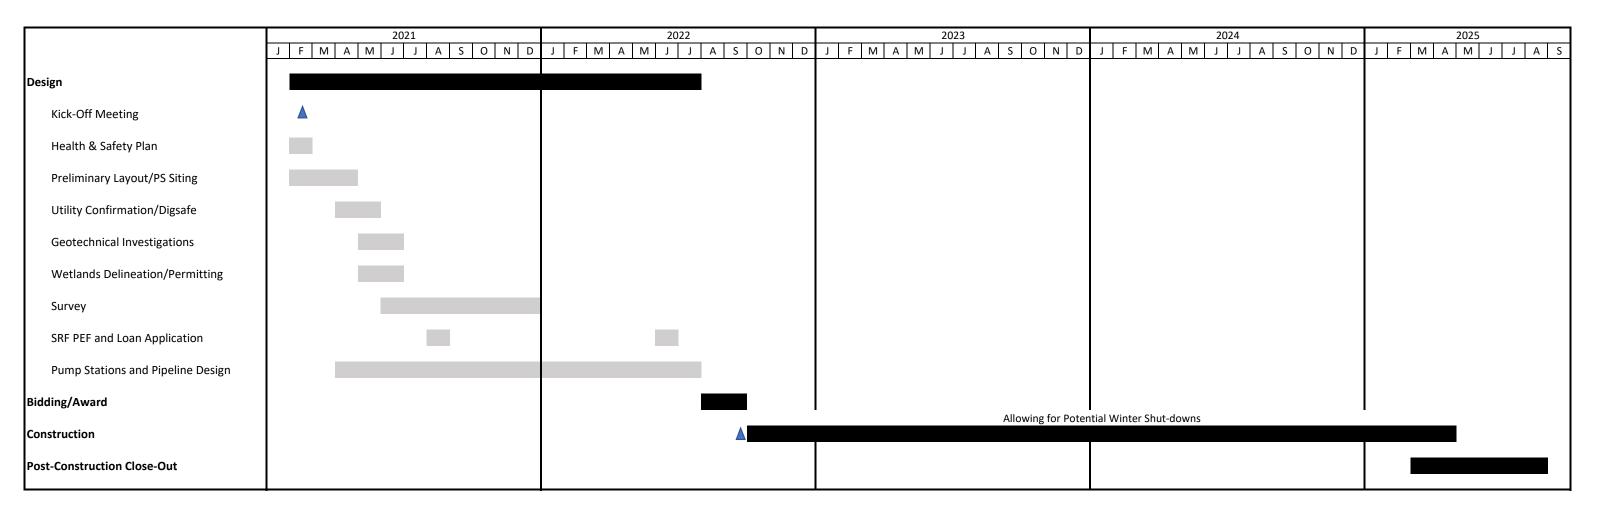
Figure 6 - Project Implementation Schedule

Project Milestone	Anticipated Schedule
Design (Siting, Geotechnical, Survey, Permitting, Pump Station and Pipeline Design)	February 2021 – July 2022
SRF PEF and Loan Application	August 2021 and August 2022
Project Bidding/Award	August 2022 – September 2022
Construction Phase	October 2022 – April 2025

A proposed schedule for implementation is shown in **Table 5 and Figure 6**.
