Bicycle and Pedestrian Improvements in Six Urban Centers

Central Transportation Planning Staff of the **Boston Region Metropolitan Planning Organization**. The MPO is composed of state and regional agencies and authorities, and local governments.

February 2010

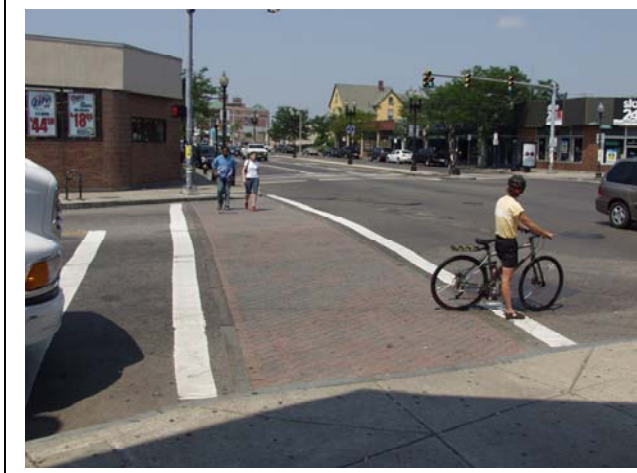
Parallel Bars with Inlaid Brick
Harvard and Brighton Avenues, Allston

There are several treatments that make crosswalks more visible to pedestrians and motorists. MassDOT Highway Division allows three crosswalk-marking patterns: ladder-style (the agency's preferred option), parallel-bar-style, and zebra-style. These patterns are shown in Figure 2-1. Many crosswalks evaluated in this study are a modified parallel-bar-style. In many cases, those crosswalks are accented by a solid painted color (yellow or green), or inlaid bricks, between two parallel white lines.

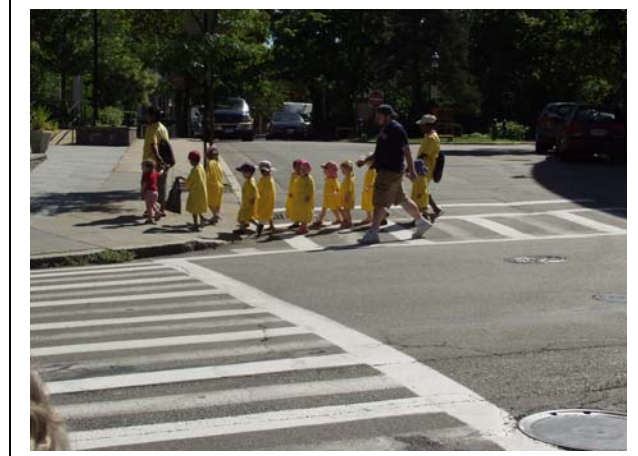
Ladder Style with Parallel Bars
Harvard and Linden Streets, Brookline

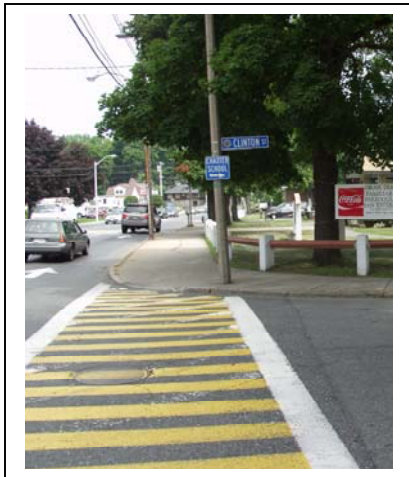
Ladder Style with Parallel Bars
Concord and Clinton Streets, Framingham

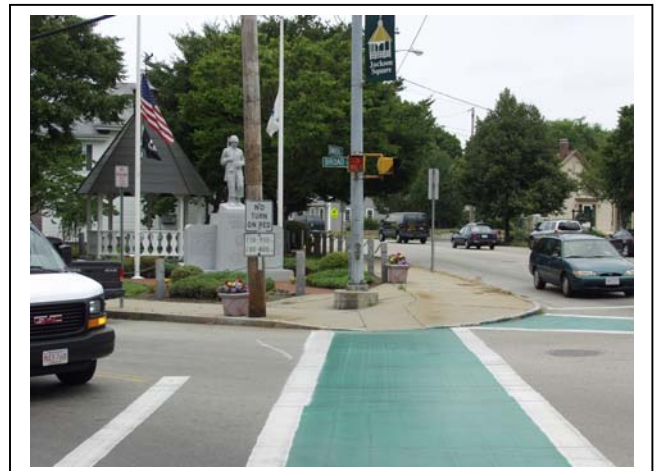
Parallel Bars, Solid Green Infill
Jackson Square, Weymouth

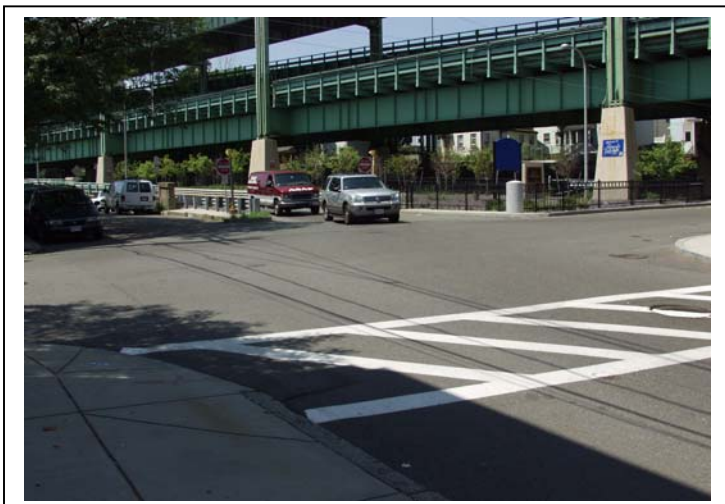
Zebra Style
Beacon Street off-ramp, Tobin Bridge, Chelsea

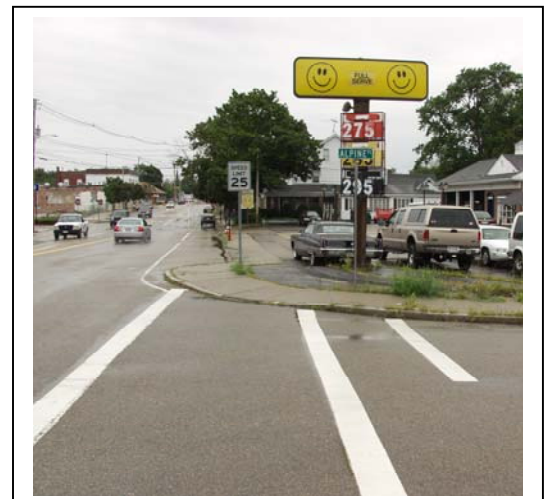
Parallel Bars
Alpine Place, Franklin

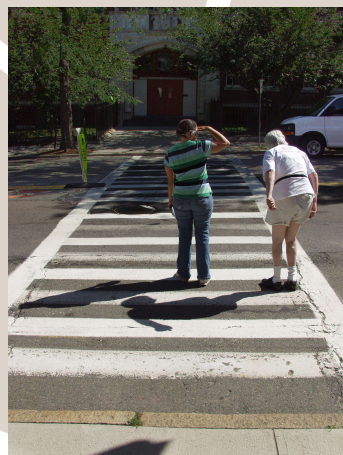
Lack of curb ramps and curb extensions

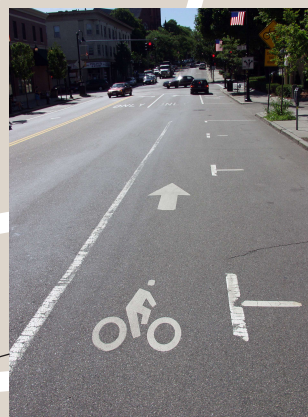
Bike lane ends at intersection

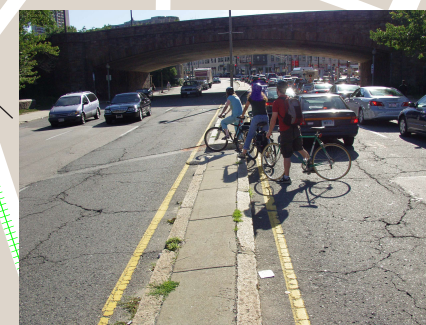
Lack of safe crossing

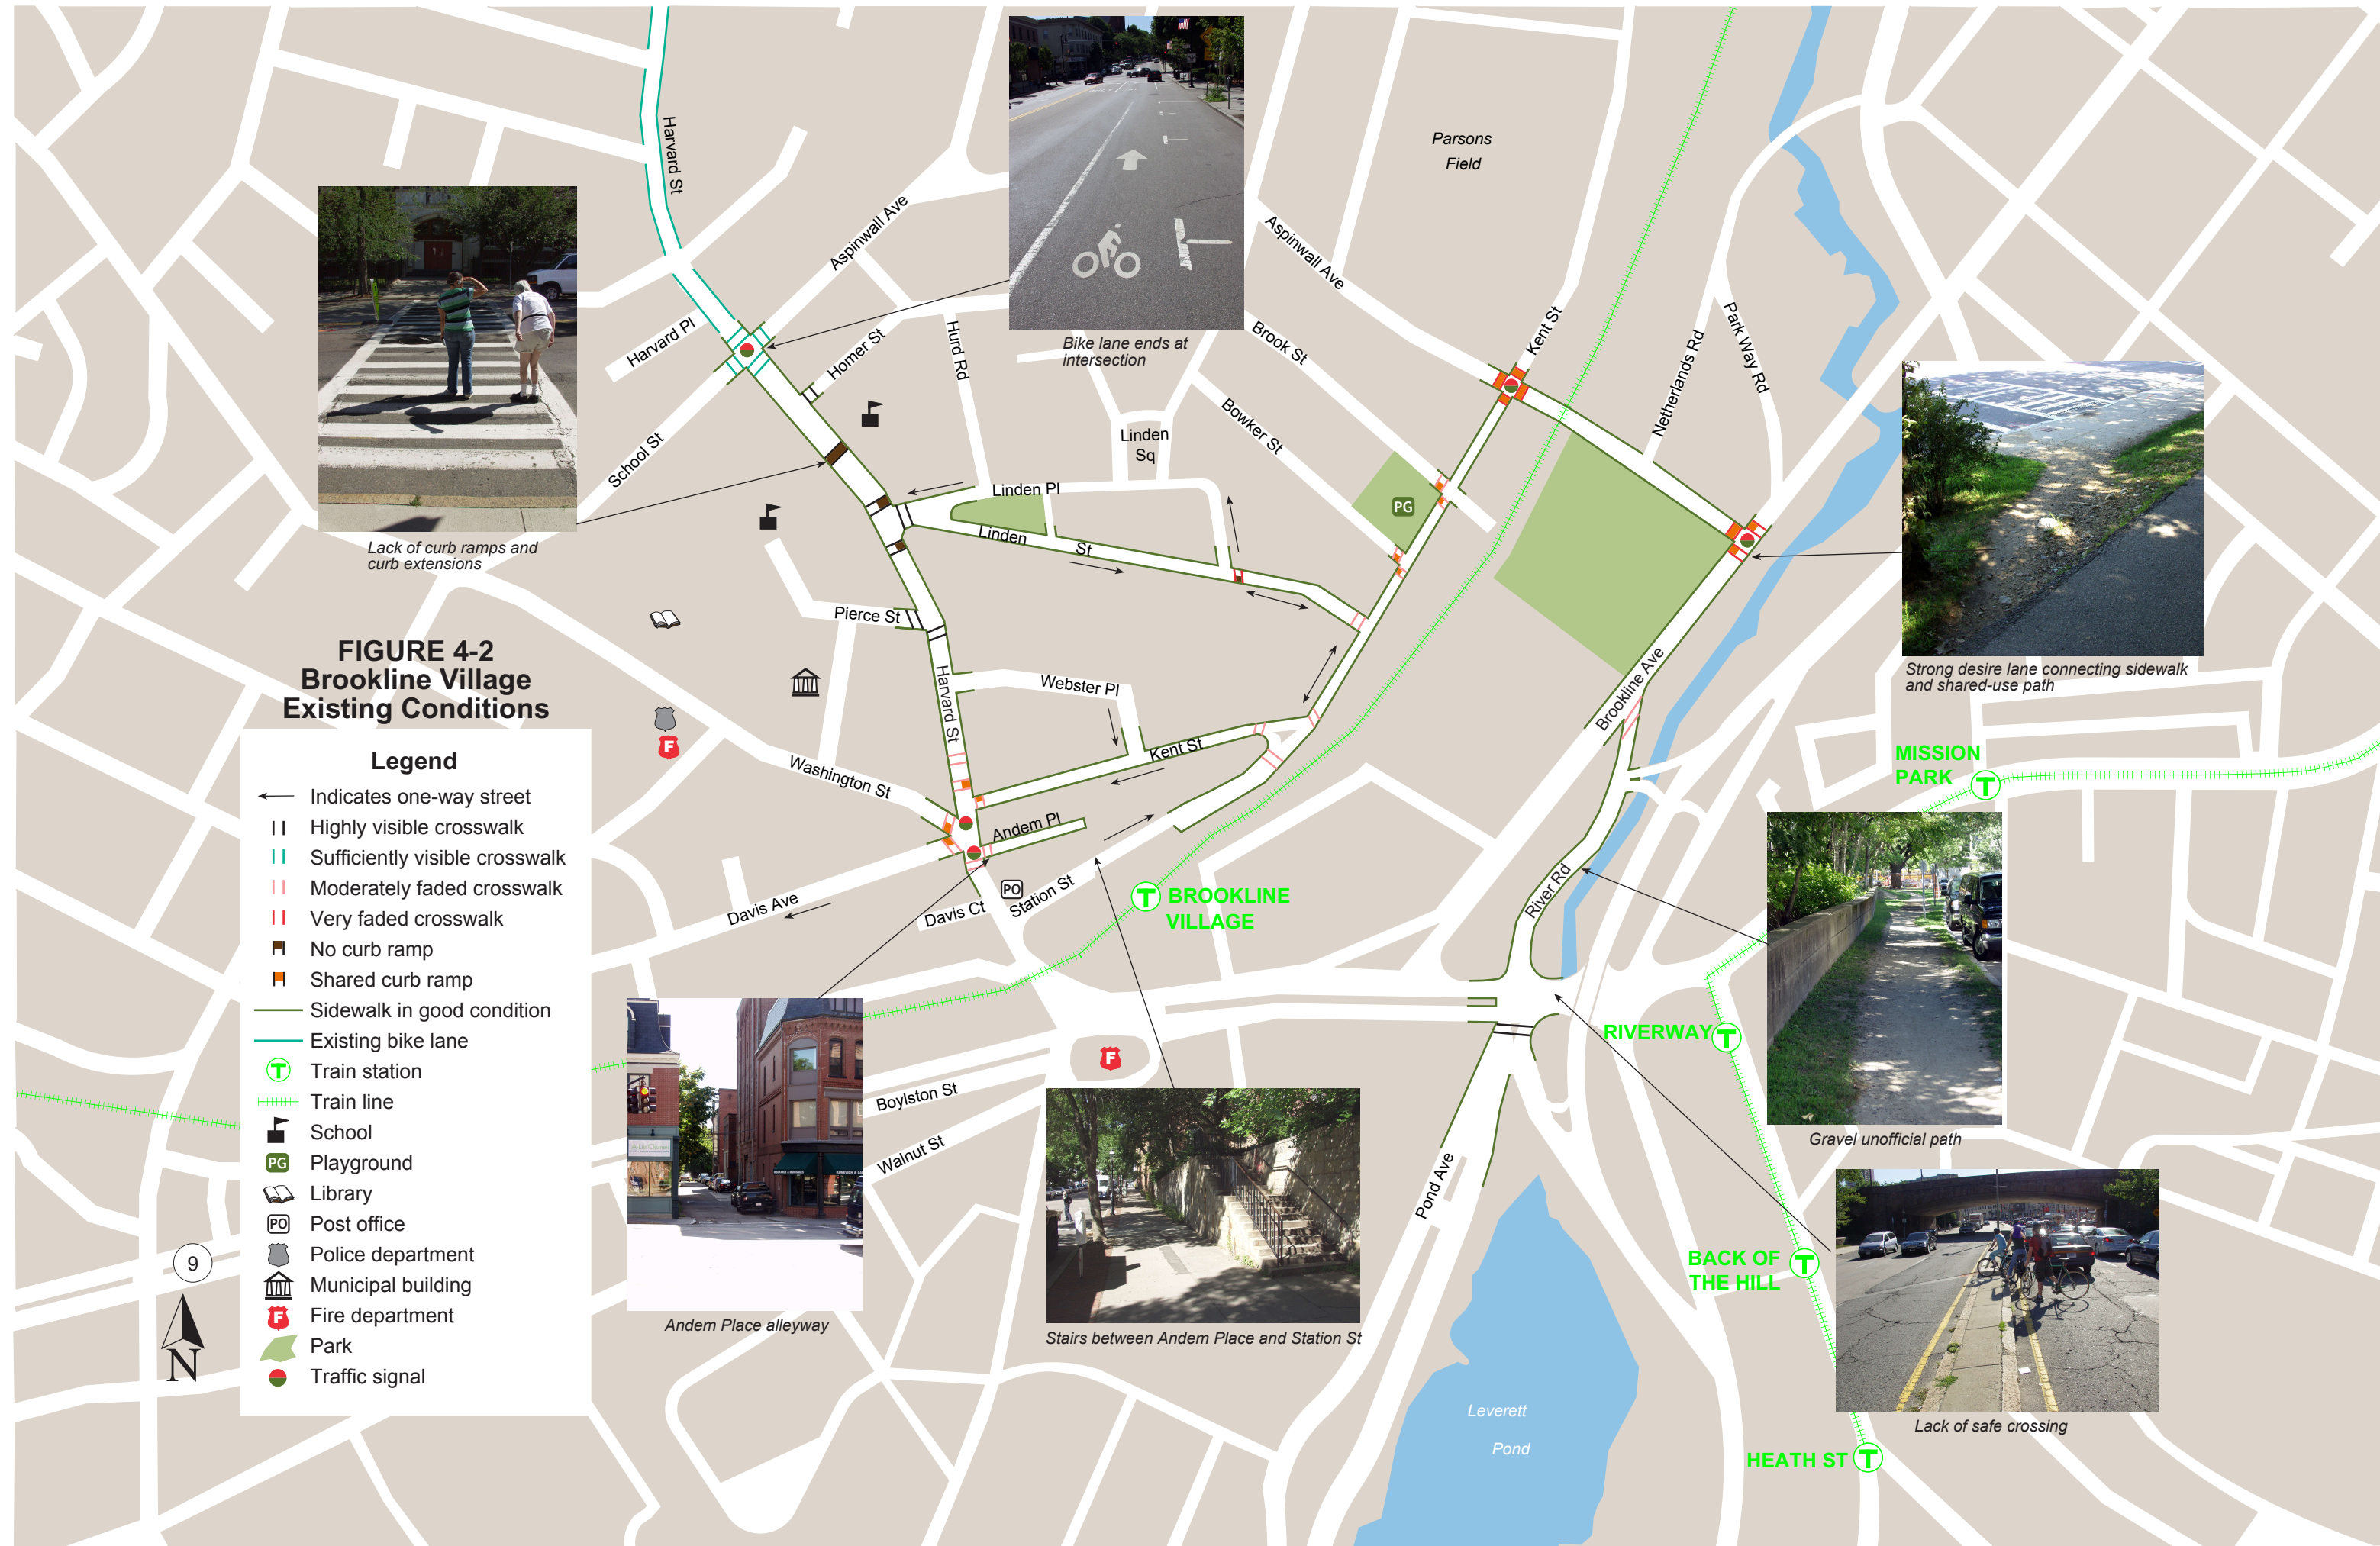
**FIGURE 4-2
Brookline Village
Existing Conditions**

Many pairs of crosswalks share curb ramps. Some crosswalks have no curb ramps. At least a few crosswalks should be added, particularly for the Route 9 crossing of the Muddy River Path. Most crosswalks extend along the most logical path for pedestrians. Most of the crosswalks are ladder-style, with white or yellow bars. Some are parallel bar-style. There are few curb extensions. A median exists at the Route 9 crossing of the Muddy River Path, but it is not adequate for the volume of people crossing this busy roadway. There is also a median in Harvard Street between Station Street and Davis Avenue.

The study area for Brookline Village (shown in Figure 4-2) includes:

Figure 4-2 indicates existing pedestrian and bicycle conditions. Sidewalks, made of concrete with granite curbs, are generally in good condition. Few have weeds or are cracked. Most have street trees, and many front yards have large trees that provide shade along the street.

The following three sections provide more detail on the bicycling and walking environments. As noted above, the existing conditions are shown in Figure 4-2. Figure 4-4 indicates recommendations.

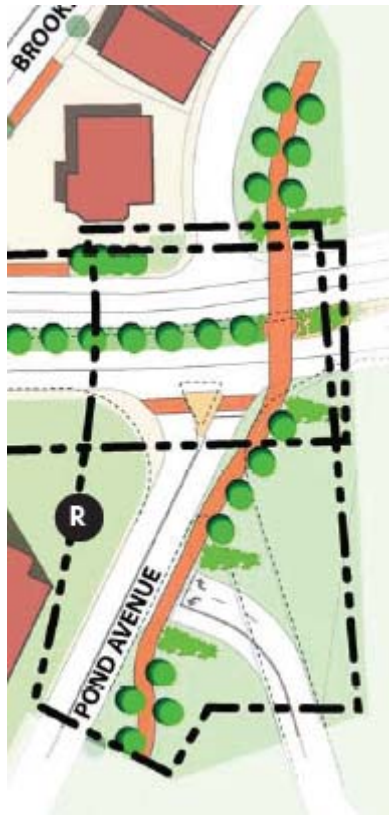
Figure 4-5: Alignment of Pond Avenue, Riverway On- and Off-Ramps, and the Crossing of Route 9

Source: Brookline’s Gateway East Public Realm Plan (2006), p. 4.

Option 1 – Create a nonsignalized, at-grade crossing with a refuge island/median planted with vegetation, as shown in the Gateway East Public Realm Plan (see Figure 4-5 below, taken from the Plan).

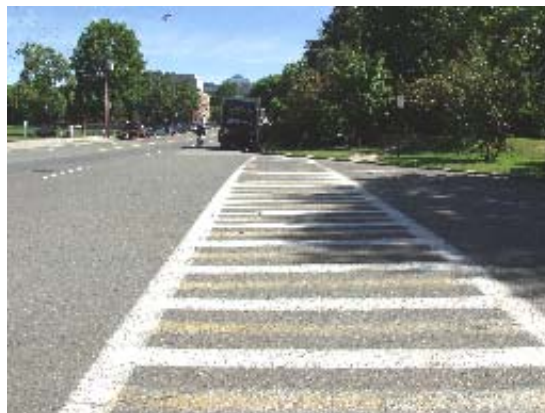
Long crosswalk on River Road at Brookline Avenue.

22. Square off the intersection of River Road and Brookline Avenue, or add an island. This will cause traffic to move more slowly, and will shorten the extremely long crossing for pedestrians.

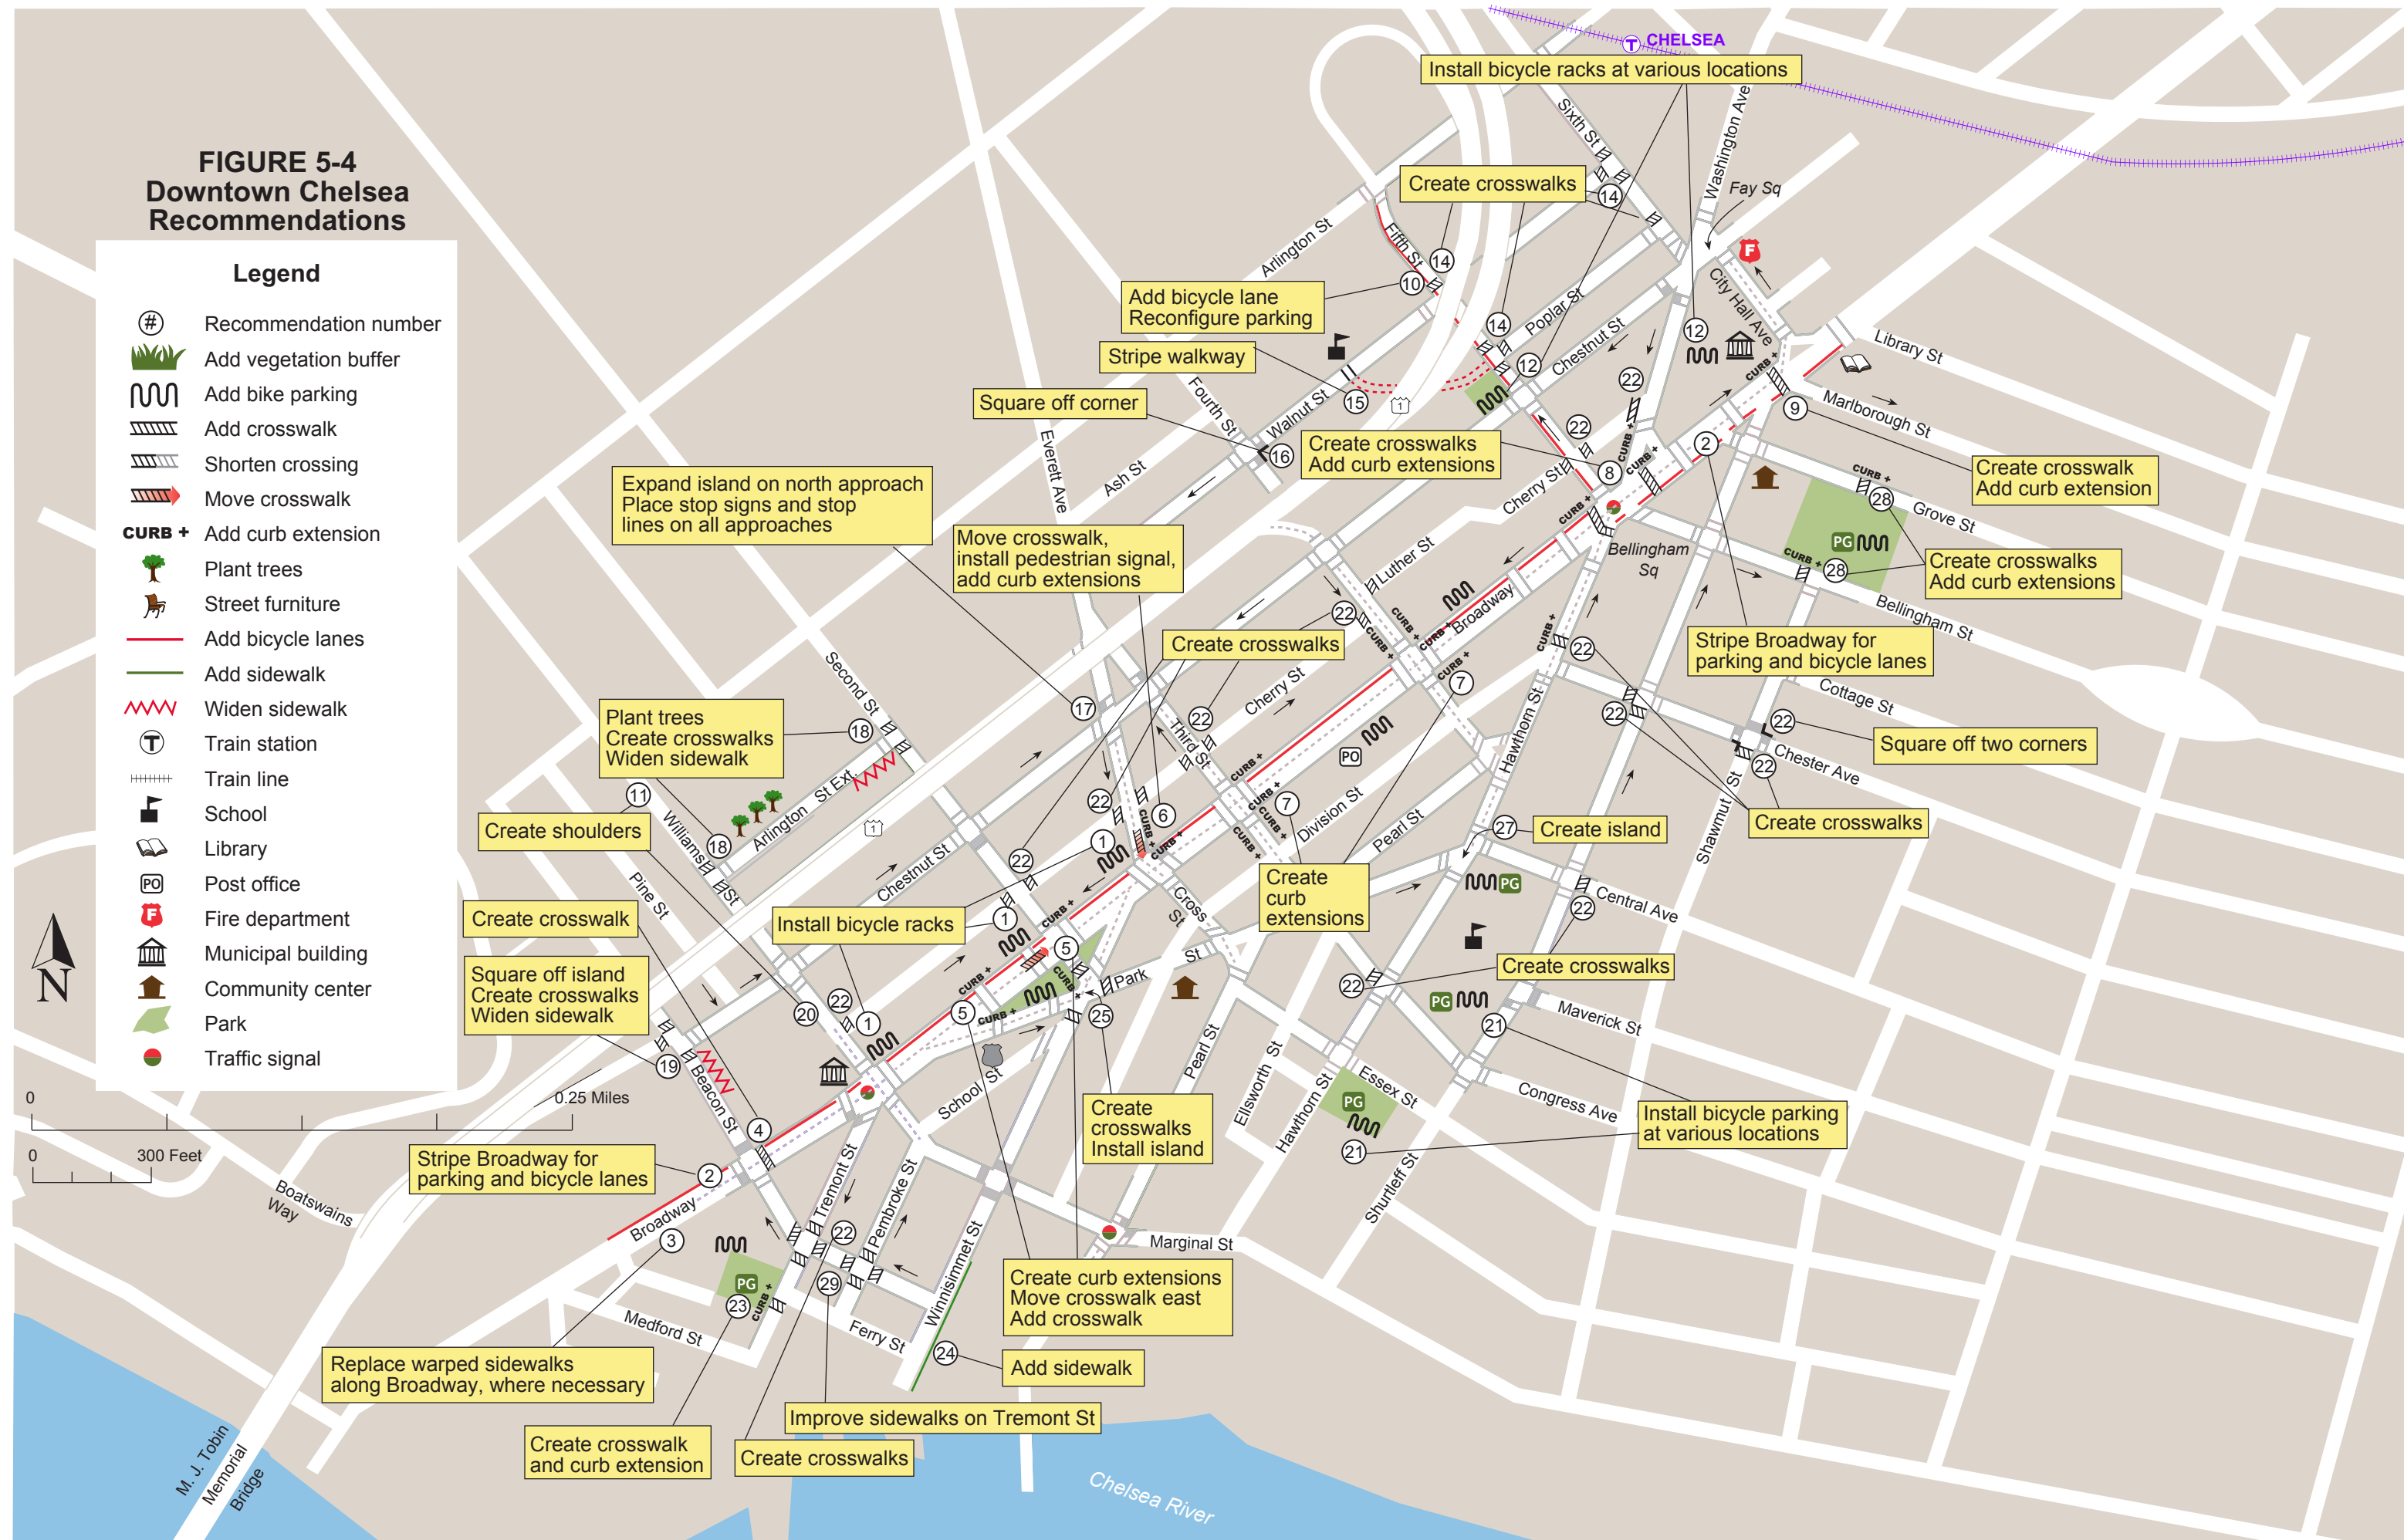
FIGURE 5-4
Downtown Chelsea
Recommendations

The subsequent sections of the chapter include more detail on existing conditions as well as recommendations; the latter are shown in Figure 5-4.

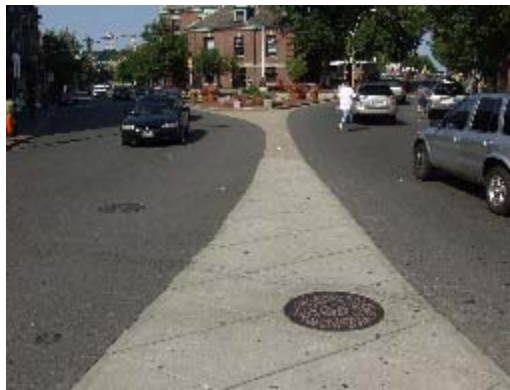
A pedestrian crossing at Bellingham Square.

Bellingham Square is a multi-way intersection, with six one-way streets: three are entering the intersection, and three are exiting. There are pedestrian-activated crossing signals across Washington Avenue and Hawthorn Street. The pedestrian phase includes a countdown signal. There are zebra-style crosswalks on each side. Clockwise, they are 40 and 30 feet long. Using a 3.5-foot-per-second standard, the pedestrian phase is adequate for the lengths of the crossings.

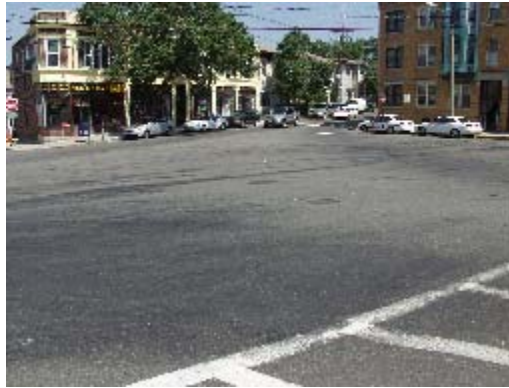
Fay Square.

The intersection of Chestnut Street, Washington Avenue, Sixth Street, and City Hall Avenue (Fay Square) is a daunting expanse of asphalt, unaccommodating for bicyclists and pedestrians, and, with no striping, essentially a “free-for-all” for motorists.

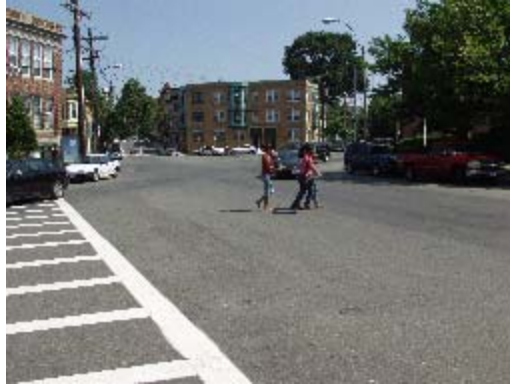
Pedestrians crossing near Fay Square.

There are several crosswalks along this corridor, all zebra-style. Most are highly visible, but a few are faded. While most crosswalks follow the natural path for pedestrians, the crosswalks at Fay Square are underutilized. A couple of crosswalks have no curb ramps, and a couple of crosswalks share one. There are two curb extensions.

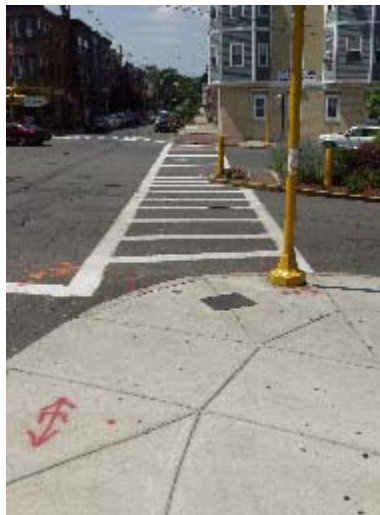
The north approach of Third, Everett, and Chestnut Streets

At the intersection of Third, Everett, and Chestnut Streets there are stop signs on Chestnut Street eastbound and on Third Street northbound. There are crosswalks across each approach of the intersection, all zebra-style. The crosswalk on the north approach is very long: 94 feet. There is a median 57 feet from the west side, but it barely reaches the crosswalk.

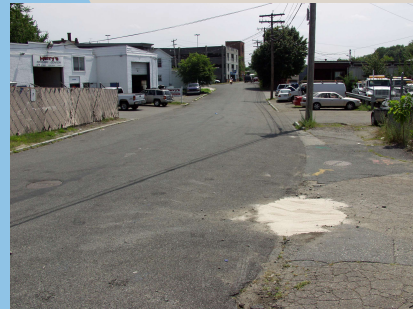
Lack of sidewalks

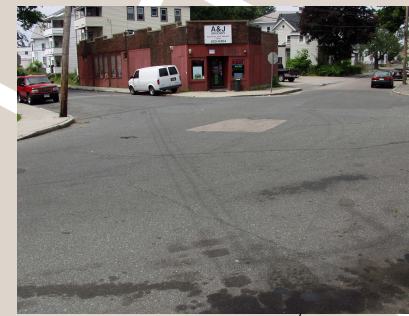
Lack of crosswalks

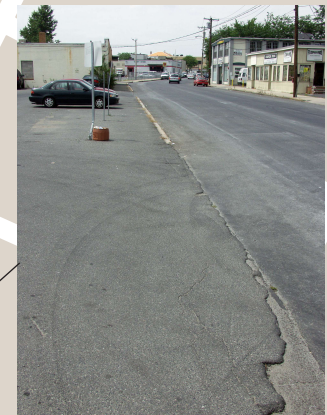
Lack of sidewalk separation

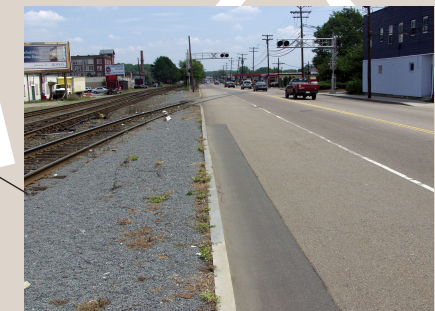
Potential for bike lanes

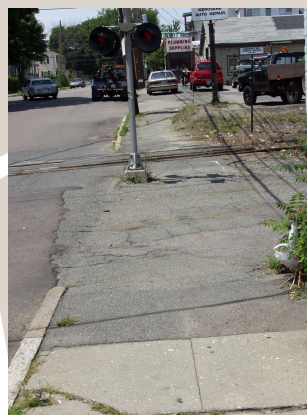
Disrepair near railroad tracks

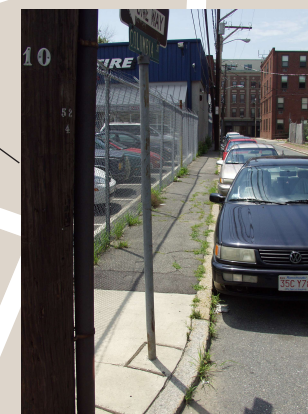
Narrow, obstructed sidewalk

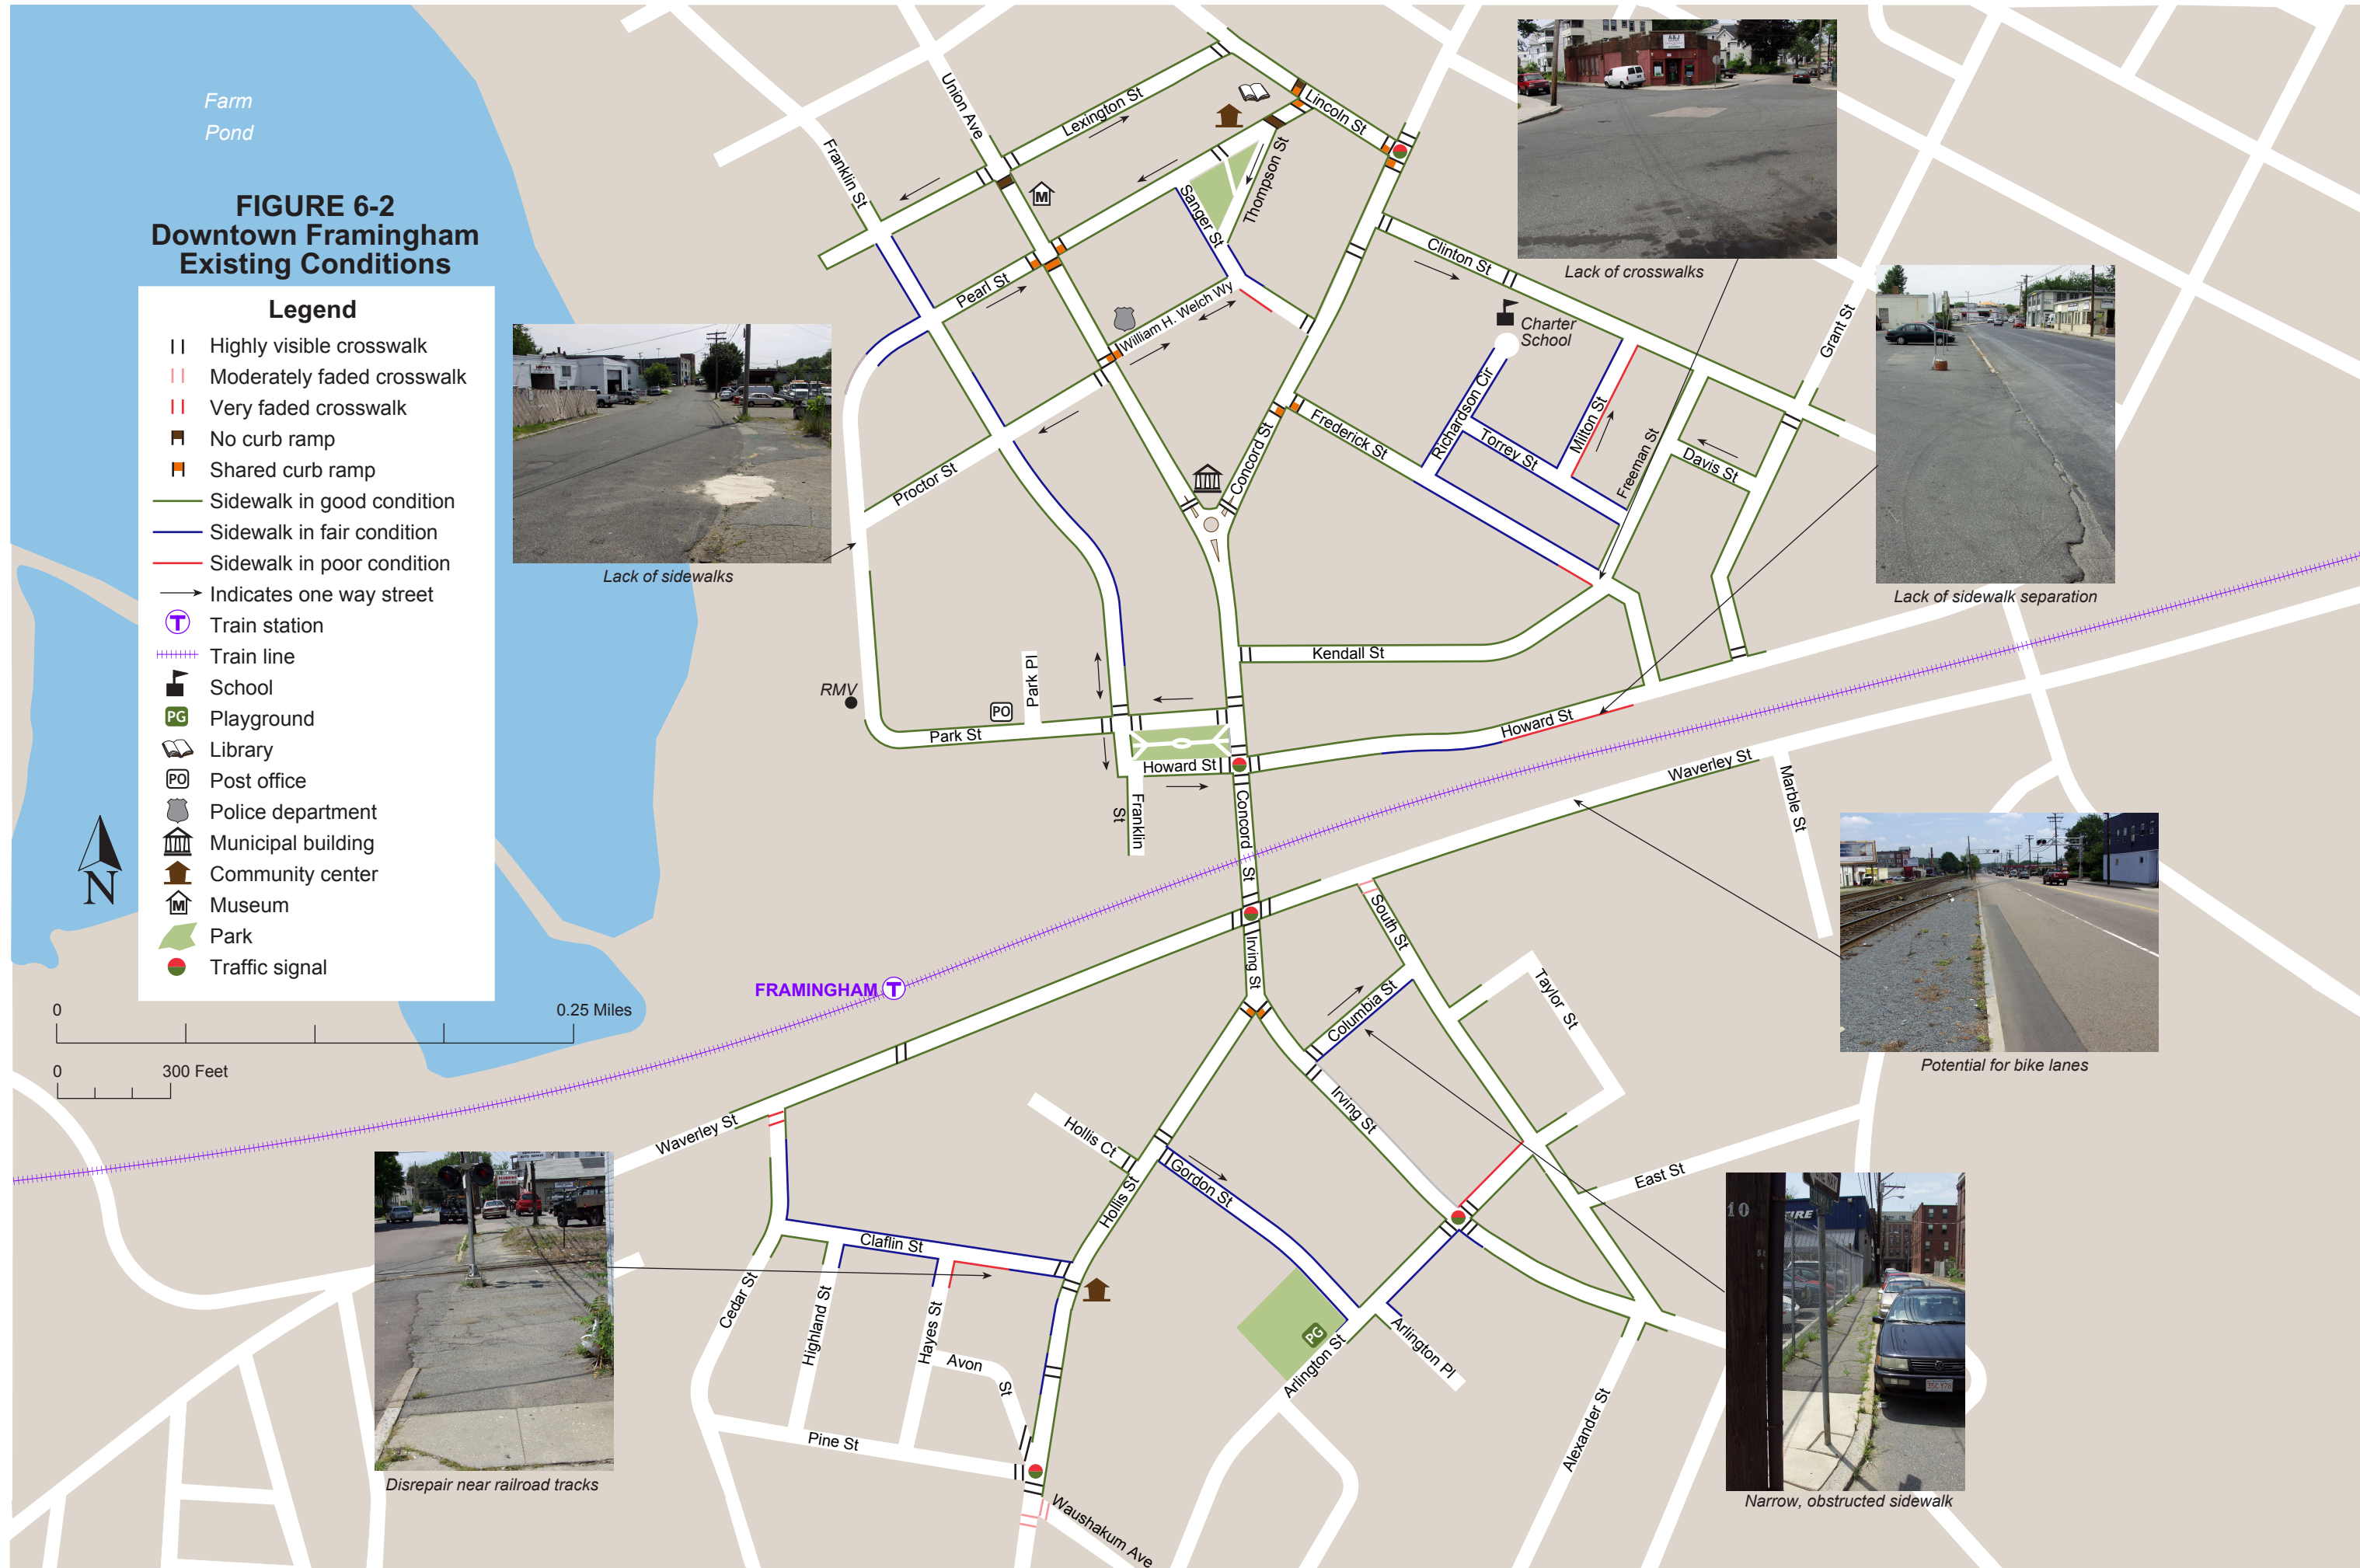
FIGURE 6-2
Downtown Framingham
Existing Conditions

There are no bicycle lanes, although some of the roadways are wide enough to accommodate them. Many of the roadways have on-street parking, which increases the risks to bicyclists. The edges of the roadway generally do not have significant cracks or large pieces of debris, and the drainage grates are set back from the roadway. See Figure 6-2 for more information on the bicycle network.

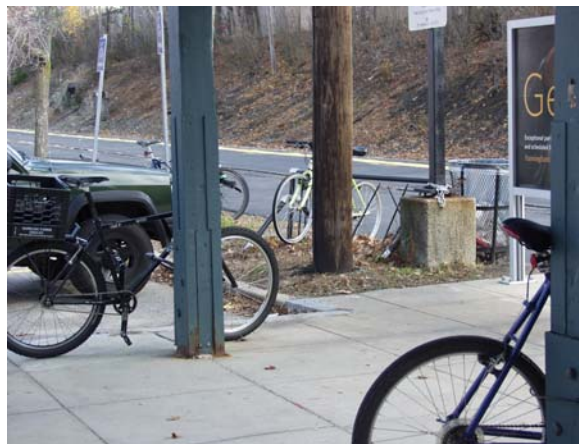
Bicycle parking at the Franklin Commuter Rail Station

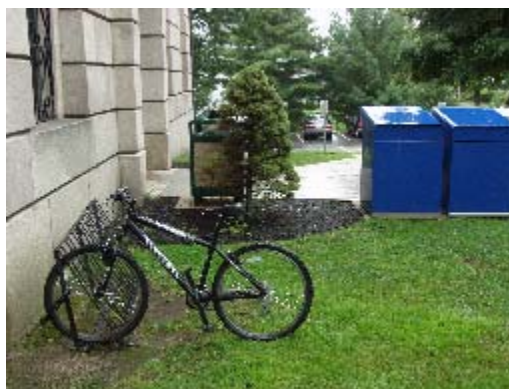
Bicycle parking at the library

There is bicycle parking at the commuter rail station and the library. However, the parking at the library is on grass with no access walkway and does not conform to current design guidance.

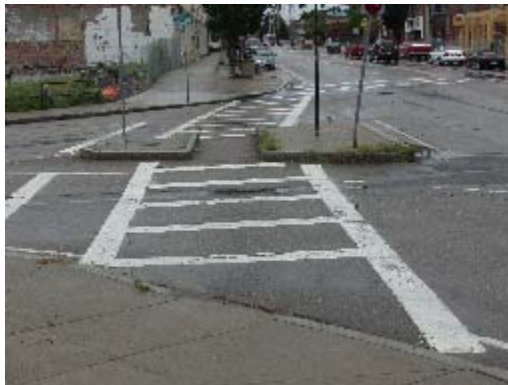
Misaligned crosswalk across Summer Street

- Realign all crosswalks to go straight across the streets

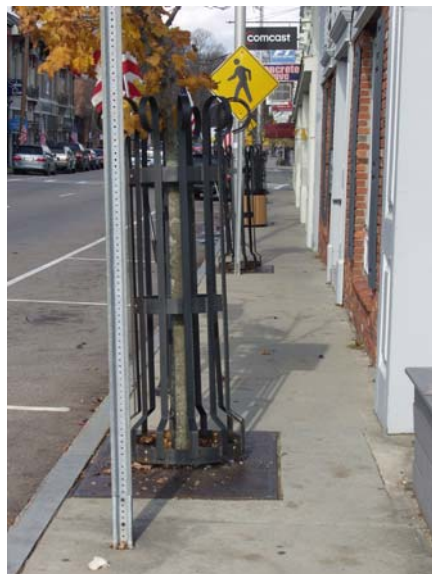
Narrow sidewalk on Main Street

Sidewalks extend along both sides of Main Street. Between Central and Emmons Streets in the downtown area, the sidewalks are very wide on the east side except between Central and Depot Streets, where they are only a few feet wide. The sidewalks on the west side are wider than five feet. Outside of the downtown area, the sidewalks are more than five feet wide. All of the sidewalks are made of concrete with granite curbs except for the west side of Main Street between School and High Streets where the sidewalk has no curb. The surface is smooth and free of significant bumps or cracks.

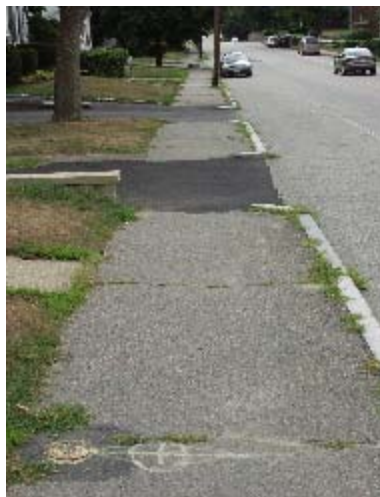
Overall, sidewalks are in good condition in the commercial area in Jackson Square, and in fair to poor condition elsewhere. The sidewalks in the commercial area are concrete, with granite curbs. The sidewalks elsewhere are either asphalt with granite curbs, or asphalt with no curbs, which results in little distinction from the roadway. Many of the sidewalks have weeds and minor cracking. Some of the minor streets have no sidewalks. Only sidewalks in the commercial area in Jackson Square along Broad Street have street trees, but there are only a few and some are in poor health.

Sidewalk on Broad Street

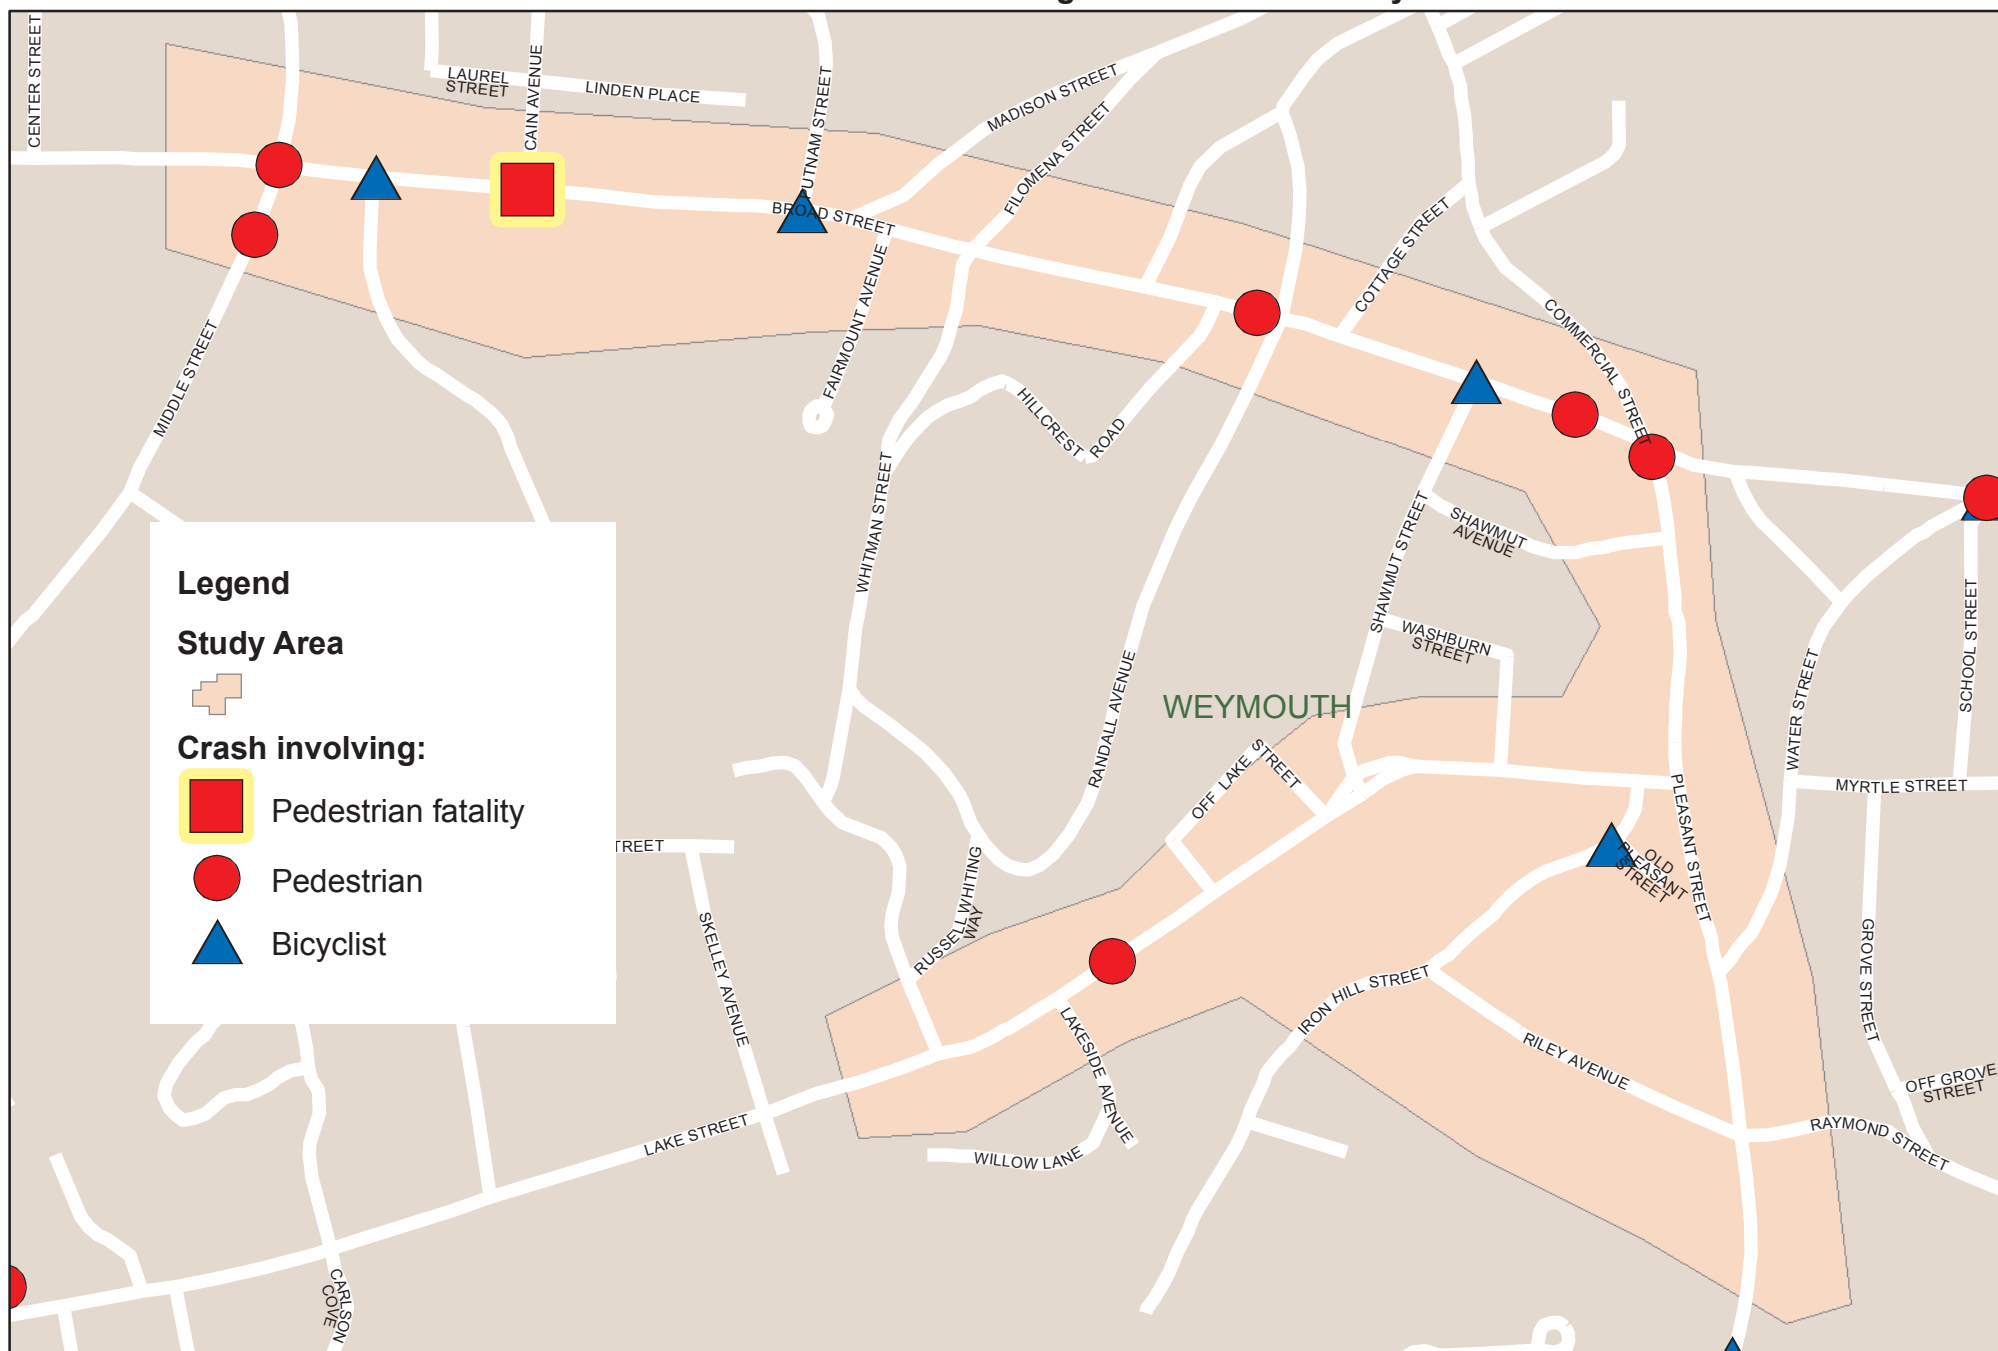
FIGURE 8-3
Jackson Square, Weymouth
Crashes in 2002-2006 Involving Pedestrians and Bicyclists

pedestrian crashes, which occurred at Broad Street and Cairn Avenue, was fatal. As shown in the figure, although most crashes occurred on Broad Street, they were not concentrated at any particular locations. The number on Broad Street might be more of an indication that more bicycling and walking occurs there than that the conditions are relatively more hazardous than at other areas.

In the five-year period of 2002 through 2006, there were seven crashes within the study area involving a pedestrian and four involving a bicyclist (see Figure 8-3). One of the

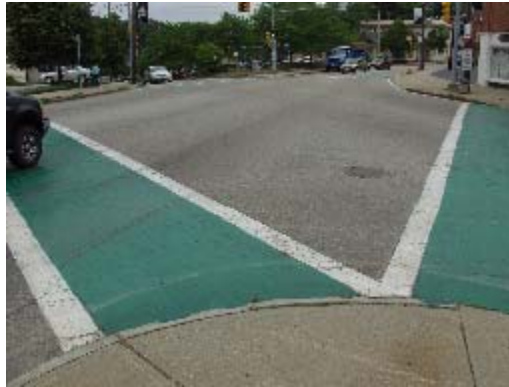
7. Install street furniture and trees along Broad Street between Middle and Commercial/Pleasant Streets.
8. Intersection of Broad, Commercial, and Pleasant Streets:
 - Create space for a curb extension on the northeast corner on Broad Street by narrowing the through and turning lanes at the intersection.
 - Reorient the crosswalk on Broad Street on the east approach, connecting it to the above-referenced curb extension, thereby shortening the crossing distance.
 - On the west approach of Broad Street, make the crosswalk perpendicular to the sidewalks, thereby shortening the crossing distance, and place it slightly farther back from the intersection than it is currently.
 - Change the pedestrian signals from exclusive to concurrent.
 - Stripe the turning movements for vehicles on the west approach of Broad Street.
 - Fix broken bulbs in pedestrian signal.

- Add at least four seconds to the pedestrian phase.

Intersection of Broad, Commercial, and Pleasant Streets

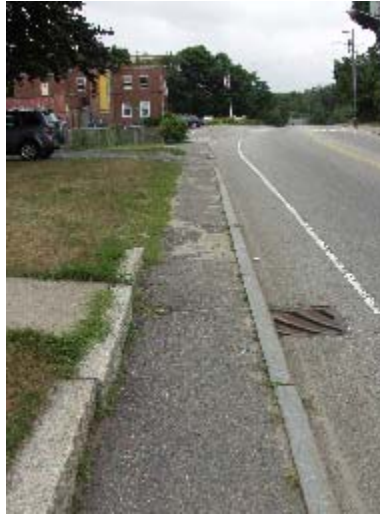
12. Widen the sidewalk between Jackson Square and the Weymouth Teen Center.

A narrow sidewalk leading to the Teen Center
