Re: Resolution 20-30: Gift Acceptance - Franklin Fire Department

CERTIFIED VEHICLE
APPRAISAL

Certified Vehicle Appraisal For Edward Guzowski

1949 American LaFrance Foamite Corp. 700 Series Ladder Truck

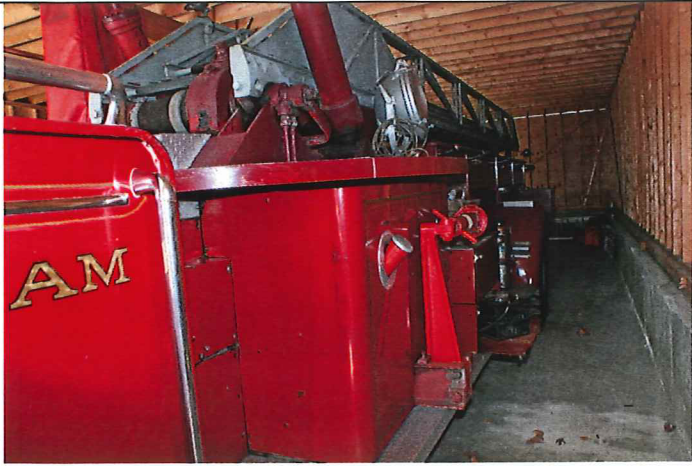
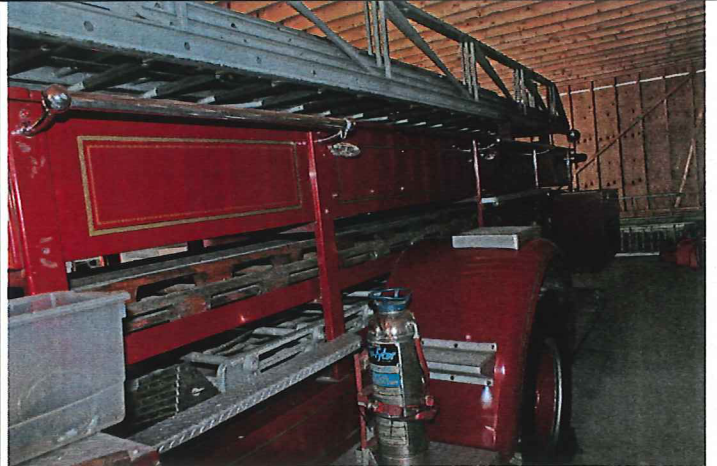
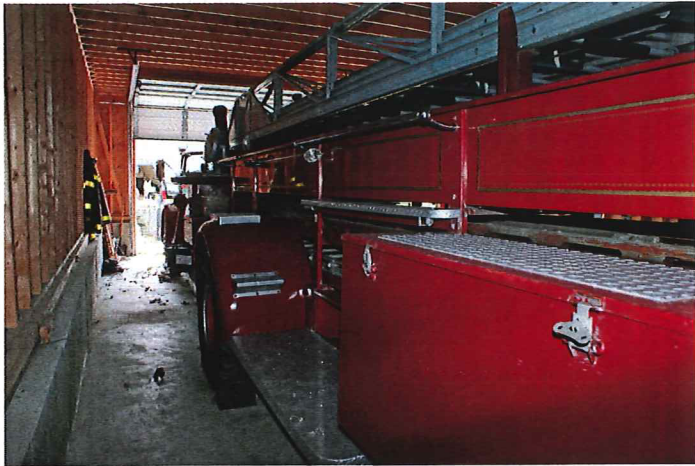
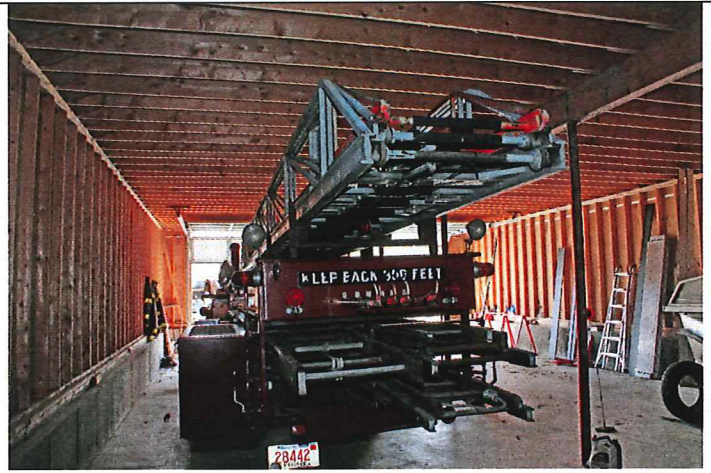
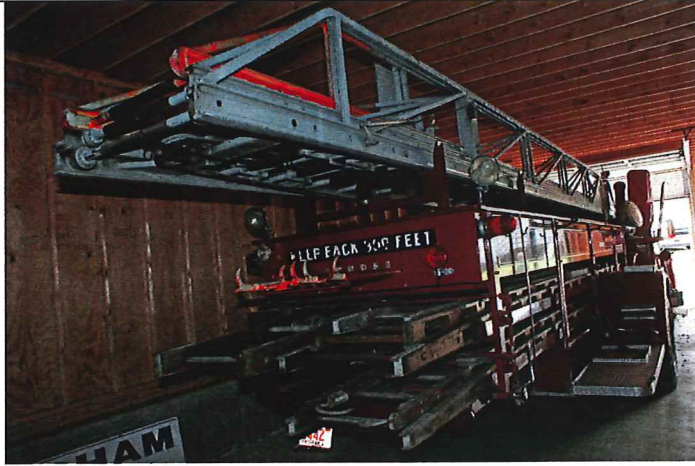
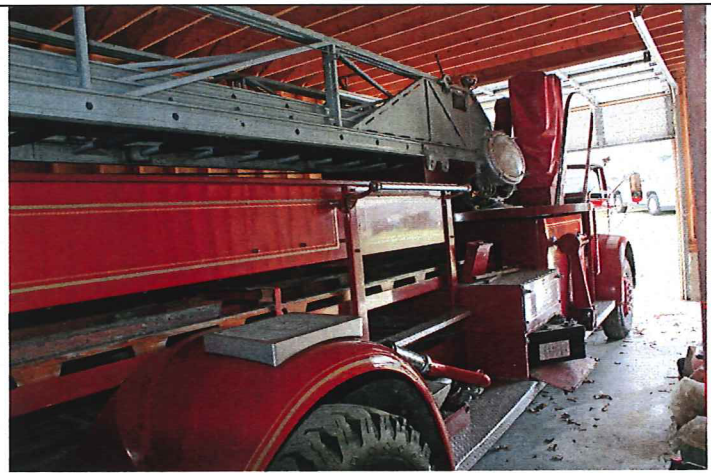
PHOTOS

The exterior of the vehicle is mostly original. It appears the cab area was repainted covering the original Franklin markings. This area has cracking and crow's feet appearing in several areas. The gold leaf is deteriorated in this area. The balance of the vehicle red paint is aged but in good condition including the gold leaf and the diamond plate painted silver. The wooden ladders appear original and aged accordingly. The pike poles are all stored and marked in the rear of the vehicle. Reflective "Keep Back" lettering is visible in rear and aged. An Air tank box was added to the left rear of the vehicle. Several spot lights and red warning lights are attached along the sides. A chrome Soda Acid Extinguisher is mounted on the driver's side. All the chrome grab handles and front bumper are in very good condition. All the lights, lenses and spot lights are in good condition. Only the glass front red lights are cracked. Aftermarket signal lights have been added front and rear. The aerial ladder is painted grey and the snorkel gun is side mounted on the passenger side. The 75 foot aerial control panel is covered with a vinyl cover. The control is in good aged condition but has never been operated by this owner. Overall the exterior is GOOD.

This is a very nice survivor ladder truck. Except for the repaint noted, minor changes, and the upgraded engine, it appears pretty much as it did when purchased in 1949. Rusting on the chassis and aging paint are the most obvious negatives. Except for the "cracks" in the aerial ladder and the fact that it has not been operated in years, it appears to be in serviceable condition. All the other mechanicals including the drive train, engine, brakes, electrical and steering are fully operational. Although it is in need of restoration in areas, this is still a nice parade vehicle. The other positive is that it has been stored indoors in dry storage for the last 20 years.
